Job No. 221037  
Fee ref LET 01  
Date 18.10.21

## **29 Great James Street, WC1N 3EY – Proposed Extension and Refurbishment Works**

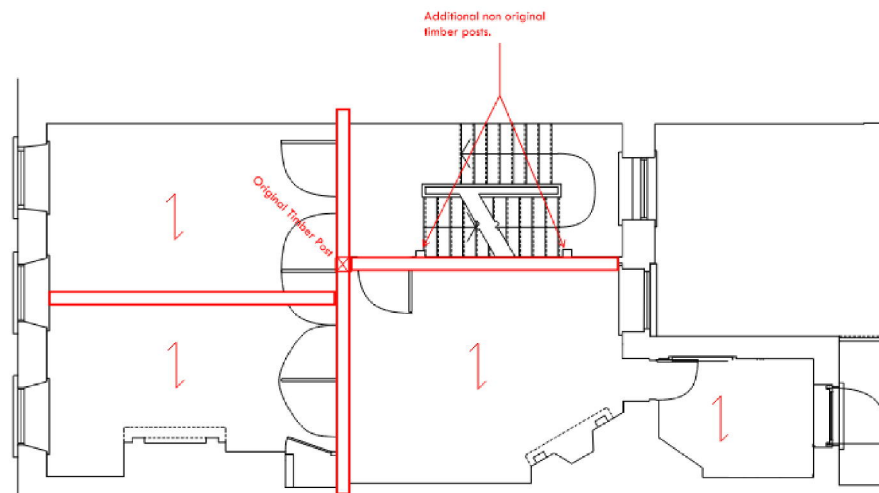
Image 1 – Typical Floor Construction

Based on our knowledge of the existing structure at no. 36 Great James Street, we understand that these buildings have existing timber joists which span from side to side from party wall to a central timber bressummer beam. The timber bressummer spans from the front to the rear of the property and is supported on a secondary timber beam spanning between party walls in the central spine wall location. The joists at no. 36 were typically 200mm deep x 60mm wide at 400mm centres and the existing bressummer beams were found to be 300mm wide x 200mm deep. No opening up works were completed as part of our visit to confirm the size of the joists and beams at no. 29 although we would expect them to be similar. Originally we understand that there was a single timber post in the location between the central spine wall and the stair wall. There appear to have been additional timber posts added at a later date up through the building in the stair wall. Presumably these were installed to strengthen the bressummer beam next to the stair.

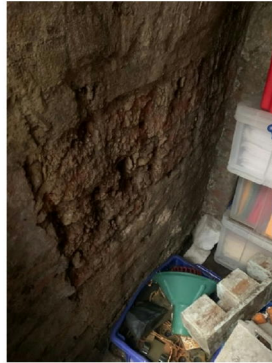
The lower ground floor under the main house seemed to be in fair condition and there was no obvious signs of any foundation movements. We wouldn't therefore expect a need for any structural repairs to this area. The brick arches to the front and rear vaults are also in a fair condition for their age and type. However, the mortar has become loose in some areas and there are signs of some brick erosion in areas with some bricks missing entirely. We would suggest the vaults be repointed with mortar to match existing and any damaged or missing brickwork be replaced.

*Images showing brick erosion*

1. Demolish existing modern timber frame extension
2. Existing brick arch vaults to be made good – missing brickwork to be carefully replaced with new bricks to match existing, loose mortar to be raked out and repointed with new lime mortar to match existing.
3. Temporarily prop and protect the vaults
4. Install new spreader beam at ground floor level under proposed new elevation on top of compressible material to avoid loading the vaults
5. Install the new strip footing where the extension is outside of the footprint of the vaults.
6. Construct a new ground bearing slab where the extension is outside of the footprint of the vaults
7. Construct new extension perimeter walls
8. Install new steelwork for the roof terrace and timber roof joists
