Project: 21_VTA_10_20
Site: Belsize House, 40 Belsize Park Gardens, London, NW3 4NA
Client: Mark Panter

Document Title:	Tree Safety Survey - 3 year time cycle.
Document Author:	Peter Haine FDS Arb, MArborA
Project Manager:	Matt Harmsworth
Project Title:	Belsize House, 40 Belsize Park Gardens, London, NW3 4NA

Report no: 21_VTA_10_20

Date: 09/11/2021

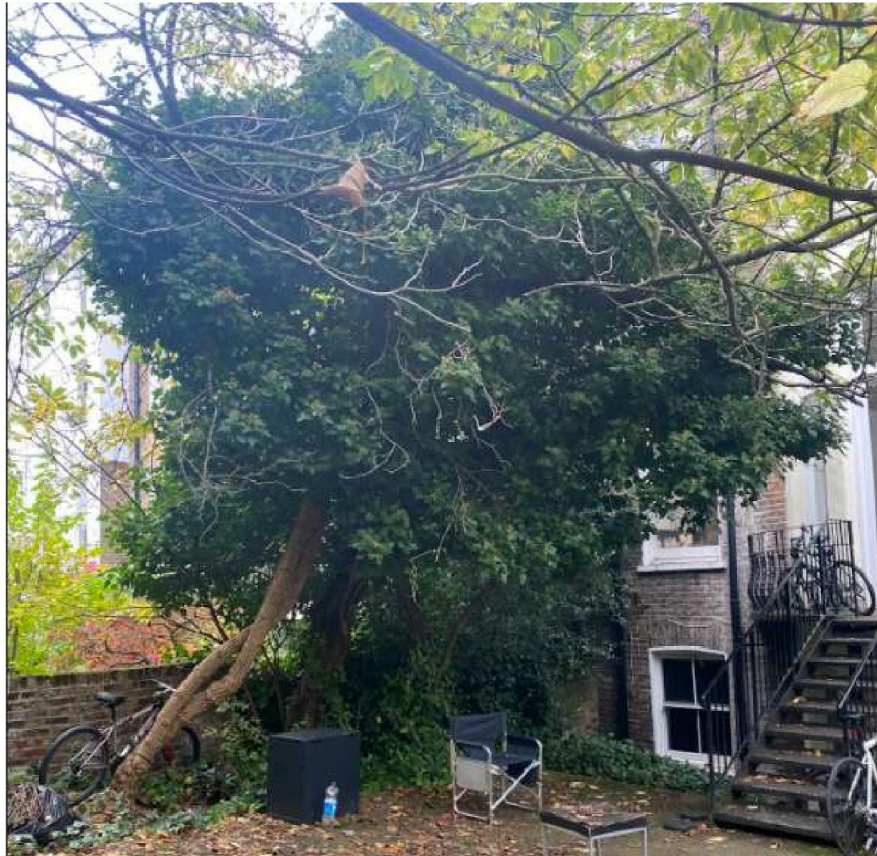
Photographic plate showing the heavy ivy growth in T0445 and T0446.

- 4.1 Recommendations for safety works are included within the data tables, with additional recommendations in the paragraphs below.
- 4.2 Heavy ivy cladding is an issue in the rear garden of 40 Belsize Park, recommendations have been made for ivy removal from T0445 and T0446.

Tree Tag	Species	Height	Age Class	Life Expectancy	Condition	Physical Description	Works Required	Timescale
445	Cherry	4 metres	M	20-40 years	Fair	Heavy ivy growth	Sever and remove ivy, prune to clear building by 2 metres.	1 year
446	Elder	4 metres	M	10-20 years	Fair	Heavy ivy growth	Sever and remove ivy, prune to clear building by 2 metres.	1 year
447	Elder	6 metres	M	<10 years	Decline	Heavily in decline.	Fell to ground level	1 year
448	Japanese Maple	3 metres		40 + years	Fair	Heavy climber growth, dead wood in canopy.	Sever and remove climber, remove dead wood.	1 year

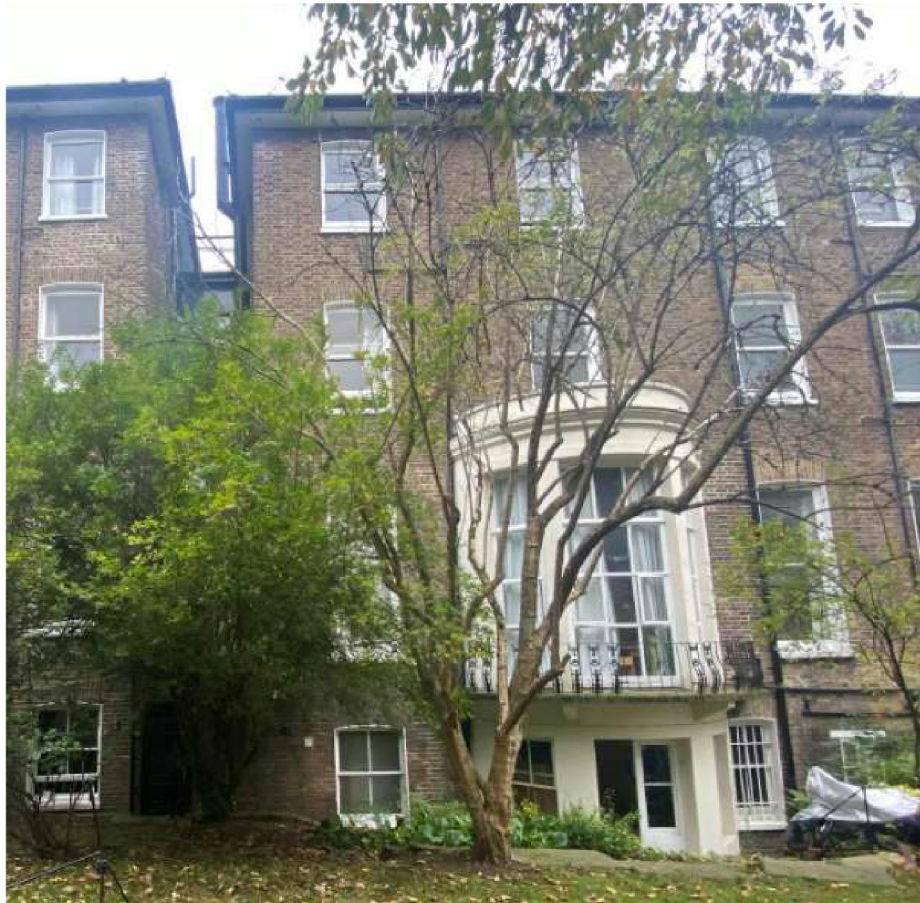
Photographic plate showing the heavily declining Elder, T0447.

T0447 is heavily in decline and will require removal.
- 4.3 T0448 in the rear garden of 30 Belsize Park is becoming overgrown with a climbing vine originating from the neighbouring garden; this will require careful removal if the tree is to survive.
- 4.4 Link to video with inspections and recommendations for surveyed trees:
