Arboricultural Report

Site: 7 Rosecroft Avenue London NW3 7QA

*Survey undertaken: Trees in relation to design, demolition and construction –
Recommendations.*

15th January 2022

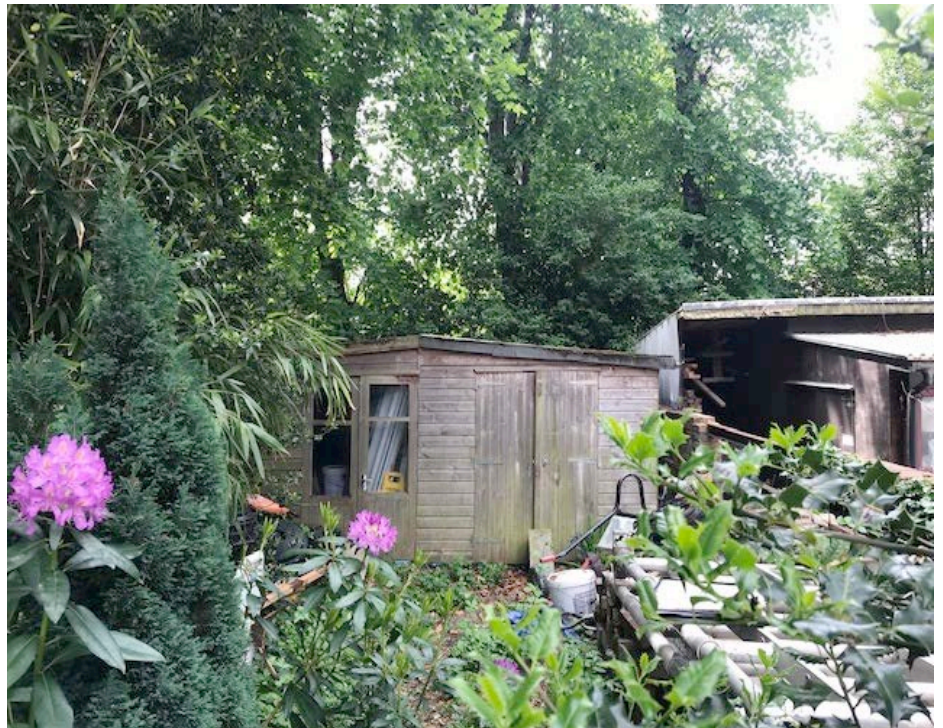
Photo1: Illustrates existing garden shed taken from rear garden aspect looking west. Outbuilding in rear garden of No.9 is to the right of photo.
