## Arboricultural Appraisal Report

### Damage Investigation at:

28 Park Village East  
London  
NW1 7PZ

| REPORT DATE: | 17/03/2021 |

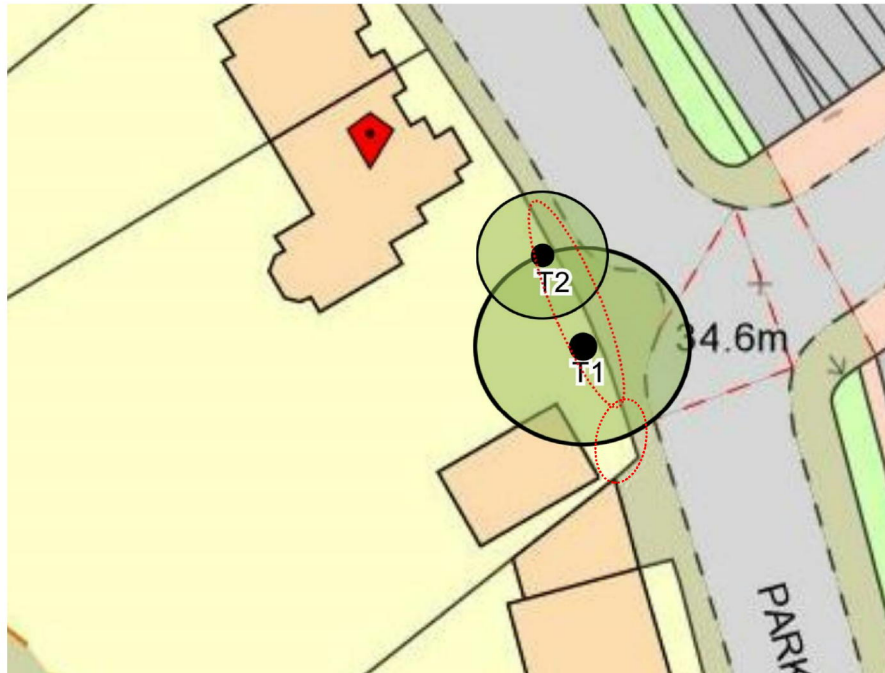
Site Plan

Approximate areas of damage

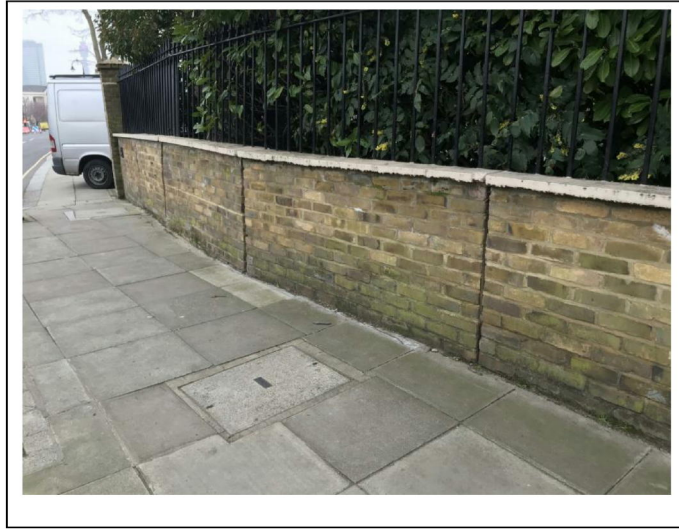
- 4.8 Both the Horse Chestnut (T1) and the Lime (T2) are located in very close proximity to the boundary wall and the deflection / distortion and cracking noted to the boundary wall is the result of direct damage caused by the incremental growth of the tree stem and by the secondary thickening of the tree roots.

View of distorted wall

- 5.3 In the event the wall is to be retained, in order to provide a durable solution, we recommend that the two trees are removed. Should replanting be considered we would advise that adequate space is allowed for future growth and that a root barrier is installed if the wall is to be rebuilt.

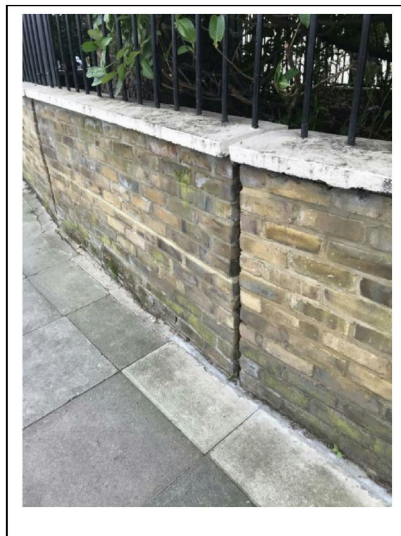
View of distorted wall

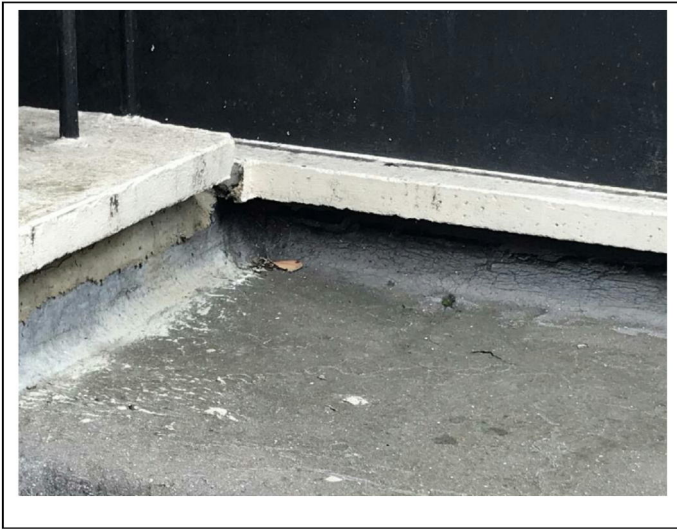
View of crack displacement

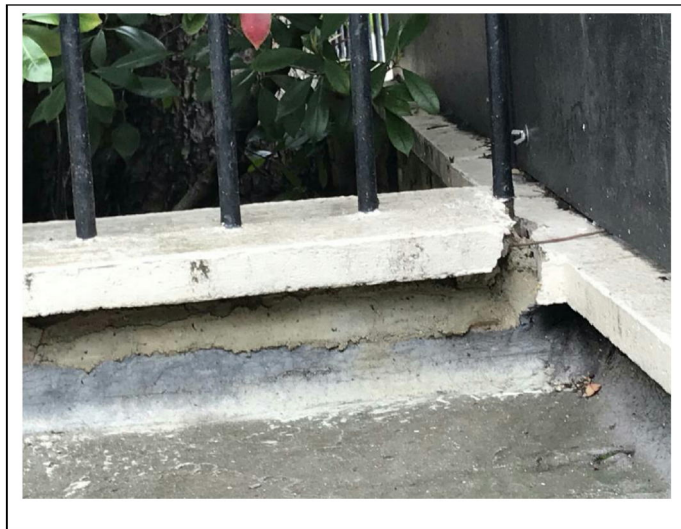
View of crack displacement

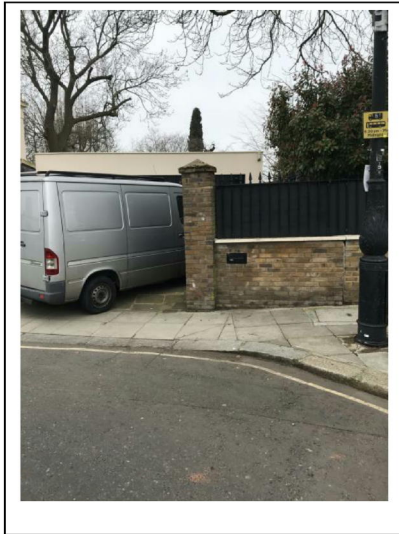
View of deflected (leaning) pillar

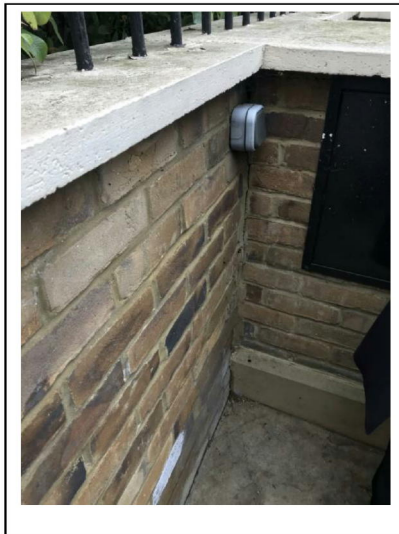
View of crack damage

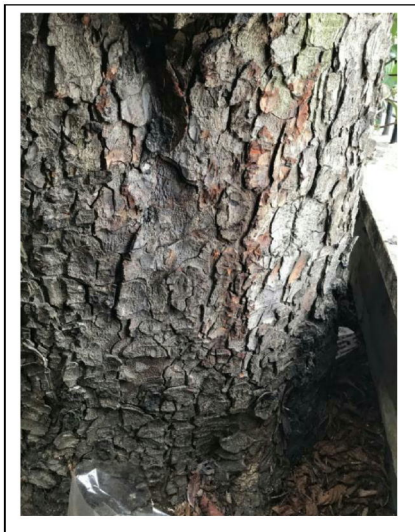
- 4.1 T1 is a fully mature Horse Chestnut growing adjacent to the boundary wall.
- 4.2 There is some evidence (Bark Staining) of Bleeding Canker of Horse Chestnut (*pseudomonas syringae* pv *aesculi*). Forest Research identifies Bleeding canker as '*a disease that affects European horse chestnut trees (Aesculus hippocastanum) in Great Britain. It is characterised by the appearance of 'bleeding cankers', or lesions, on the stems (trunks) and branches. These cankers ooze, or bleed, dark fluid. In most cases diagnosed since the year 2000 the cause has been the bacterium Pseudomonas syringae pathovar aesculi. It can kill affected trees, although some do recover from infection, and some appear to be resistant to it.*' The staining was not extensive and there was no evidence of significant lesions or large necrotic areas of bark. Accordingly, we do not consider that the disease is significant (at this stage) in terms of the tree being classified as Dead, Dying or Dangerous however, disease progression can be rapid (in some instances) so the tree should be inspected regularly.

View of Horse Chestnut trunk (T1) showing bark staining

| Tree No. | Species | Ht (m) | Dia (mm) | Crown Spread (m) | Dist. to building (m) | Age Classification | Ownership |
|---|---|---|---|---|---|---|---|
| Recommendation | | Remove (fell) to near ground level and treat stump to inhibit regrowth. | | | | | |

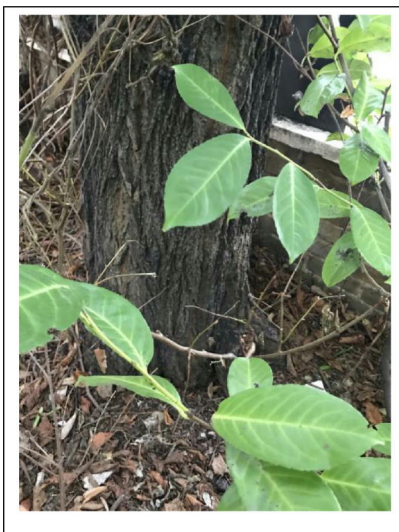
- 4.6 T2 is an early mature lime which has been the subject of historic pruning (crown reduced circa 4-5 years ago).
- 4.7 No significant defects were observed and the tree appears to be in good health.

View of Lime (T2) trunk

| Tree No. | Species | Ht (m) | Dia (mm) | Crown Spread (m) | Dist. to building (m) | Age Classification | Ownership |
|---|---|---|---|---|---|---|---|
| Recommendation | | Remove (fell) to near ground level and treat stump to inhibit regrowth. | | | | | |

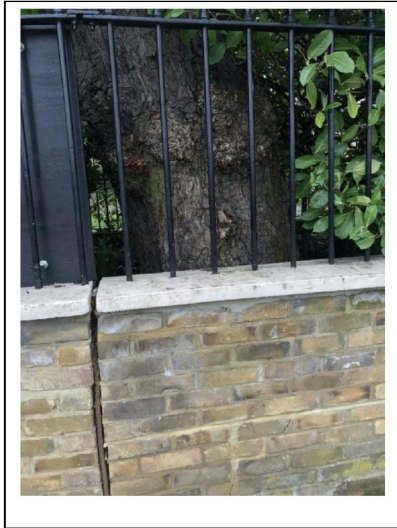
View of Horse Chestnut (T1)

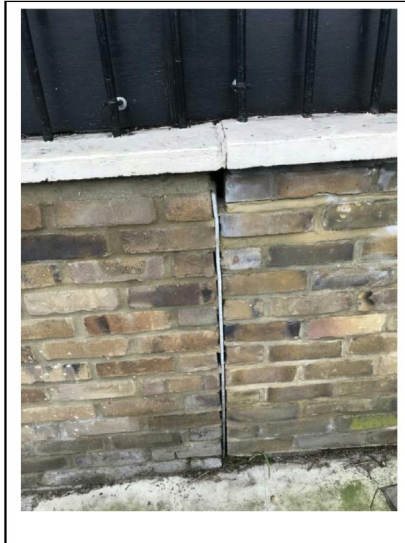
View of wall displacement

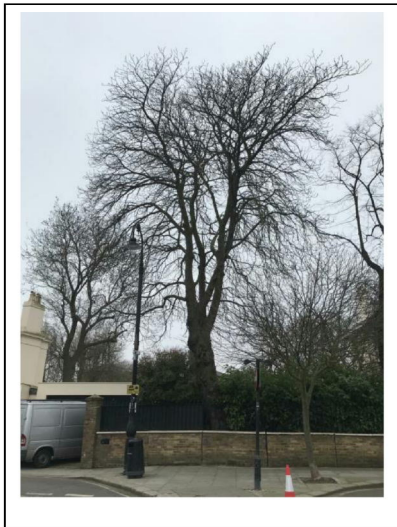
View of Horse Chestnut (T1)

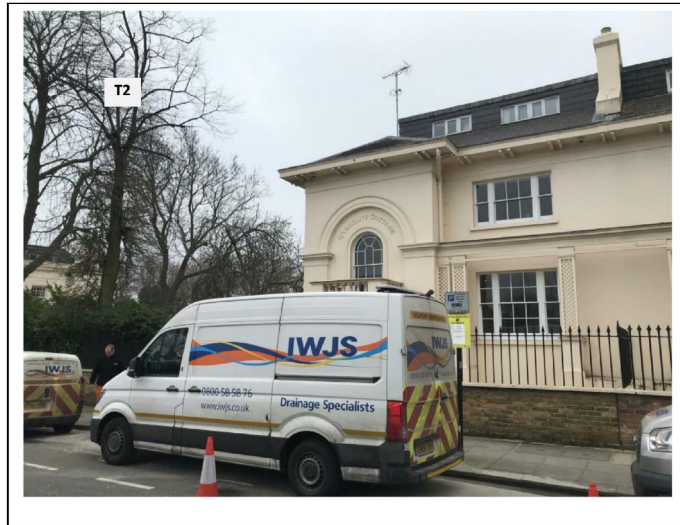
View of Lime (T2)

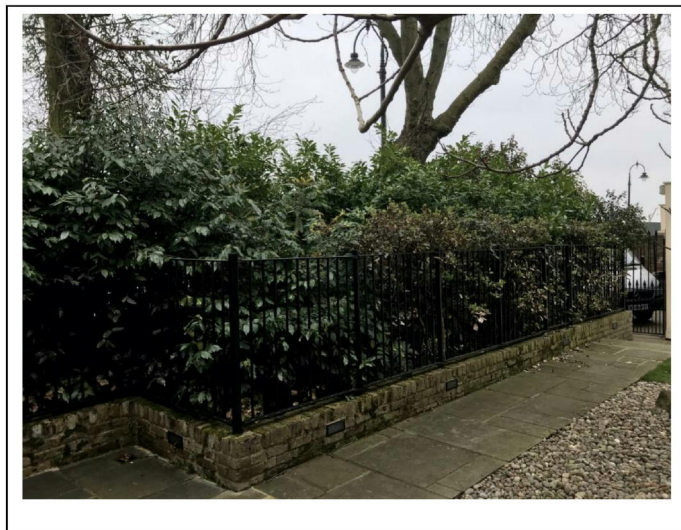
View of fenced off section to rear of boundary (retaining) wall showing T1 and T2.
