BS5837 Arboricultural Report,

Arboricultural Impact Assessment

OUR REFERENCE	AC.2021.426
CLIENT	Mr Karl Noonan
SITE	Flat 2, 68 Priory Road, Camden, London, NW6 3RE
REPORT BY	I S Thompson (known as Tom) MArborA., BSc. (Hons) Arb, MSc. eFor
DATE	17th January 2022
DATE OF SITE VISIT	1st October 2021

**Side extension to existing residential ground floor
apartment.**

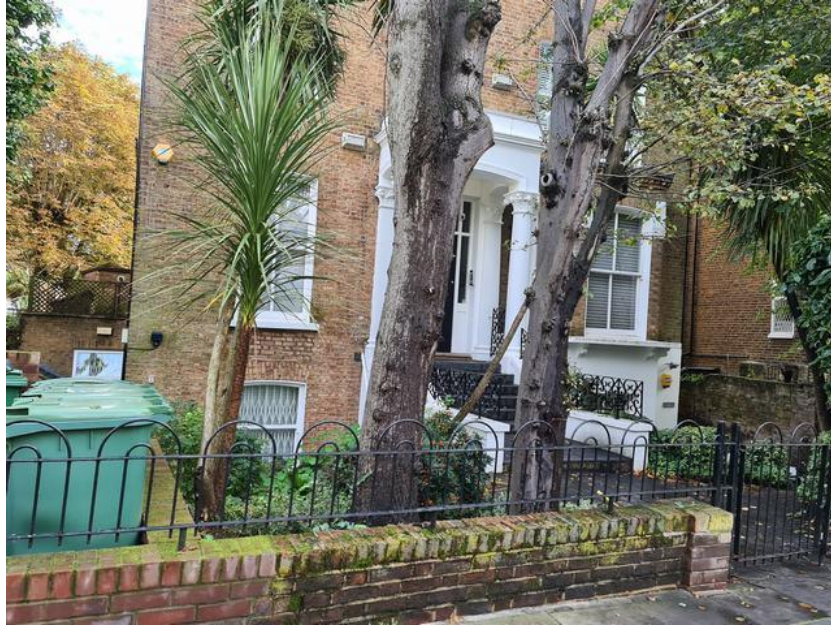
Image 1 Base if T1 on left, T2 in the centre and T3 on the right.

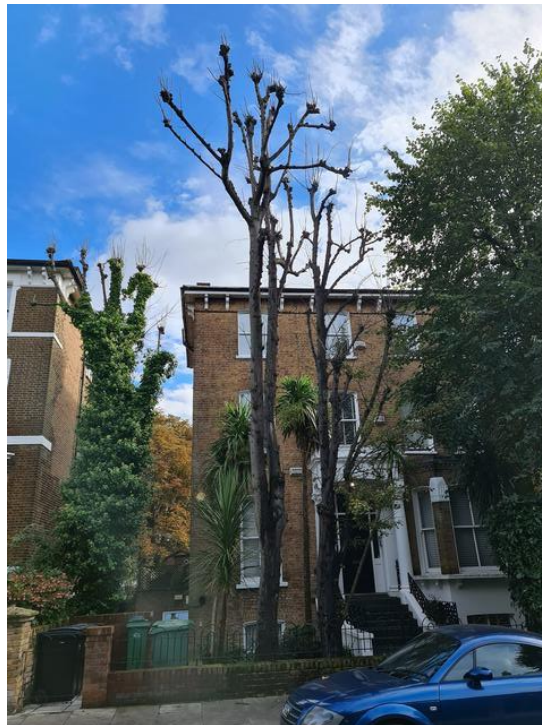
Image 2 T2 and T3 to left of the entrance.

- 12.2** There are only two dead or dying trees that are proposed for removal as part of this applications. These are T02 and T03 both lime trees.
- 12.3** If at any time additional pruning works are required permission must be sought from the Local Planning Authority first and then carried out in accordance with BS 3998 Recommendations for Tree Works 2010, unless otherwise specified with clear justification for any deviation from the British Standard.

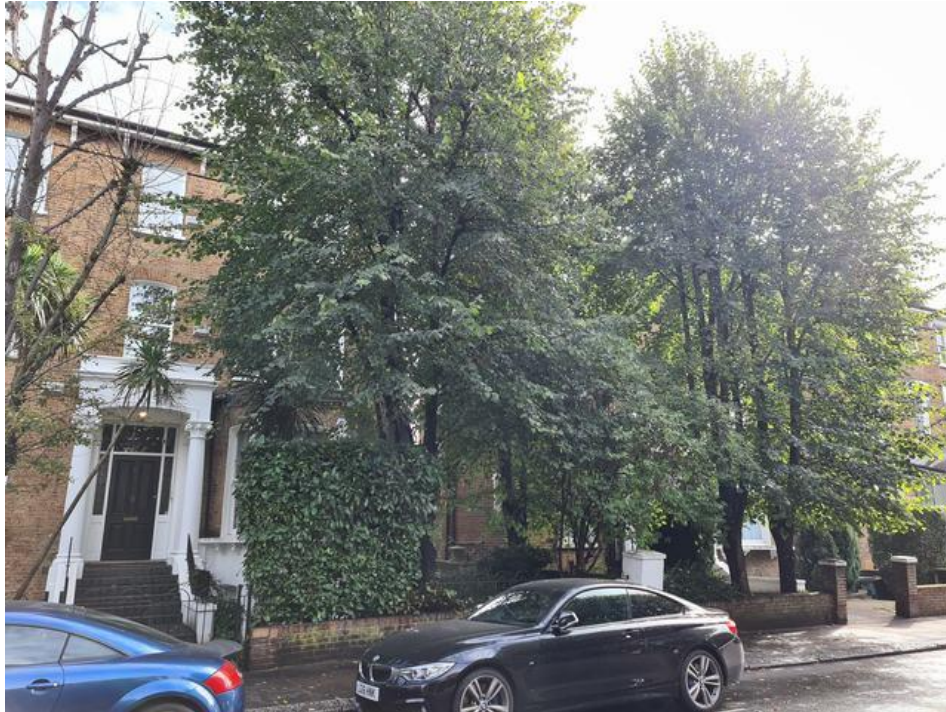
Image 3 View of T6 and T7 to the right of the entrance.

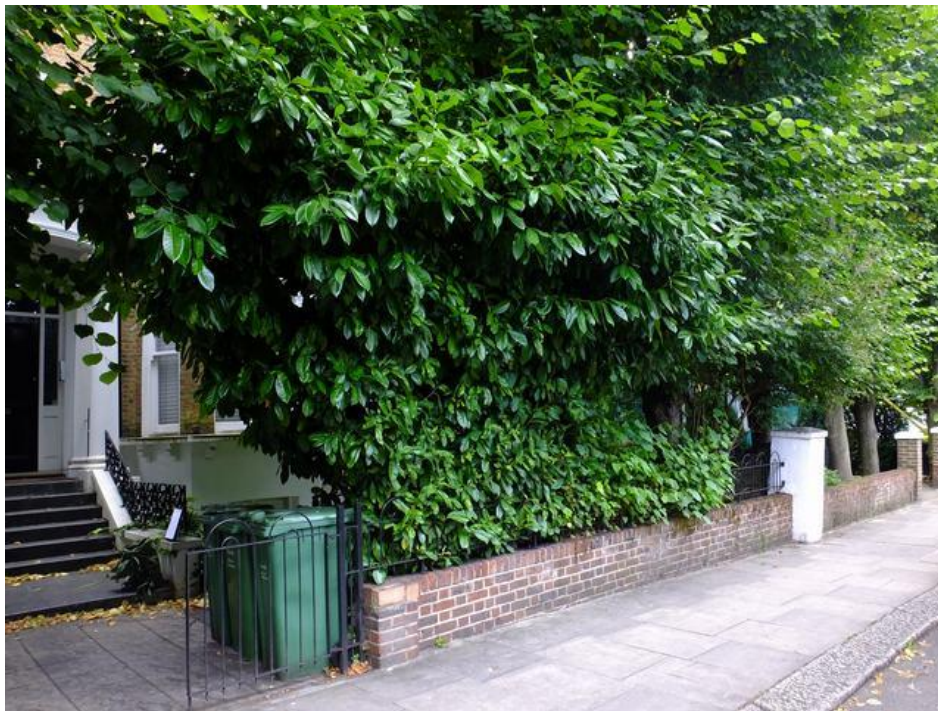
Image 4 T4, Chery laurel bush.

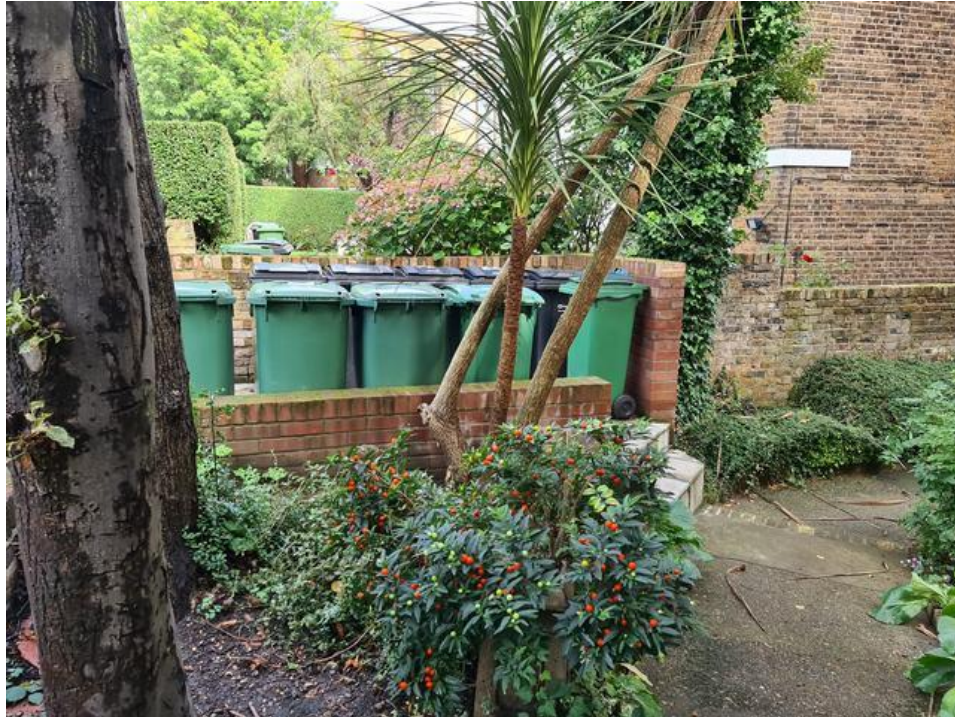
Image 5 Cabbage palms T1 on the right.

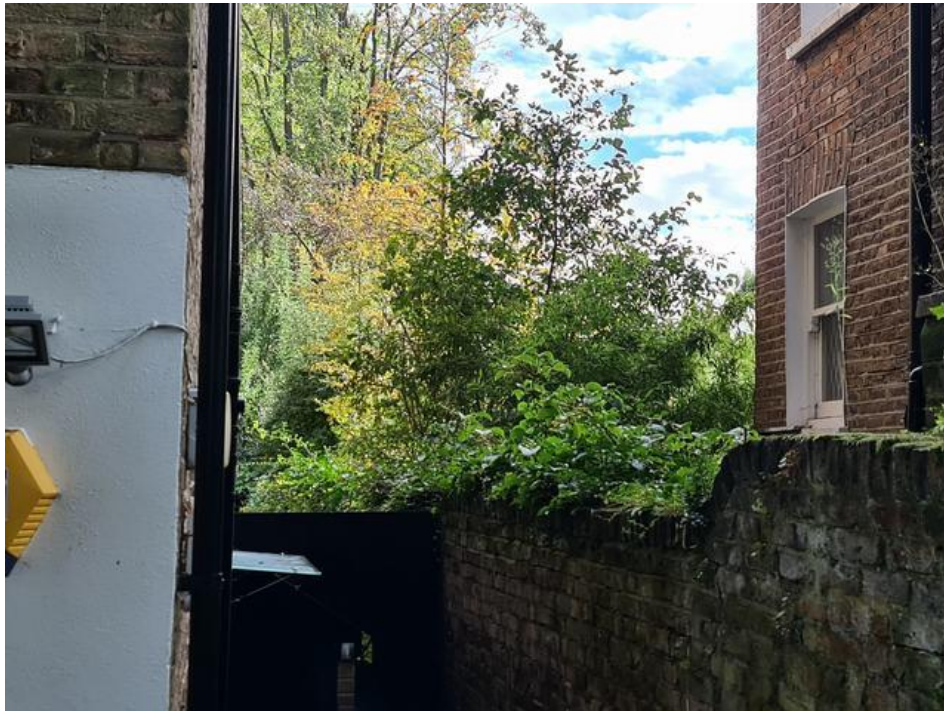
Image 6 T9, a small rowan tree in the adjacent property.

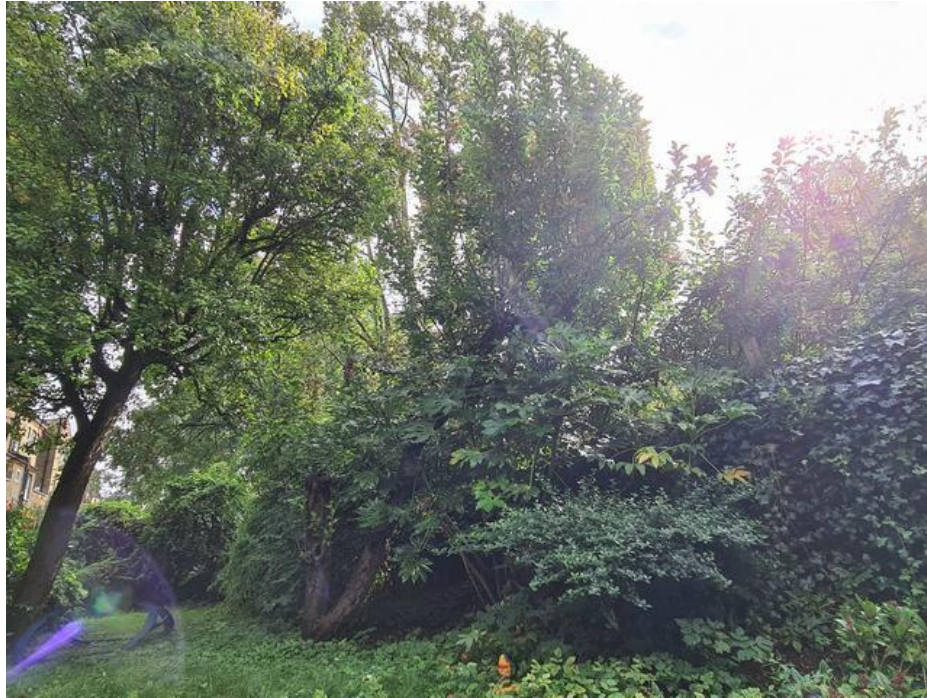
Image 7 T10, an aging apple tree in the rear garden (right) with T11 a pear (left).

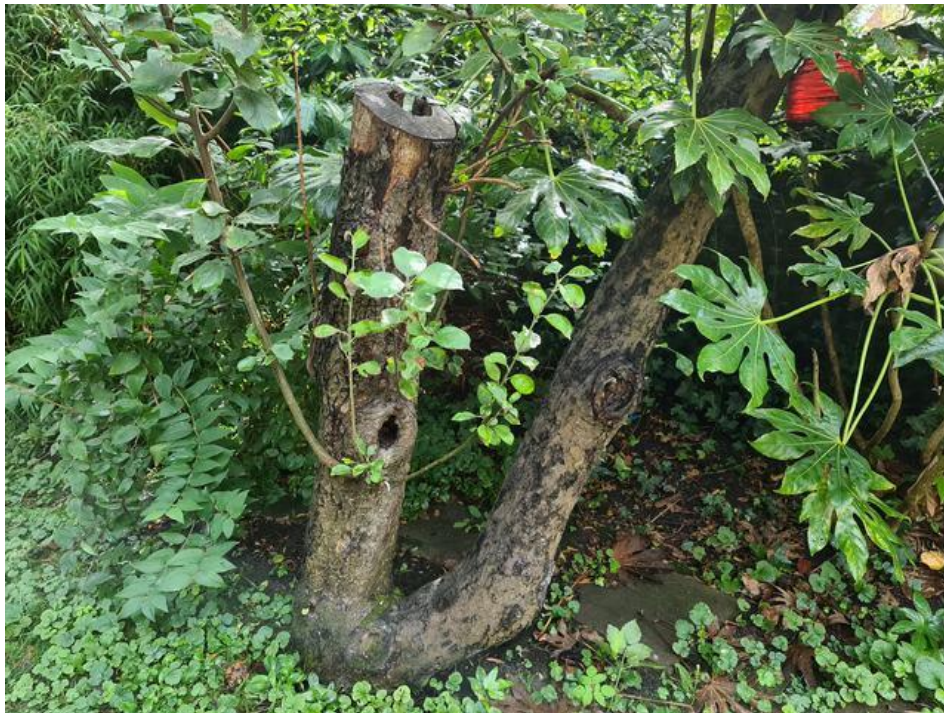
Image 8 Stems of apple tree with signs of decay.

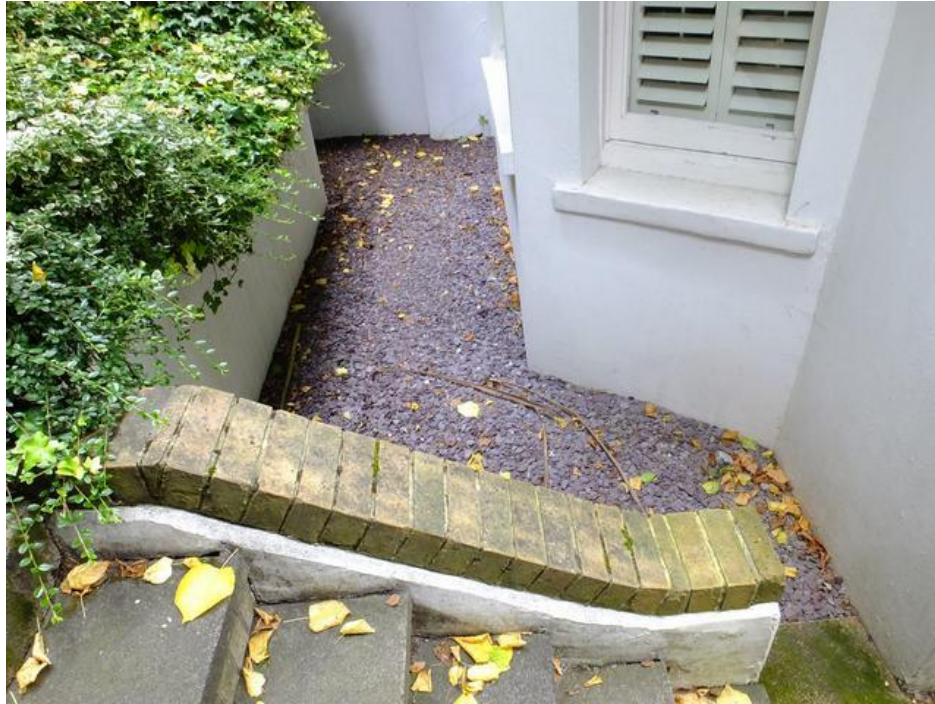
Image 13 Further space to the front of the apartment for materials to be stored.
