1.4 Harrison Shortt Structural Engineers Ltd. (HSSE) have been appointed by the building owners to prepare the structural design of the alterations at 82 Fitzjohns Avenue.

1.5 This report is focused solely on the boundary wall with spring walk

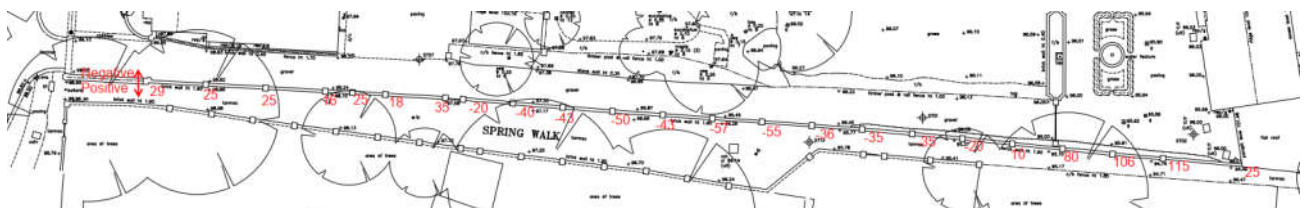
3.1

0-35m leans into spring walk 35-90m leans into the site and the remaining wall leans into spring walk

5.2 Where possible the traffic should be kept back from the wall with a fence creating an exclusion. Where this is not possible local to the house the wall should be carefully dis-assembled (the bricks labelled and kept) for the duration of the construction works and reassembled once the works are complete.

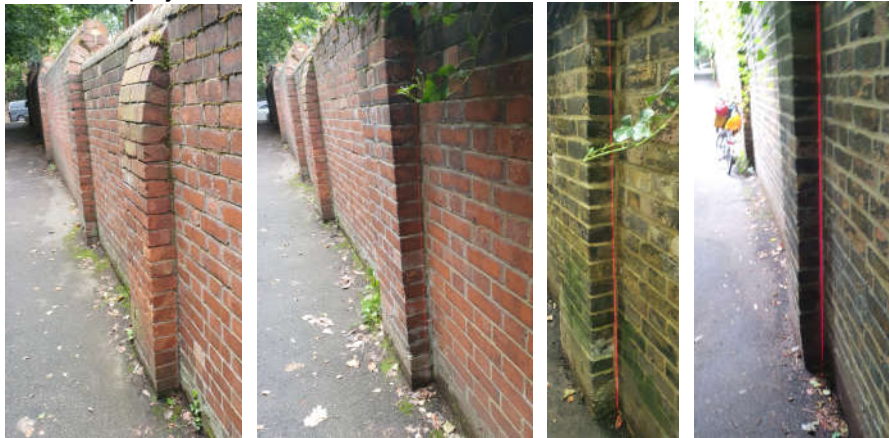
3.2 Sample of vertical laser line projected onto wall
