## SJ Stephens Associates

24<sup>th</sup> May 2021

### **Re: Report on Trees at 44 Denning Road, NW3 1SU**

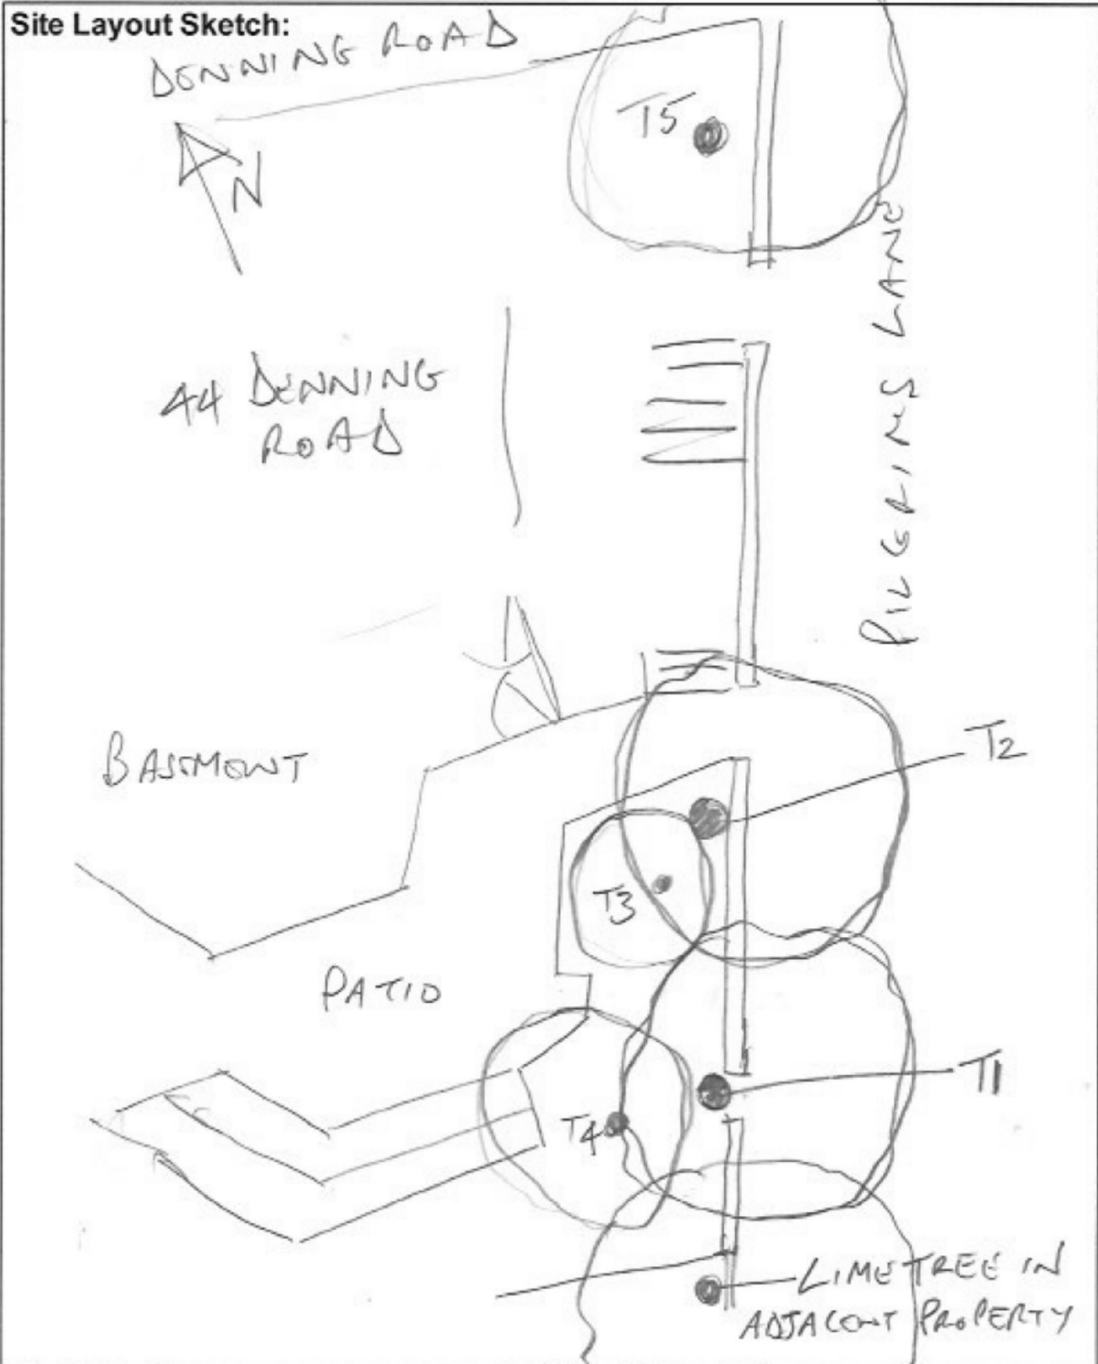
Site Layout Sketch:

There are three early mature lime trees, T1, T2 and T5, growing close to boundary walls bordering onto Pilgrims Lane. T1 and T2 are growing approximately 0.7m above pavement level and T5 is growing approximately 0.3m above pavement level. All three are causing damage to the wall.

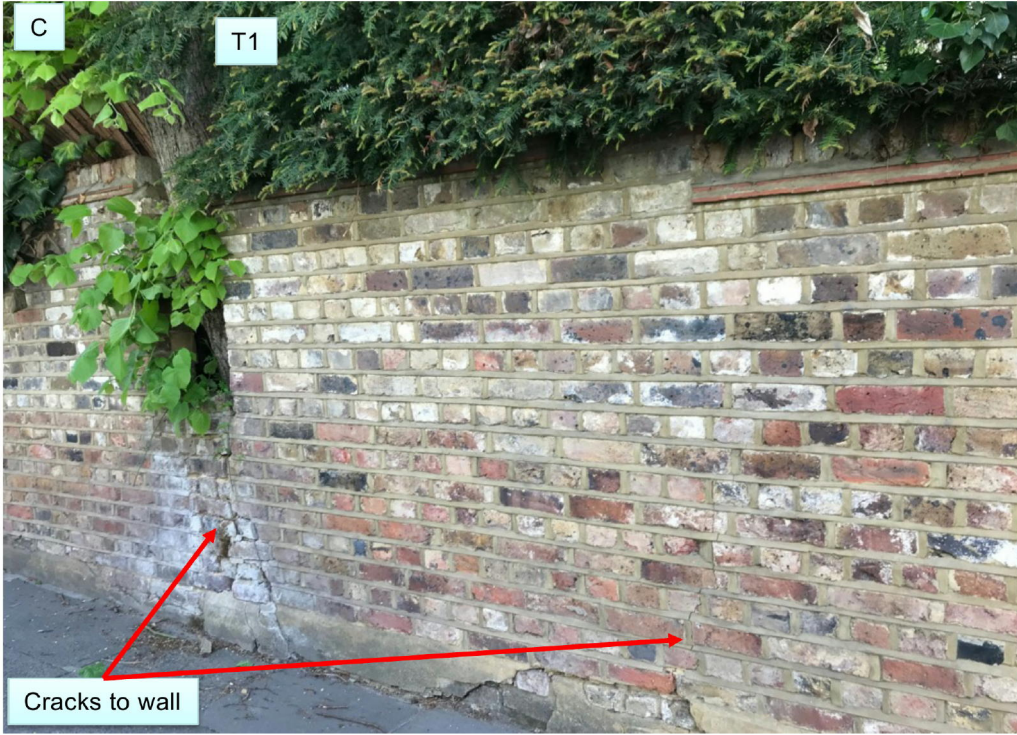
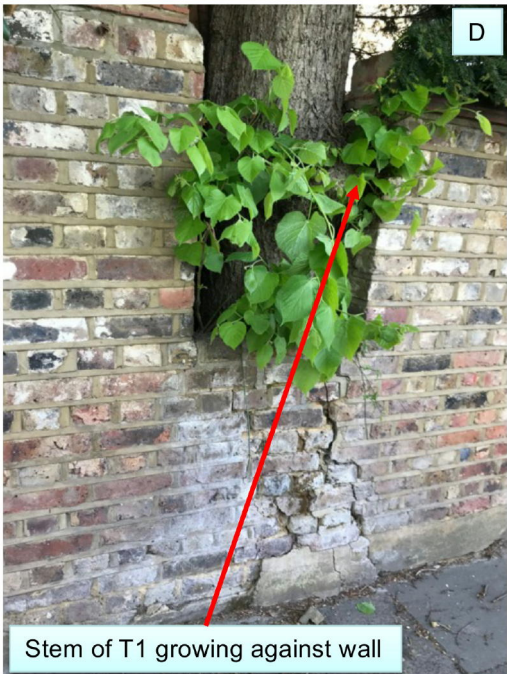
The wall has been built around T1, as can be seen in photos C and D, however the stem base is now growing against the base of the wall and higher up, the stem is growing against a point approximately 0.3m from the top of the wall. The base of T2 is further from the wall, however the tree has a slight lean over the pavement and the stem, combined with dense ivy growth, is growing against the top of the wall. As seen in photo E, there are cracks in the wall between T1 and T2 and it is leaning over the pavement as a consequence of the increasing pressure exerted by both trees. This will get more extreme as the trees grow.

Modification of the wall, increasing the width of the "window" around T1 and creating a similar "window" in the brickwork around T2 would reduce stresses on the wall. However, advice from a structural engineer should be sought to advise whether this action, together with repointing, would be adequate to make the wall safe and limit further deterioration. Ivy should be removed from around the base of T2 and regular pollarding of the trees will help to limit future growth.
