Subsidence Tree Report

For The Egypt Exploration Society

2-4 Doughty Mews, London, WC1N 2PG

Insured:	The Egypt Exploration Society
Insurer:	TBC
Insurer Ref:	TBC
Client Ref:	TBC
Our Reference:	03679R
Consultant:	Keiron Hart (BSc Hons, C.Env, F.Arbor.A, MICFor, MEWI)
Visit Date:	10.11.2021
Report Date:	12.11.2021

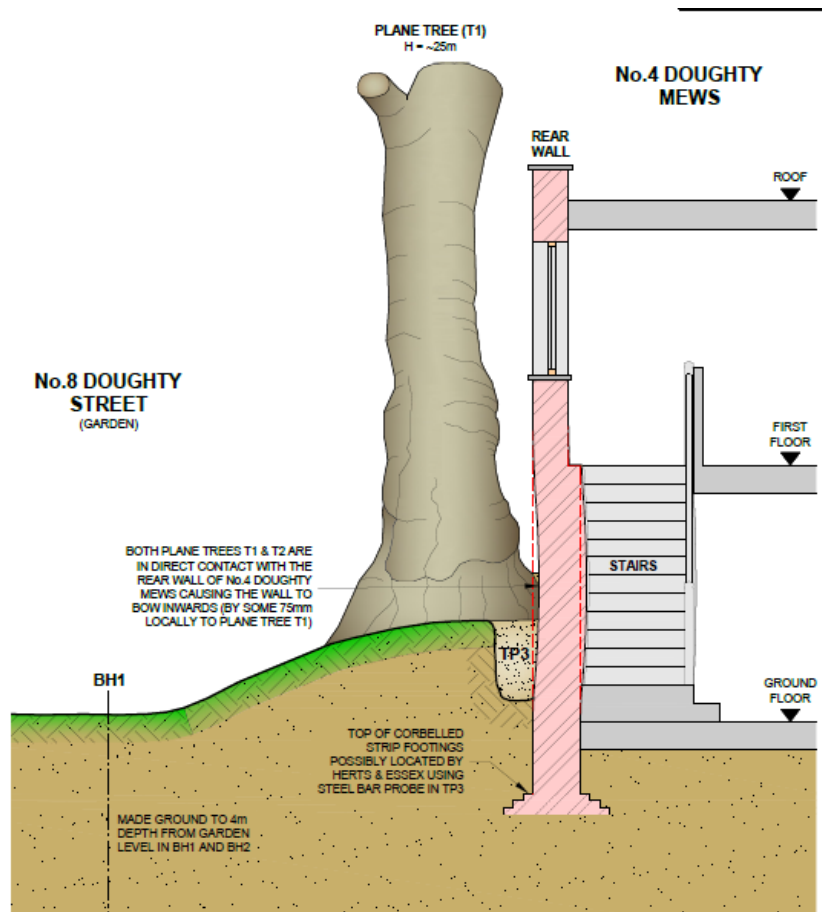
- 5.8 Soil testing is inconclusive given the underlying soil type but there can be no doubt given the size of T1 & T2 relative to the property that the trees will be depleting soil moisture levels below foundation level. However, soil moisture depletion/ clay shrinkage is not the advised mode of damage in this claim.
- 5.9 No monitoring is available but the overall engineering opinion is one of direct physical displacement damage of the rear wall being caused by long standing direct contact of an expanding lower stem. This is pushing the rear wall of the property out of line.

Fig 2 – Annex 1 from William J Marshall & Partners (19.7.2021) visualising the physical displacement of the rear elevation.

- 5.13 The trees are located within a Conservation Area and notification to the council under s211 would be required to progress removal of the trees. Removal is the only action which will remove the direct physical contact of the stems with the building and allow repairs in the location of the existing building line. There is no doubting the trees are large and locally significant although their wider public amenity is somewhat limited by their rear garden location.

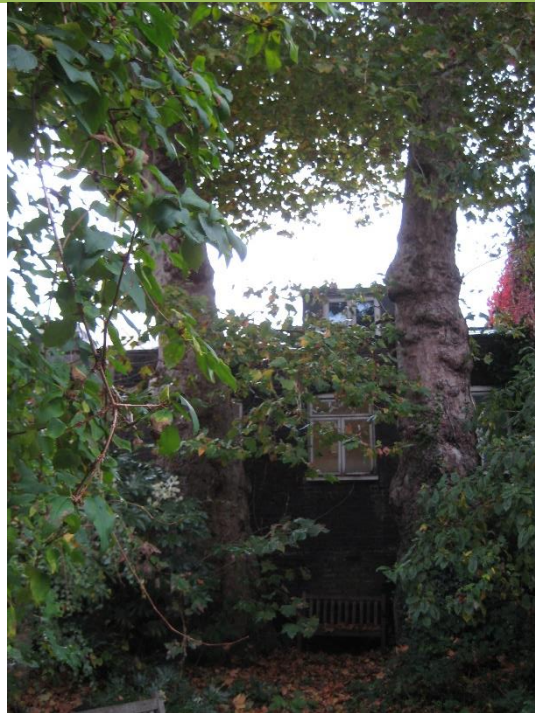
Image 1 - The property (rear elevation) and T1 & T2

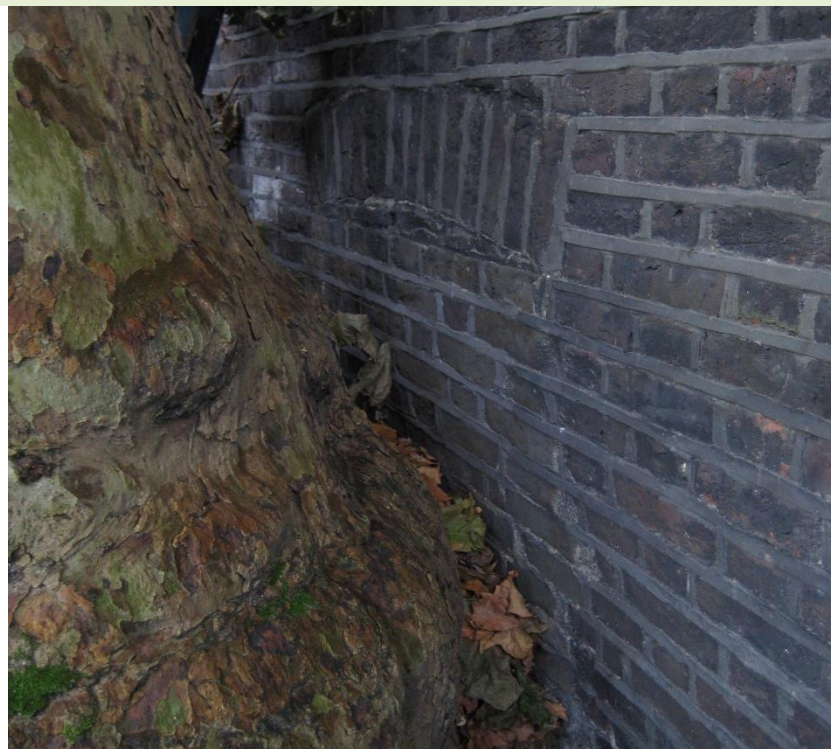
Tree No.	Species	Age Cat	Height (m)	Distance to Building (m)	Ownership	Observations	Subsidence Risk Action	Recommended Tree Work
T1	Plane (London)	B	21	0	One Housing	Mature example. Large basal stem diameter. Basal area not fully visible given undergrowth and leaf litter. In direct physical contact with the affected property. Previously reduced with relatively minor crown reduction pruning.	Current Claim	Remove & replace
T2	Plane (London)	B	21	0	One Housing	Mature example. Large basal stem diameter. Basal area not fully visible given undergrowth and leaf litter. In direct physical contact with the affected property. Previously reduced with relatively minor crown reduction pruning.	Current Claim	Remove & replace

Image 2 – T1 showing direct contact with the rear of the property. Only removal of T1 & T2 will remove this issue

- 5.17 Scope exists to replace T1 & T2 with suitable ornamentals further from the building. We would recommend trees of a slightly smaller size in this instance and chosen from lower water demand species planted spatially further from the buildings to seek to avoid a return of damage as they mature. Engineers should confirm issues of heave prior to the removal of the trees.

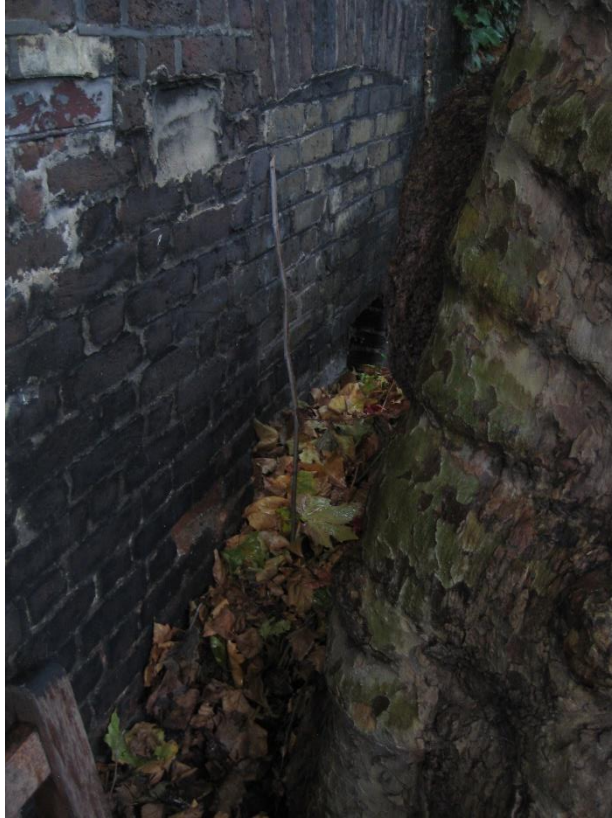
Image 3 – T2 and the rear elevation

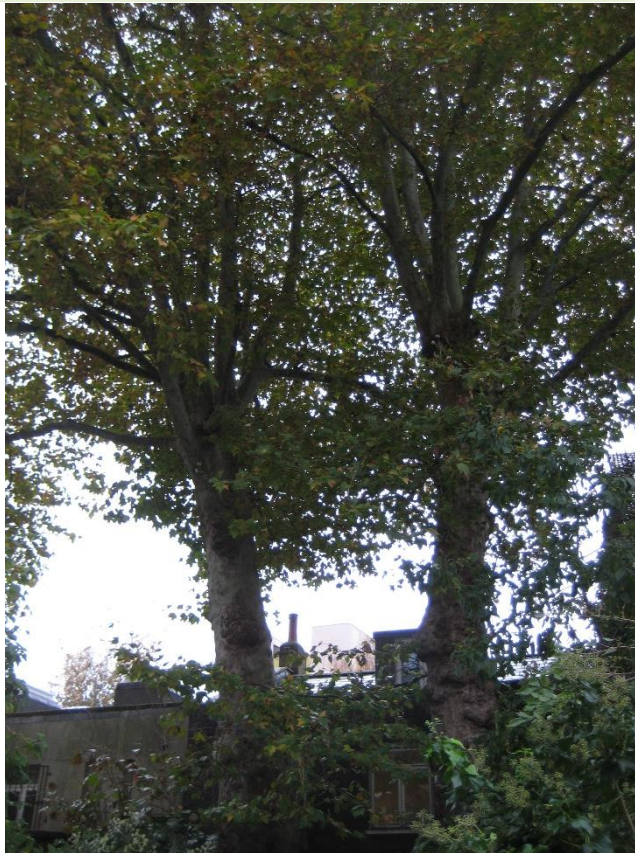
Image 4 – T1 & T2
