# Tree Survey, Arboricultural Impact Assessment Preliminary Arboricultural Method Statement & Tree Protection Plan In Accordance with BS 5837:2012

Proj. No <b>9293</b>	The Engineer, 65 Gloucester Avenue, Chalk Farm, London, NW1 8JH						
	Clie	nt:	The JTS Pa	artnership			
Date of F	of Report: 27/01/2022		Revision:	Original

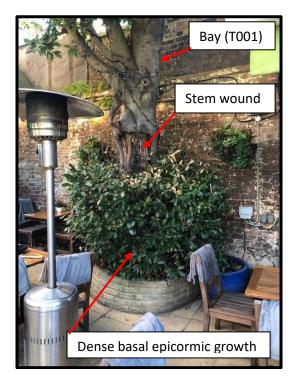
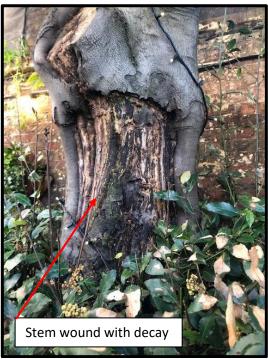
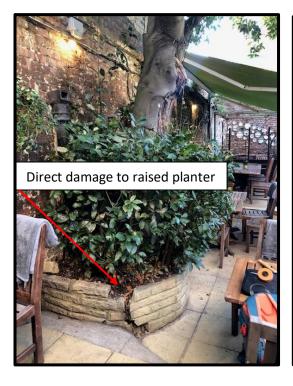
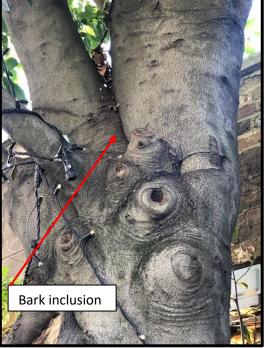
- 4.3.2 Whilst the tree's removal is required to facilitate the proposed renovations to the external garden area, its removal is recommended irrespective of the whether the renovations proceed or not. The tree is located in a raised planter, circa. 0.4m high and within 0.4m of a circa. 3.5m high boundary wall. The raised planter is failing with extensive cracking present that can be attributed to direct damage from its roots. The dense epicormic basal growth is also exacerbating the damage. A large, decaying wound is also present on the stem's western aspect at circa. 1.5m above ground and above this at circa. 2.5m above ground level is a bark inclusion. The tree's roots are also girdling the base of the stem.

- 4.3.3 Whilst the tree is not considered to pose an imminent risk, given the direct damage evident, it's impaired form and compromised structural integrity in conjunction with its proximity to the adjacent boundary wall, its future retention is no longer considered advisable.

4.3.4 The photographs below highlight the direct damage, stem wound and impaired structural integrity referred to at points 4.3.2 and 4.3.3 above.

Tree No.	Species	Work required	Priority
T001	Bay Laurel	Fell.	3
