The Heath & Hampstead Society

To London Borough of Camden, Tree Preservation Team

Planning Ref: 2022/0247/T
Address: 44 Denning Road London NW3 1SU
Case Officer: Tree Allocation
Date: 5th February 2022

We are concerned about this Notice of Intent to fell 2 lime trees at this property fronting Pilgrims Lane.

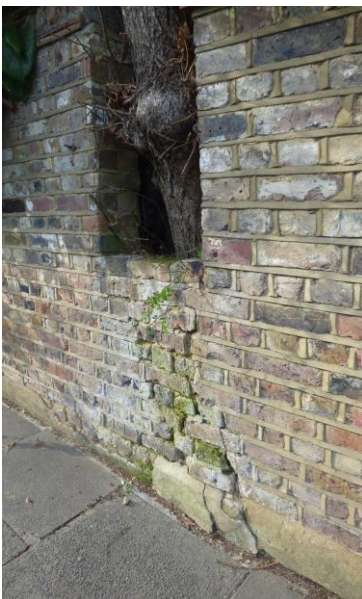
We agree with the arboriculturalist that a structural engineer is required to determine the fate of the wall. The wall by T1 & T2 is in a pretty damp state, by T1 it is in a parlous state, partly due to inappropriate cementitious pointing that has allowed frost damage of the bricks. It requires a significant degree of re-building, though Street View indicates this has been present and little different since 2017 at least.

1: Wall in front of T1

I suggest all the factors operating here require consideration by a structural engineer when planning to rebuild the walls, but that these three trees with high public amenity – as well as the lime tree on the neighbouring property with a low, now cracking, wall built very close around it – should all be retained for the future.

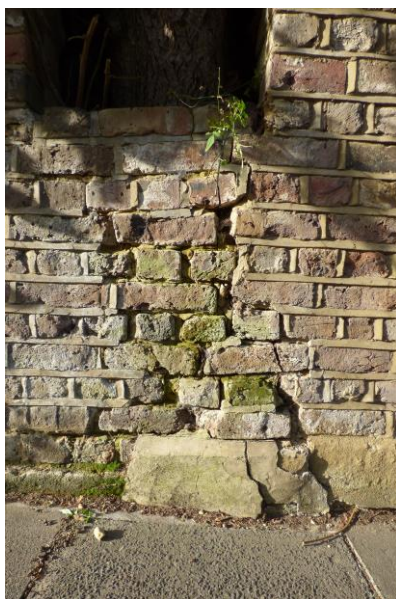
2: Wall & cement pointing failure

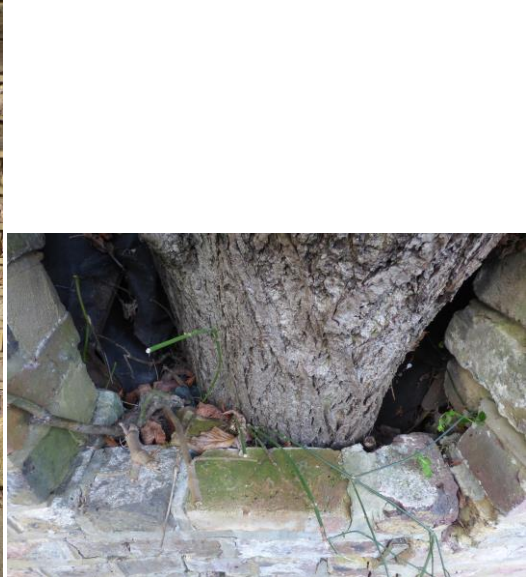
The wall has been pushed on for many years by both T1 & T2's expanding trunks. The wall in front of T1's lower trunk has been cut out and replaced with a one-brick width thick wall, while the wall was extended out in the past to go in front of (but too close to) T2, with a minimal lean outwards, considerably inside a lean-angle of concern. Photo 4 seems to indicate this length of angled wall that is one-brick *length* thick and built to 'contain' T2 has not moved since, but T2 is up against it. Since risk is not an immediate issue, we suggest there be no rush to fell the trees, but advice sought from a structural engineer (as suggested but which has apparently not yet occurred) regarding how the wall in front of T1 and T2 can be safely re-built and supported *with the trees retained*. This could be done with complete gaps where both T1 and T2 are to allow for the trees' future growth long term, and for a slight degree of trunk movement during strong winds. Low weep holes may be recommended to drain the damp soil behind. Retention of the Conservation Area character by re-using these bricks with appropriate mortar/pointing will also be essential.

3: Wall 1-brick width thick by T1

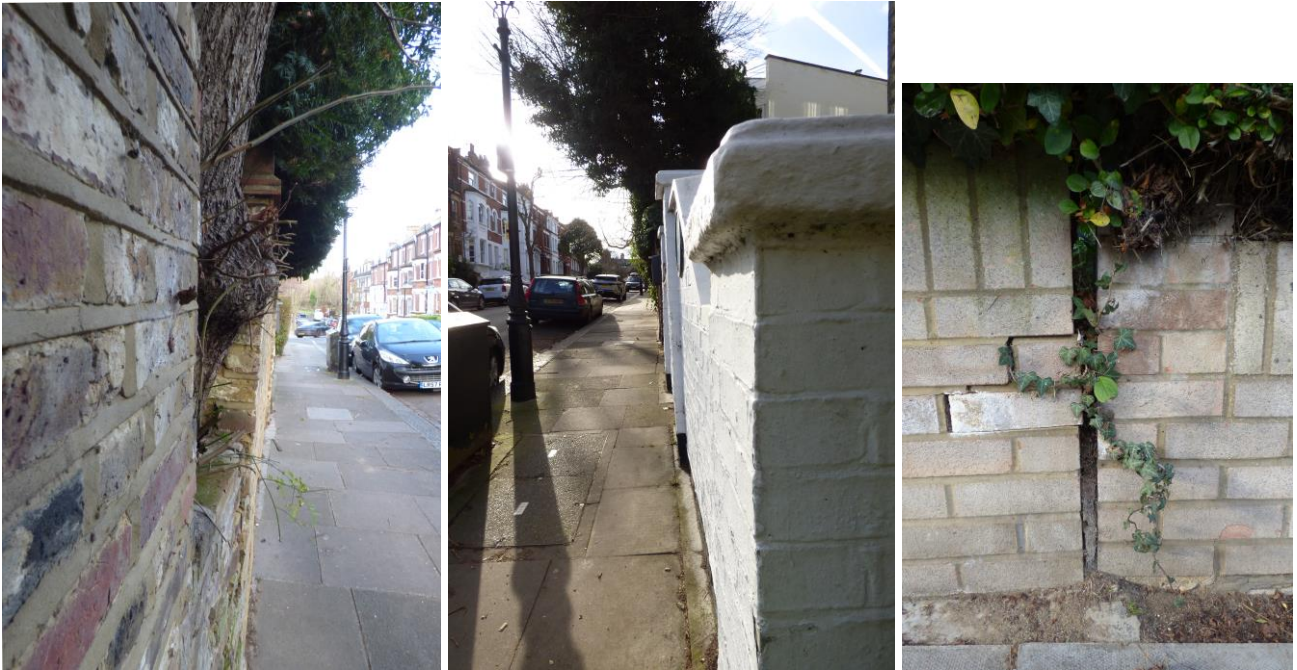
4: View down Pilgrims Ln from above T1 5: View up Pilgrims Ln from below T2 6: Movement joint in wall near corner

T5 is by a lower more modern wall that is also cracking, its movement joints widening and showing signs of dropping a little at its corner at the Pilgrim's Lane with Denning Road intersection, in conjunction with cracking pavement and sagging of the roadway over a wider area. This wall is not built to withstand tree or ground movement though it had movement joints, now widened and showing some angulation.
