Landmark Trees

FURTHER INVESTIGATION REPORT:

52-54 Avenue Road
London
NW8 6HS

Ref: DML/52AVR/PCS/01

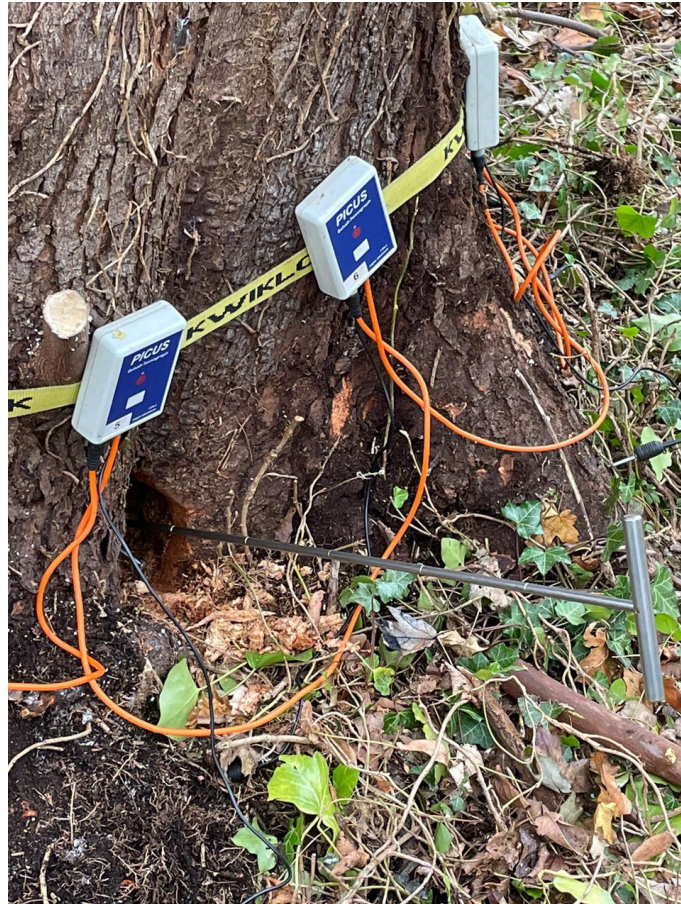
Photograph 1: Cavity at base of T6

This tree is situated 8 metres to the east of the property's boundary wall. The main stem bifurcates at 2.5m with co-dominant stems rising and branching to a height of 17m. There is epicormic growth from ground level to a height of 3m. The crown appears to be in a moderate condition, with some sparseness to the south and further epicormic sprouts within the crown interior indicative of physiological stress. There is also a break-out wound in the primary forks at c. 10m above ground where a historic limb failed (and cavity we previously reported), the species having a reputation for such. There is a cavity opening 10cm in diameter to the south of the stem at ground level (shown in Photograph 1). On physical examination this progresses 25cm horizontally towards the centre of the stem where stringy decayed wood, typical of honey fungus (*Armillaria*), is encountered. Probing at 45 degrees down into the root ball, there is softness and decay to a depth of 50cm.

Crown reduce by 2m in height and spread

Re-inspect in 1yr; monitor crown condition for any signs of dieback or thinning in interim.

Fell and replace with new healthy specimen subject to Conservation Area / planning consent

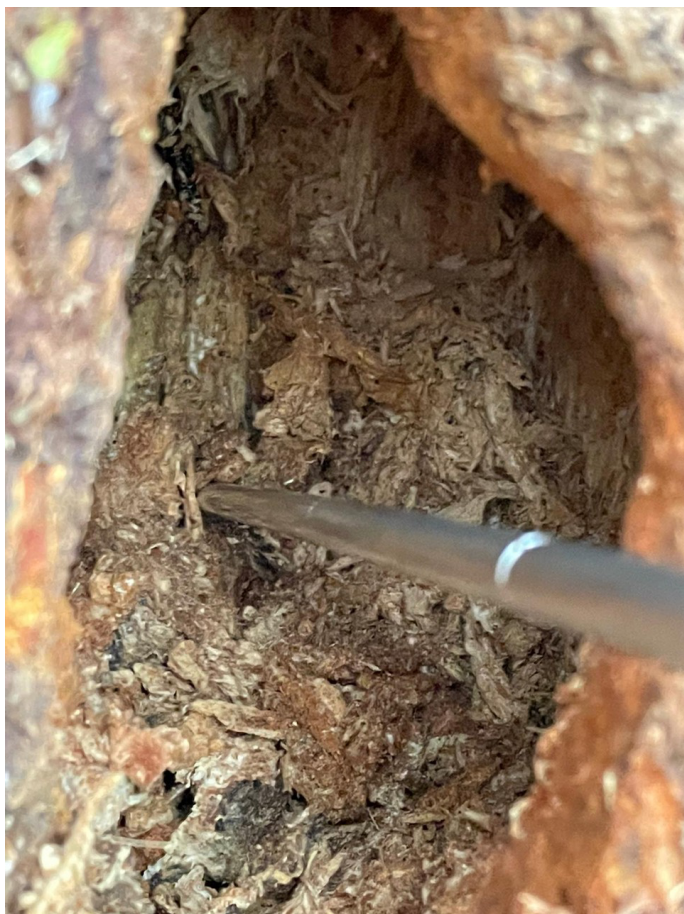
Photograph 2: Stringy rot within cavity typical of honey fungus.

The Tomograph shows pockets of decay above the cavity, surrounded by more extensive incipient decay distributed across the south and east of the stem cross, as confirmed by the Resistograph drillings. Although the fruit are not currently visible due to the time of year, honey fungus (*Armillaria mellea*) is a common pathogen of the species and the texture (stringy) and mode of decay (root collar) are signatures of the fungus. This pathogen first colonises the root system before the decay it causes moves upwards to the stem base. Whilst the decay in the above ground stem is not yet advanced, it is undoubtedly advancing in terms of penetrating the tree's defences, and clearly visible, advanced / cavitated at and below ground level (photograph 2). The seat of decay is of course in the roots and the image at 5cm above ground could be considered as the tip of the iceberg with the probe accordingly penetrating 25cm horizontally and 50cm at a downward incline. It is my experience that *advanced* root decay is likely to manifest in the root collar and stem base as showing signs of substantive colonisation, as we are beginning to see here. In terms of overall prognosis, for this American tree, I would defer to the USDA publication:

Shoestring root rot (Armillaria mellea) is common on the species and kills trees that are already in a weakened state.

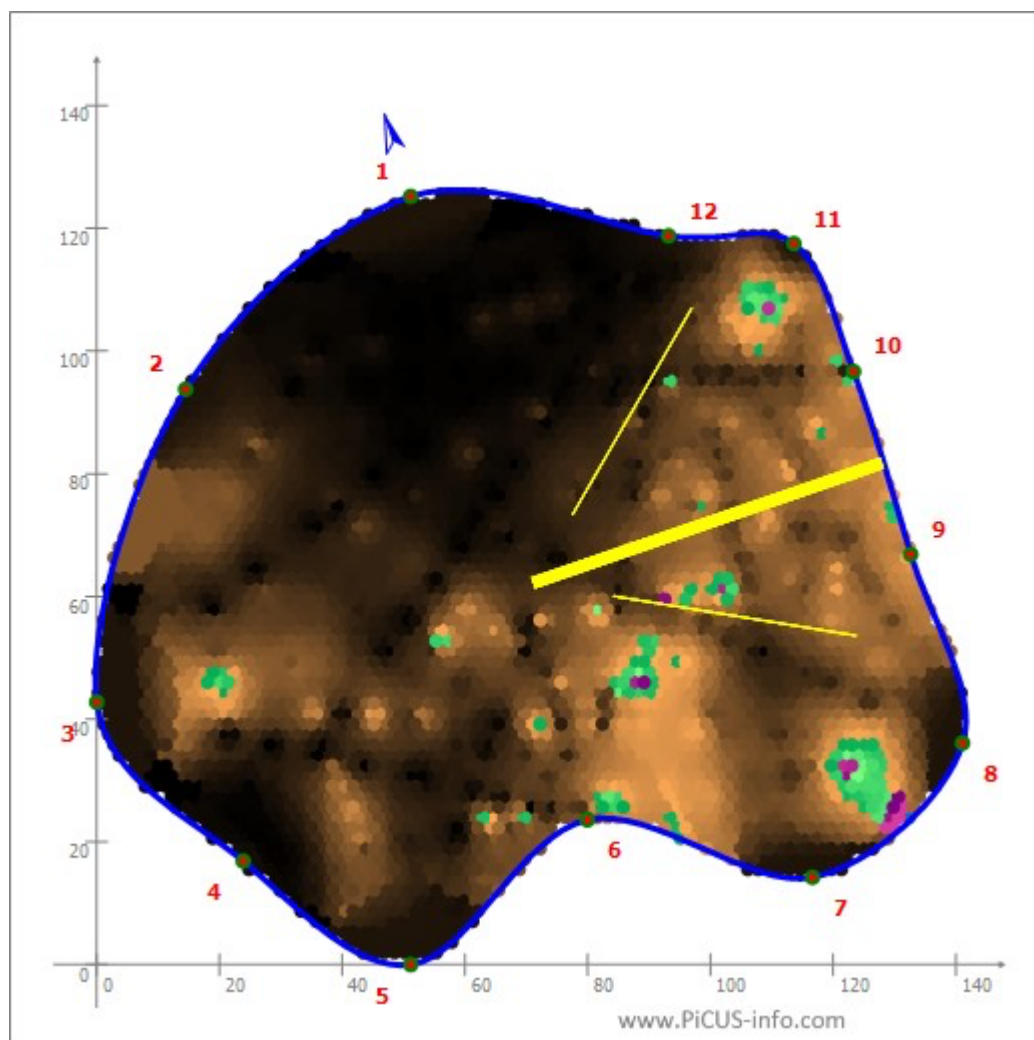
One tomograph was taken, at a level 5cm above ground, just above the basal cavity. The tomograph shows pockets of decay (purple) and cavitation (blue) spreading up into the stem, with incipient decay coloured green and internal cracks (yellow).

Figure 1: Tomograph of T6 taken at 5cm above ground level (just above cavity)

The condition of the inner and southern crown, internal stress cracks and the penetration of incipient decay across the stem base indicate a weakened state. The tree is considered to have a limited useful life expectancy of <10-20 years in a residential open space.

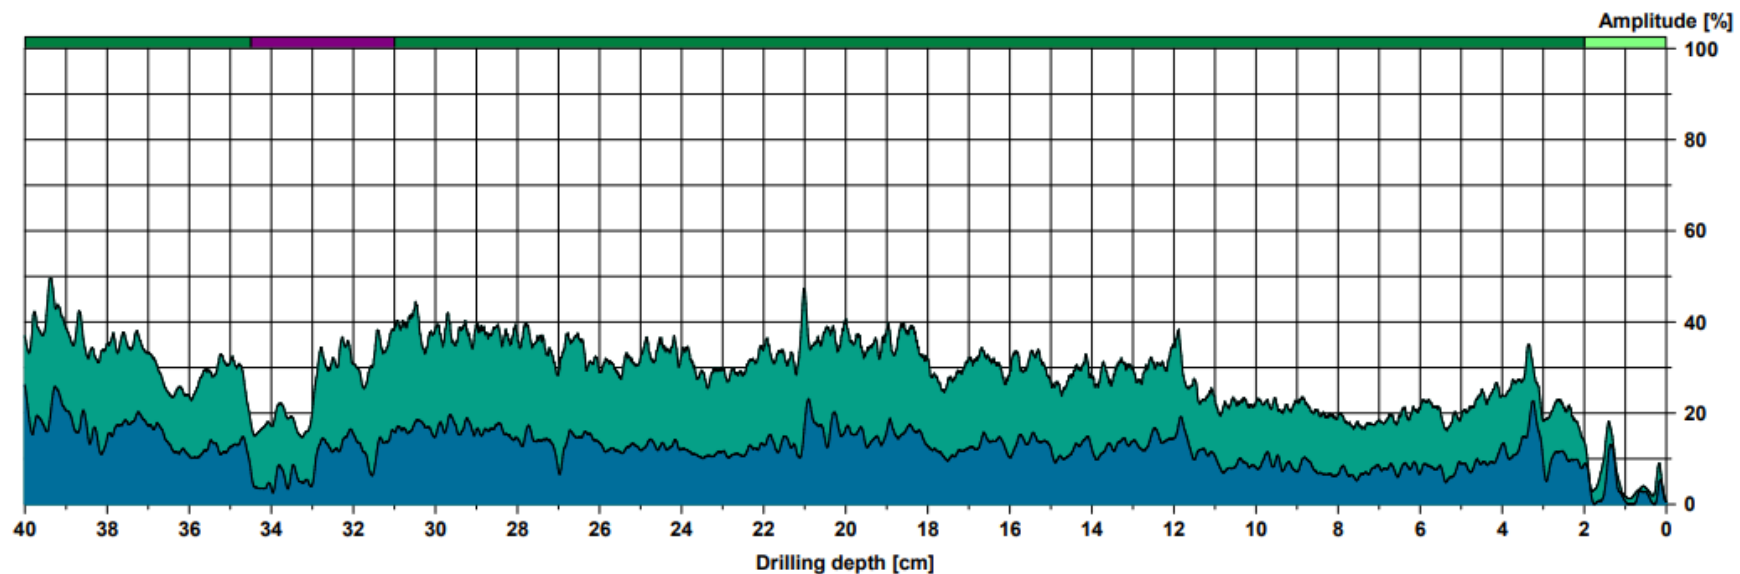
52 avenue rd SILVER MAPLE 5cm NM001

From	0,00 cm to	2,00 cm	: Bark
From	2,00 cm to	31,00 cm	: Sound Wood
From	31,00 cm to	34,50 cm	: Variable decay
From	34,50 cm to	40,00 cm	: Sound Wood

Drilling adjacent to cavity, peaks at 3 and 12cm possible barrier zone as section between slightly soft.

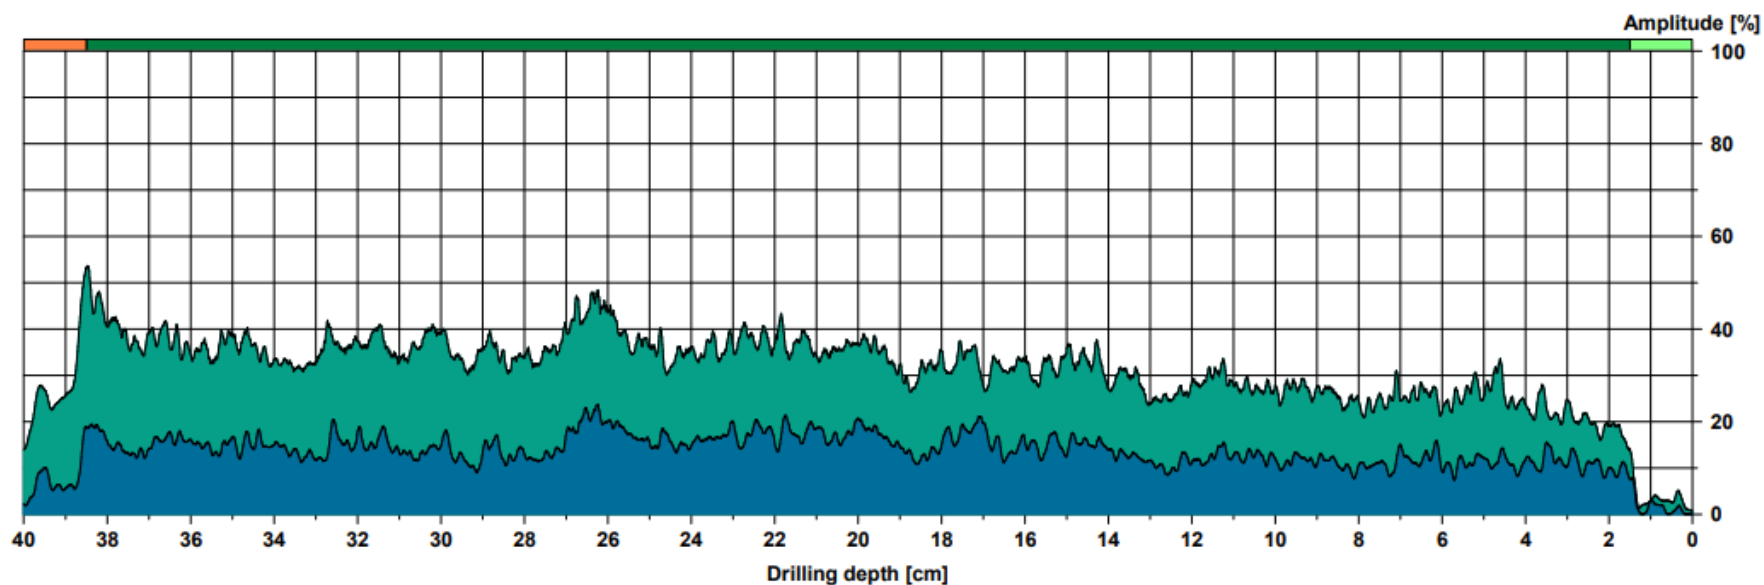
52 avenue rd SILVER MAPLE 5cm EM004

From 0,00 cm to 1,50 cm : Bark
From 1,50 cm to 38,50 cm : Sound Wood
From 38,50 cm to 40,00 cm : Decay

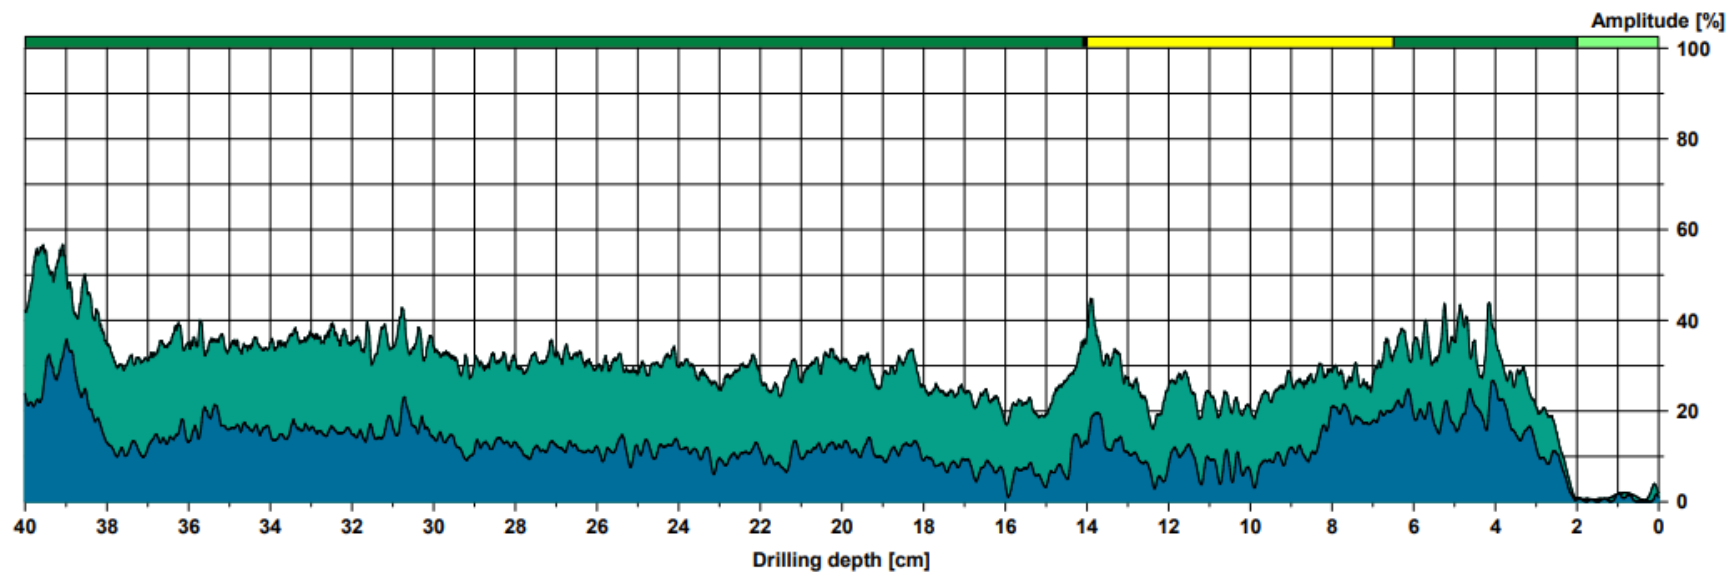
52 avenue rd SILVER MAPLE 5cm SM003

From	0,00 cm to	2,00 cm	: Bark
From	2,00 cm to	6,50 cm	: Sound Wood
From	6,50 cm to	14,00 cm	: EarlyIncipient decay
From	14,00 cm to	14,10 cm	: Barrier Zone
From	14,10 cm to	40,00 cm	: Sound Wood

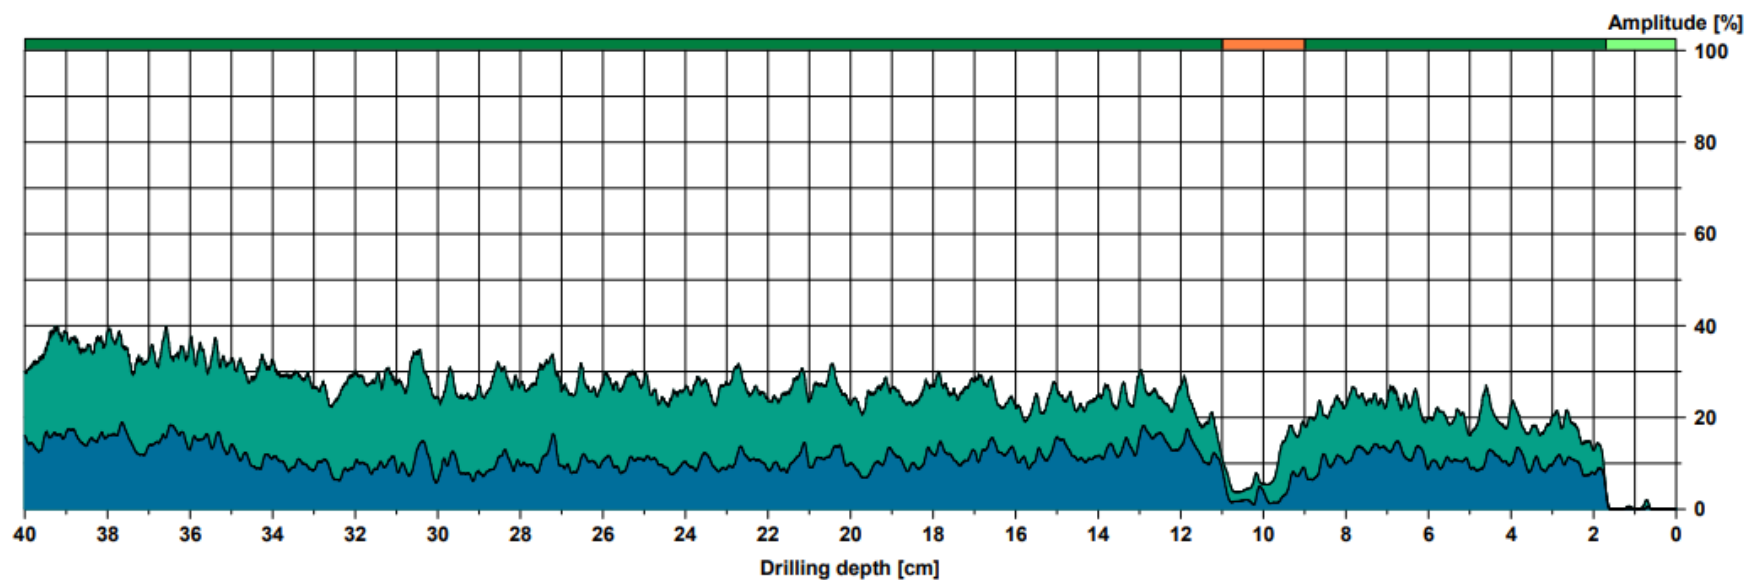
52 avenue rd SILVER MAPLE 5cm WM002

From	0,00 cm to	1,70 cm	: Bark
From	1,70 cm to	9,00 cm	: Sound Wood
From	9,00 cm to	11,00 cm	: Decay
From	11,00 cm to	40,00 cm	: Sound Wood
