## 55 Cumberland Terrace: Vaults

Site note 4 for 1 December 2021, job No. 154-11

Damp investigation of lower ground floor vaults

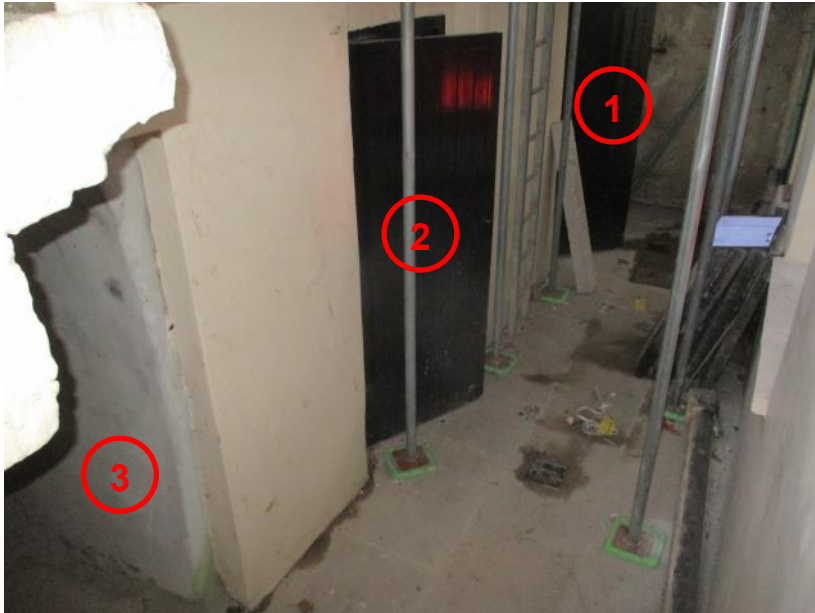
**Fig 1:**

Lower ground floor, west side; showing general arrangement of lightwell access passageway and entrances to vaults 1, 2 and 3

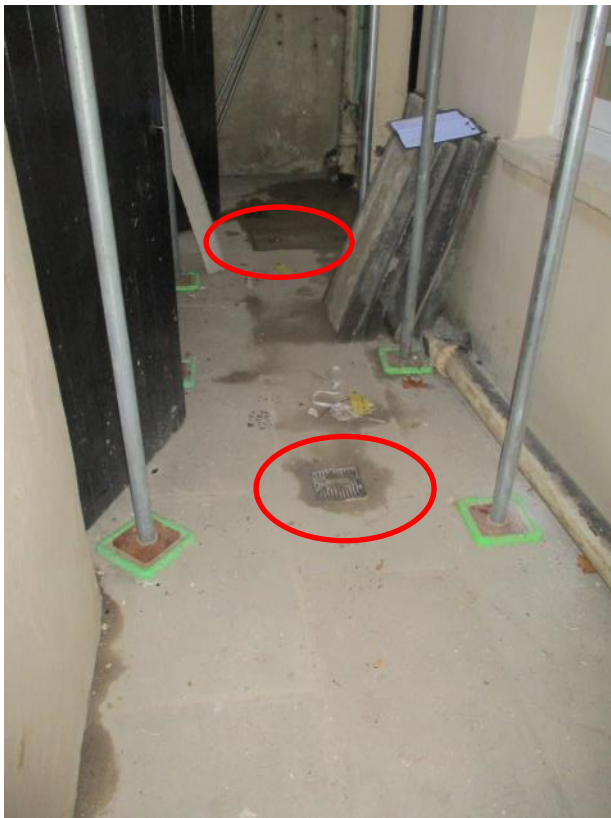
**Fig 2:**

Access lightwell passageway viewed from west; showing 2 no. surface gullies with surrounding paving in good condition and laid to consistent falls to the drainage outlets

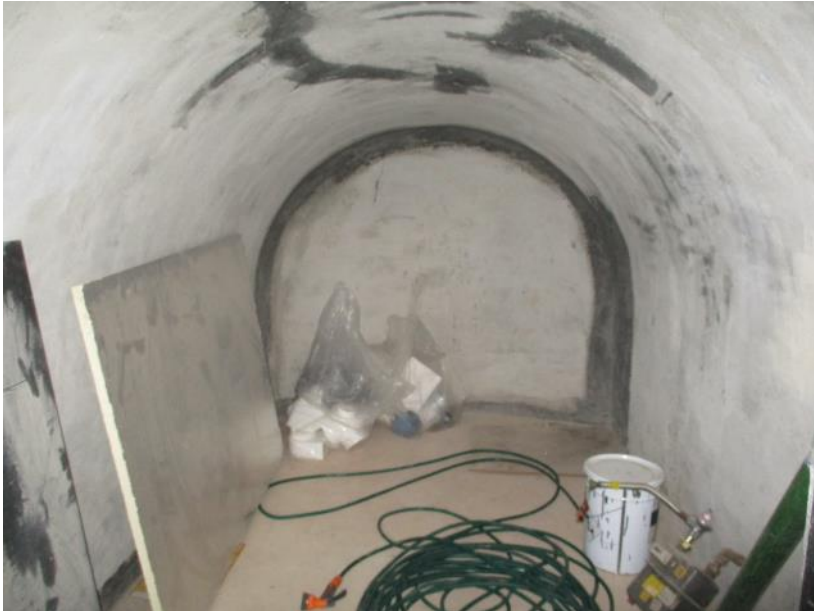
**Fig 3:**

Vault 1, viewed from entrance doorway; showing generally good condition of existing cementitious render waterproofing

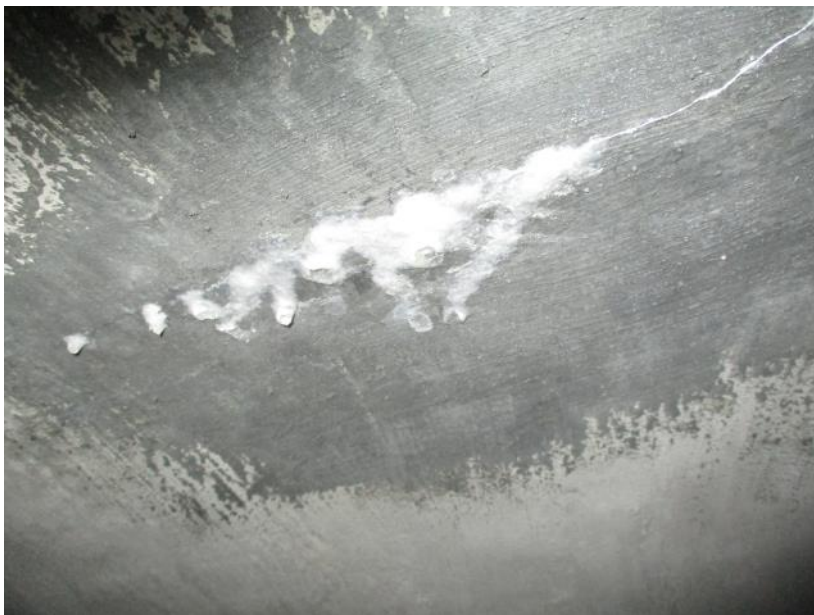
**Fig 4:**

Existing cementitious render waterproofing was in fair condition, with some evidence of historic or intermittent water ingress towards the centre on the north side, where a crack had formed in the render coat. Other cracks, generally running laterally from east to west showed localised surface efflorescence of hygroscopic salts, consistent with salt contaminated water draining through paving surfaces above to the interior, depositing soluble minerals and creating short 'stalactites' of calcium carbonate and other water soluble minerals. Service voids had been created in the south-west and north-east corners to link pipework and cabling between the vaults as part of current refurbishment works. Percussion auscultation testing of walls and soffits indicated that the render waterproofing system was firmly adhered to throughout

Vault 1, east end; showing salt efflorescence around cracks in the render system, with short 'stalactites' or soluble minerals forming on the soffit

Loose and damaged decorative finishes should be removed, followed by surface preparation and application of a thin (c.2mm) vapour permeable cementitious render, with flexible 'bandage' repairs to cracks and reinforcement of corners and wall/floor junctions as directed by the specialist installation contractor.

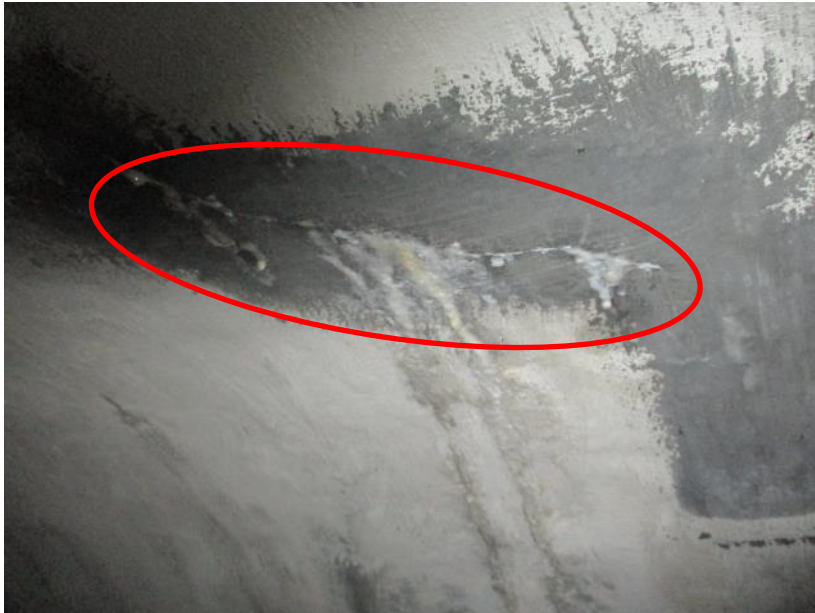
**Fig 5:**

Vault 1, central section; showing mineral deposits and 'streaking' on cementitious render surfaces, where water drained intermittently to the interior. Note evidence of patch repair to cracks on previous refurbishment

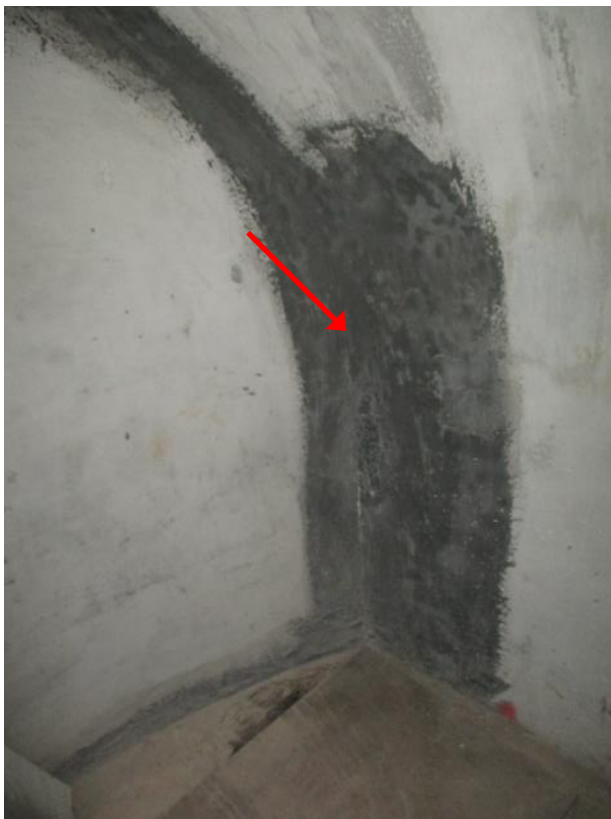
**Fig 6:**

Vault 1, north-west corner; showing apparent patch repair to existing cementitious render waterproofing

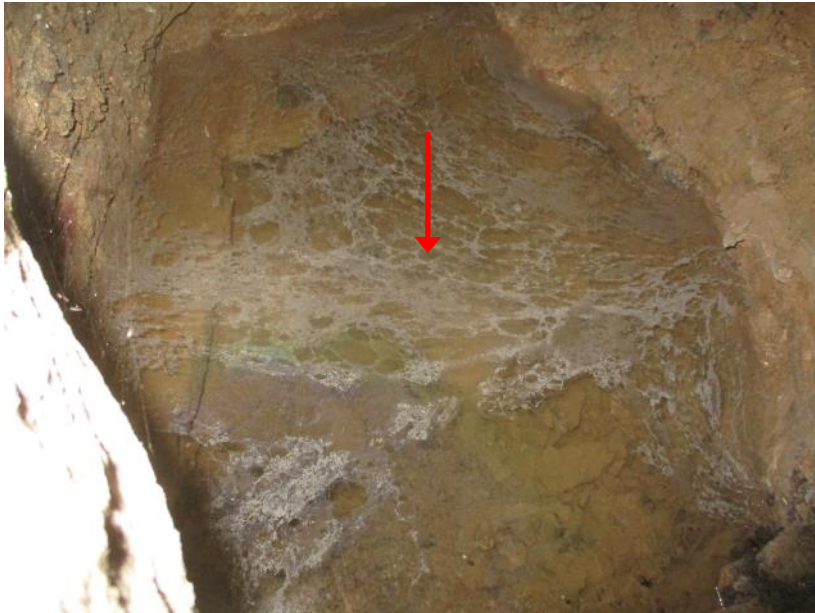
**Fig 7:**

Vault 1, north-west corner; showing trial pit, with standing water approximately 400mm below the vault floor surface

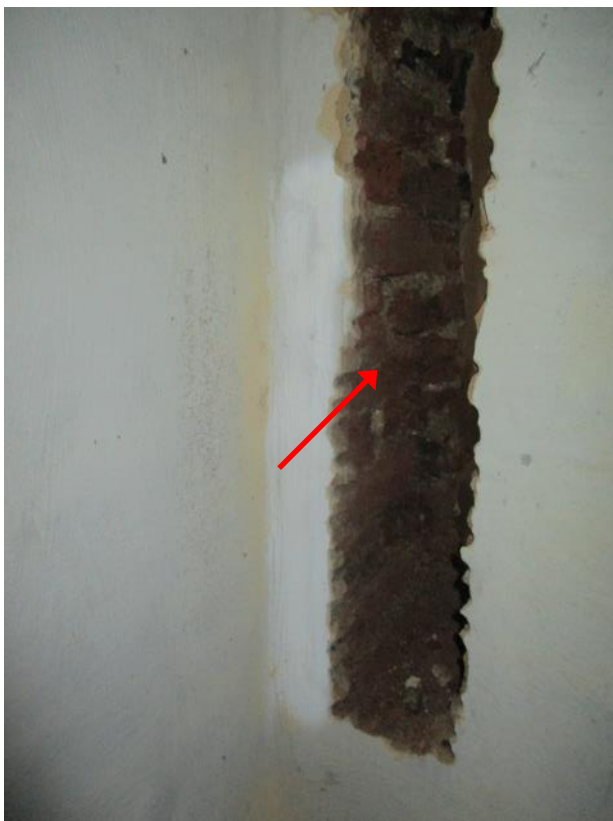
**Fig 8:**

Vault 1, north end of east wall; showing void formed in structure for building services. The wall thickness in this location was 400mm

Consideration should be given to including ventilation pathways between the vaults, perhaps by expanding the existing service conduit openings, to include an air duct subject to requirement for fire separation. Consideration should be given to providing ventilation pathways around the vault doorways at high and low level, to encourage air circulation

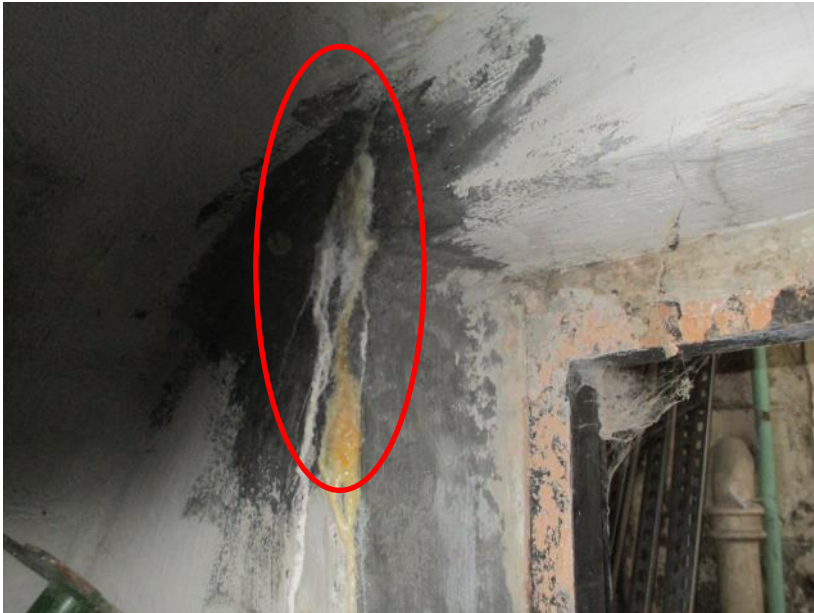
**Fig 9:**

The timber door frames to vaults 1 and 2 were in direct contact with the surrounding reveal masonry, which was likely to have provided the conditions for decay, as was noted at the head of the door frame to vault 2

Vault 1, north side of entrance reveal; showing water draining through a defect in the cementitious render waterproofing, leaving soluble mineral deposits on the wall surfaces. Note timber door frames not isolated from surrounding masonry and vulnerable to decay

Allowance should be made for removal of existing door frames and for making good of render and the provision for waterproofing behind. On reinstatement, all new and retained timbers should be isolated from the door reveals by continuous strips of a suitable damp-proof material, or by a continuous air gap and plastic packing wedges. Provision of a ventilation slot, the full width of the door openings and above the frame heads, would also provide isolation, which in combination with a gap below the door leaves, say, 20mm wide, could provide the ventilation by fresh external air recommended at 4.4 above

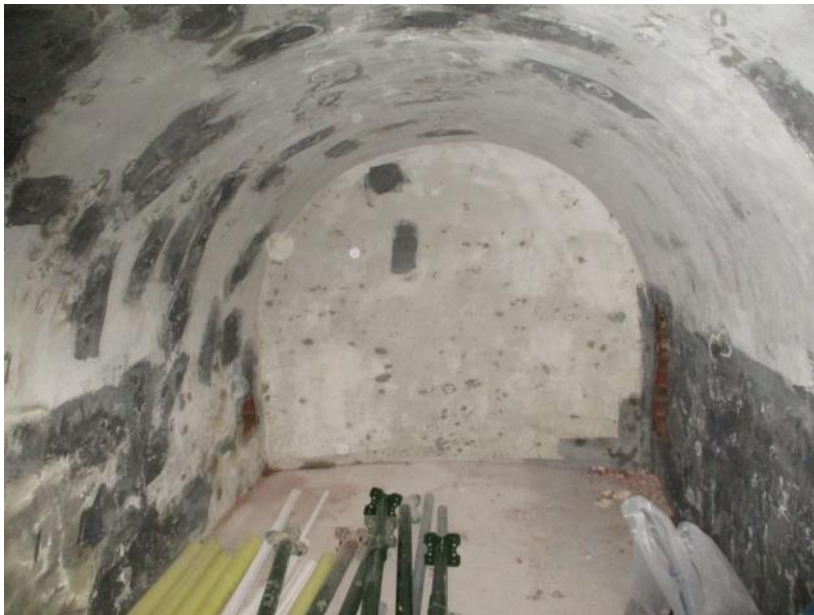
**Fig 10:**

Vault 2, general view from east doorway; showing condition of existing cementitious waterproofing render system

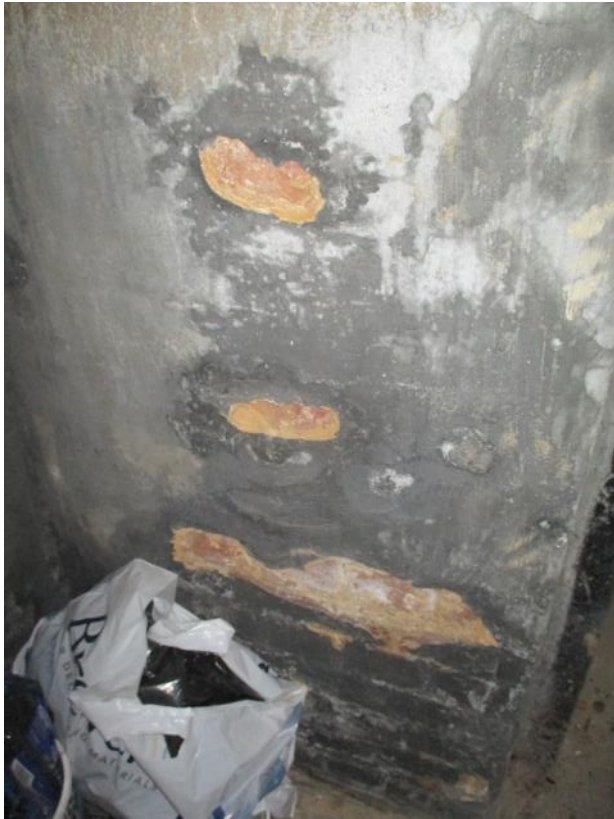
**Fig 11:**

Vault 2, east wall to north of entrance doorway; showing areas of render detachment, exposing semi-engineering brickwork behind

The more advanced failure of the render waterproofing system in Vault 2 indicated that this vault had been waterproofed at a different time to vaults 1 and 3, using different materials. The render system should be overhauled as described at 4.2.1 but preparation should include removal of sections of render that have already become detached from the bricks behind and repair in new materials that match the existing.

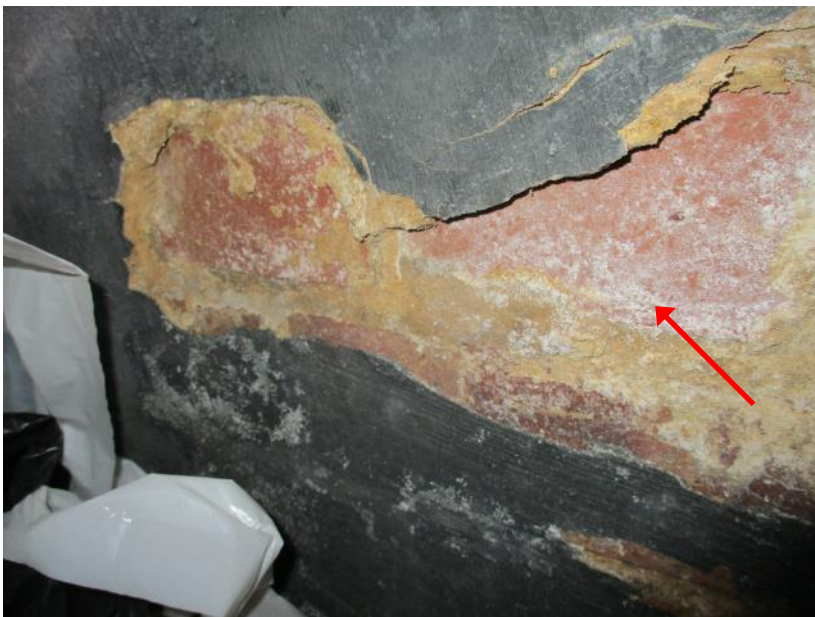
**Fig 12:**

Vault 2, east wall to north of entrance doorway; showing detail of exposed brickwork, with surface and interstitial efflorescence of hygroscopic salts causing disruption to the sand and cement basecoat and thin cementitious waterproof render that had been applied on previous refurbishment

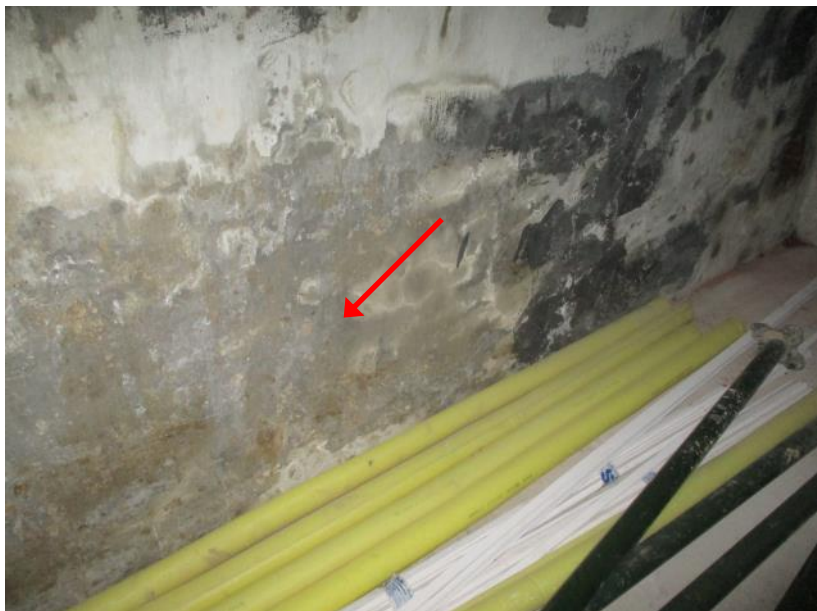
**Fig 13:**

Cementitious render waterproofing showed more widespread defects associated with progressive failure and were noted in vault 1, with multiple circular patches of staining and salt efflorescence focussed on point defects in the render coatings. These areas linked together at low level on the north and south sides. Waterproof render coatings had failed on the north side of the entrance doorway, consistent with chronic interstitial efflorescence of hygroscopic salts, forcing the impermeable render coating away from the cement render and masonry substrates. Approximately 20 per cent of the wall and ceiling surface had been treated with a remedial render coating on a previous refurbishment, including the full width of the north wall to approximately 0.9m above floor level. Percussion auscultation testing of the render system identified two areas of render detachment: approximately 1m above floor level on the south side of the entrance doorway and at low level at the east end of the south wall. Render elsewhere was firmly adhered. Openings had been formed in the walls separating vault 2 from vaults 1 and 3, at the west ends of the north and south walls, to allow building service conduits, pipes and cables to pass between the vaults. The timber door frame on the east side showed signs of historic decay, where in direct contact with the surrounding structures at the door head

Vault 2, south side; showing widespread surface staining and salt efflorescence consistent with progressive failure of the cementitious waterproofing system and a limited residual service life. However, the render was found to be firmly adhered on percussion testing

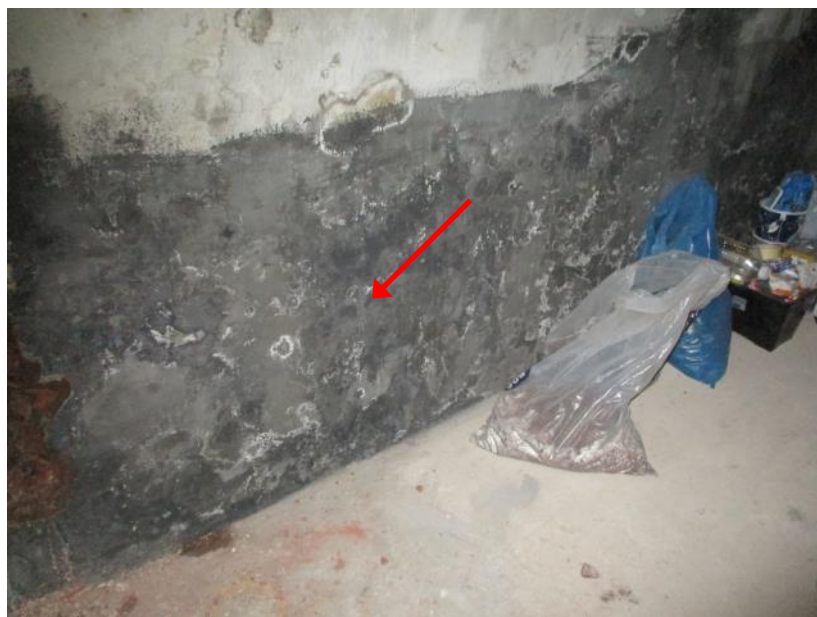
**Fig 14:**

Vault 2, north wall; showing the general application of remedial cementitious render to approximately 0.9m above floor level on a previous refurbishment

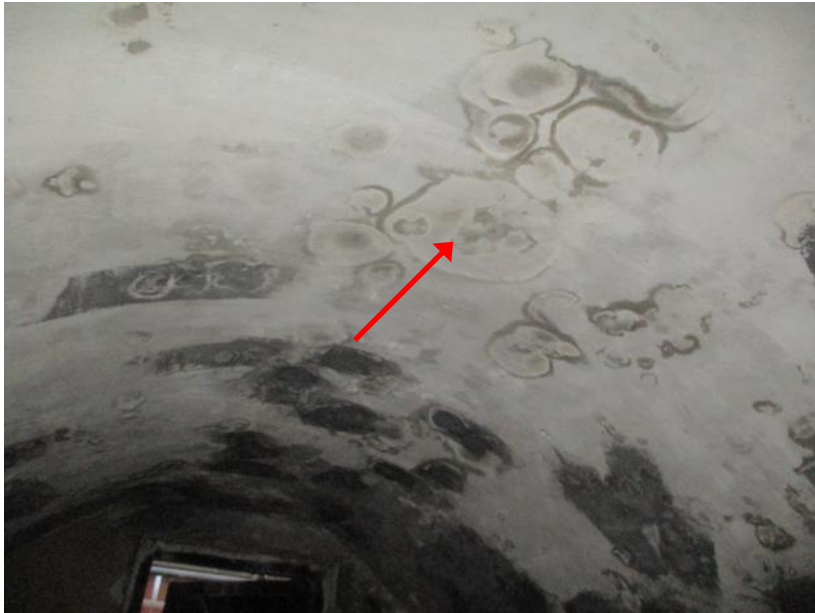
**Fig 15:**

Vault 2, arched soffit; showing 'point' defects, with circular patterns of staining and salt efflorescence indicating progressive failure of the cementitious waterproofing system

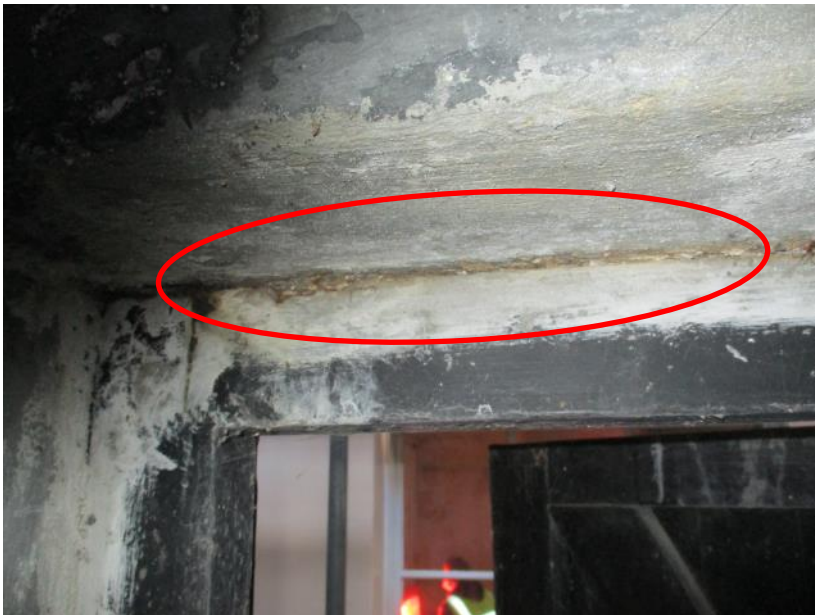
**Fig 16:**

Vault 2, east side; showing headrail of doorframe subject to historic decay where in direct contact with damp affected masonry

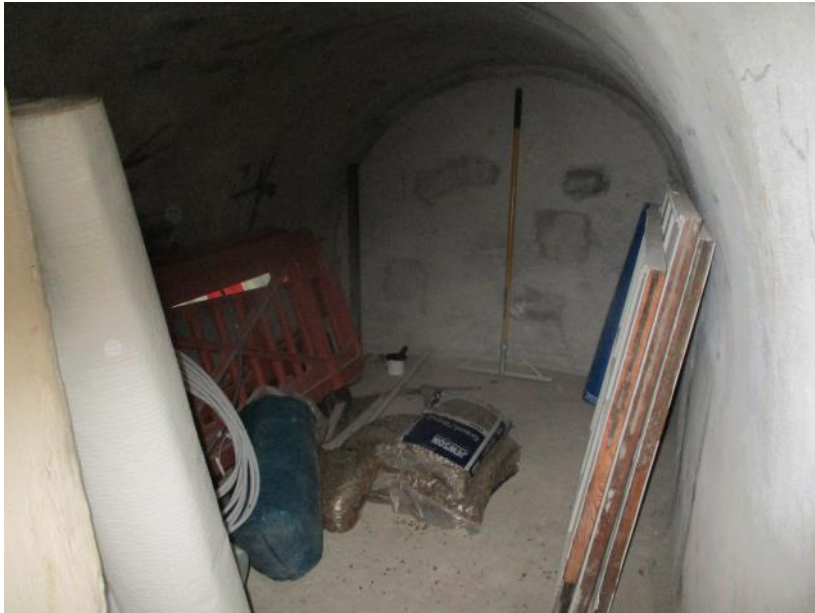
**Fig 17:**

Vault 3, view from entrance doorway; showing general condition of existing cementitious waterproof render

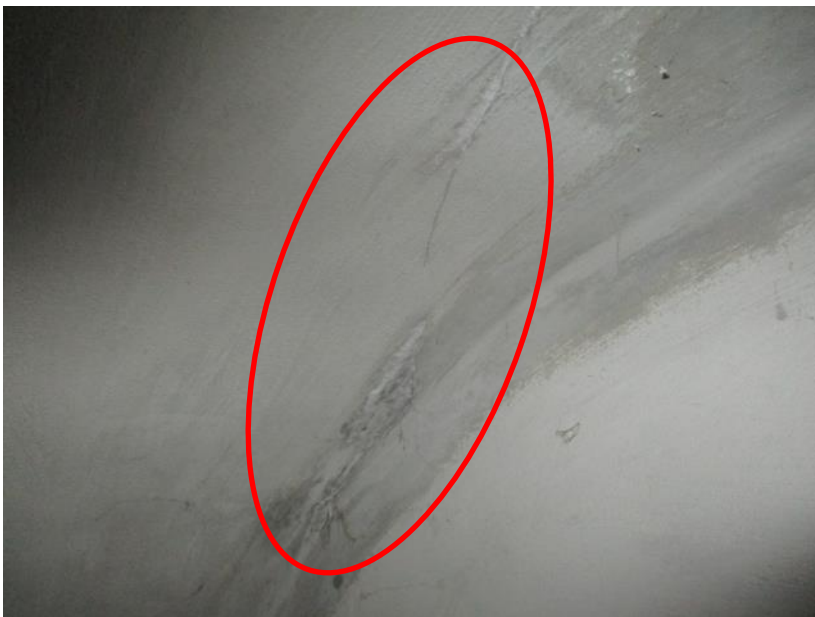
**Fig 18:**

Waterproof cementitious coatings and decorative finishes to the walls and soffit were in fair condition, with isolated detachment of a 'film forming' paint system noted, where salt efflorescence had occurred between the paint and the gypsum plaster substrate. Salt efflorescence and 'stalactite' formation around cracks in the ceiling render were restricted

Vault 3, south-west corner; showing salt efflorescence and 'stalactite' formation around a crack in the ceiling render system

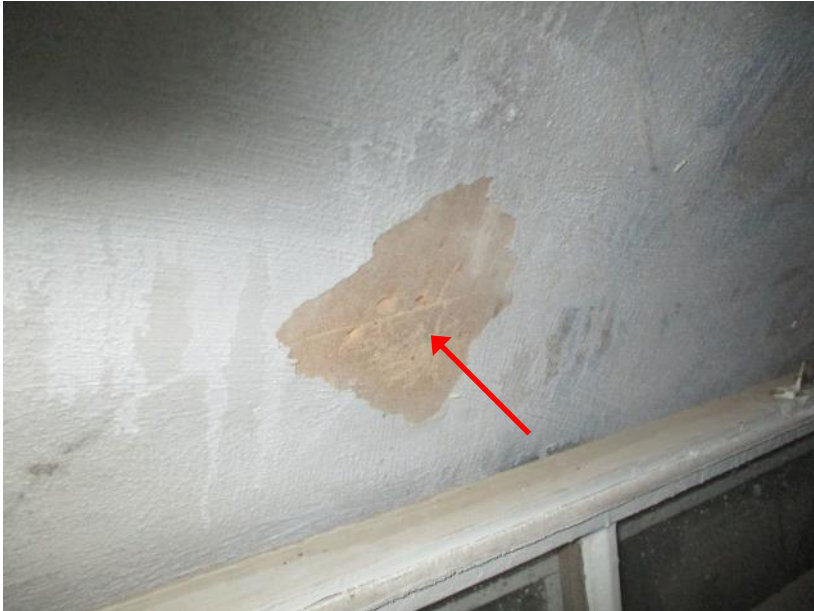
**Fig 19:**

Vault 3, north side; showing isolated patch of paint detachment from the gypsum based plaster substrate

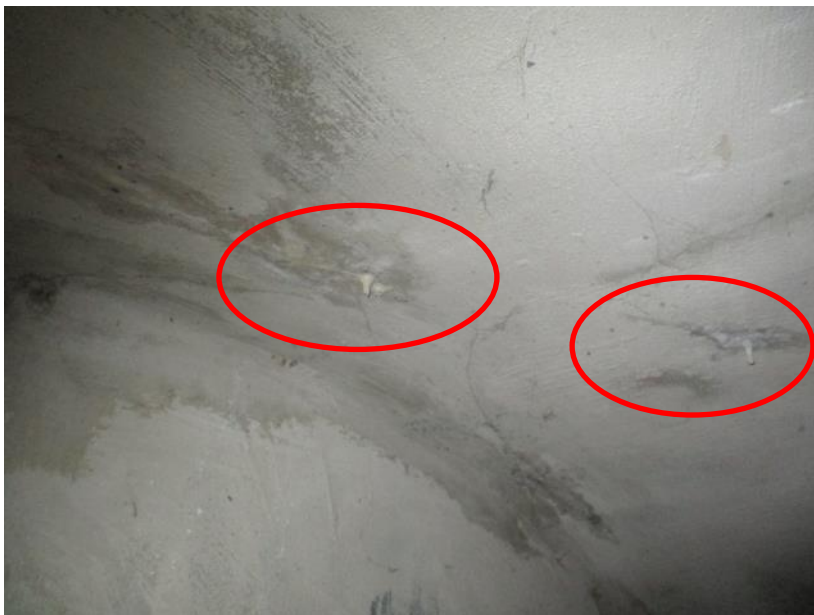
**Fig 20:**

Vault 3, east end; showing salt efflorescence and 'stalactite' formation in isolated locations, focussed on hairline cracks in the soffit render system

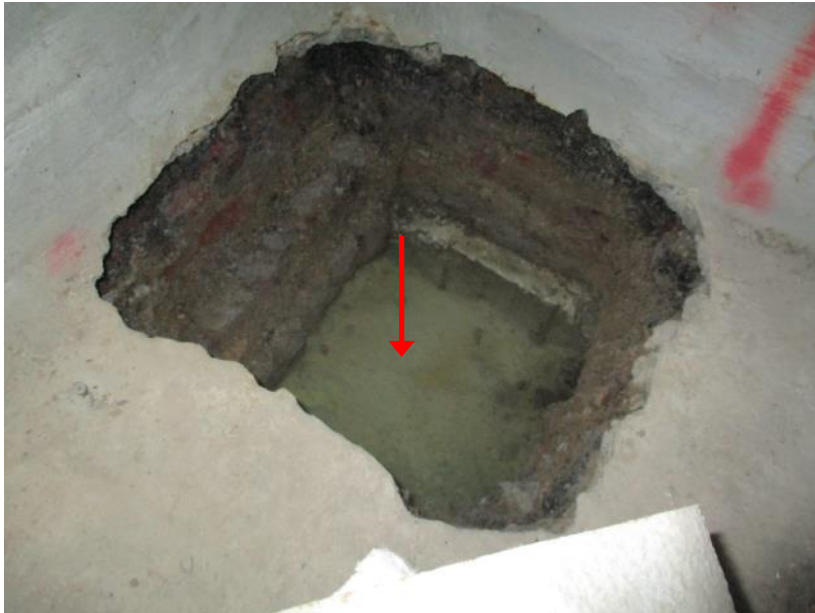
**Fig 21:**

to the east and west ends, notably towards the south-west corner. Percussion auscultation testing of render identified no areas of hollowness or detachment. Inspection of a trial pit, formed in the south-east corner showed standing water 400mm below the floor surface, approximately 100mm below the footings of the east wall, separating the vaults from the access passageway

Vault 3, south-east corner; showing trial pit in floor structure with standing water approximately 400mm below the floor surface and 100mm below the footings of the east wall

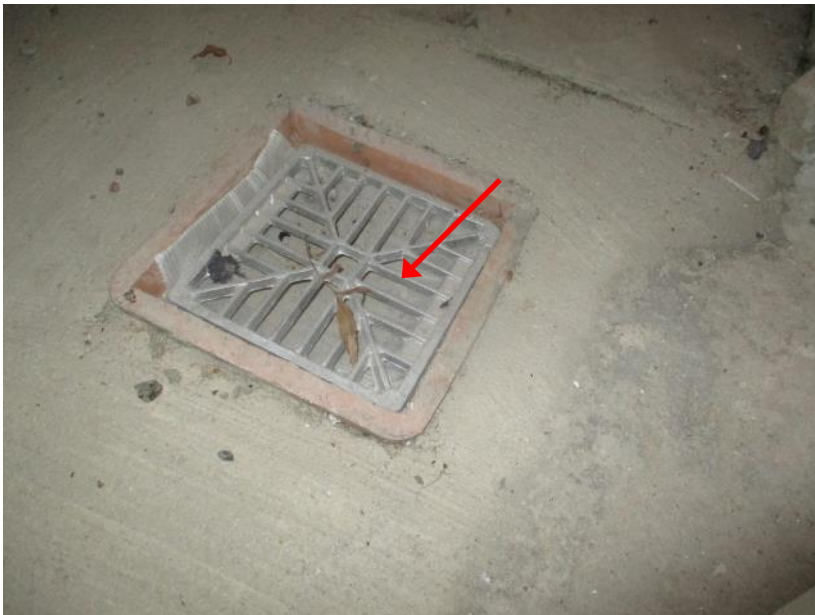
**Fig 22:**

Vault 3, east end; showing typical surface drainage gulley set into the vault floor. This detail was common to all three vaults

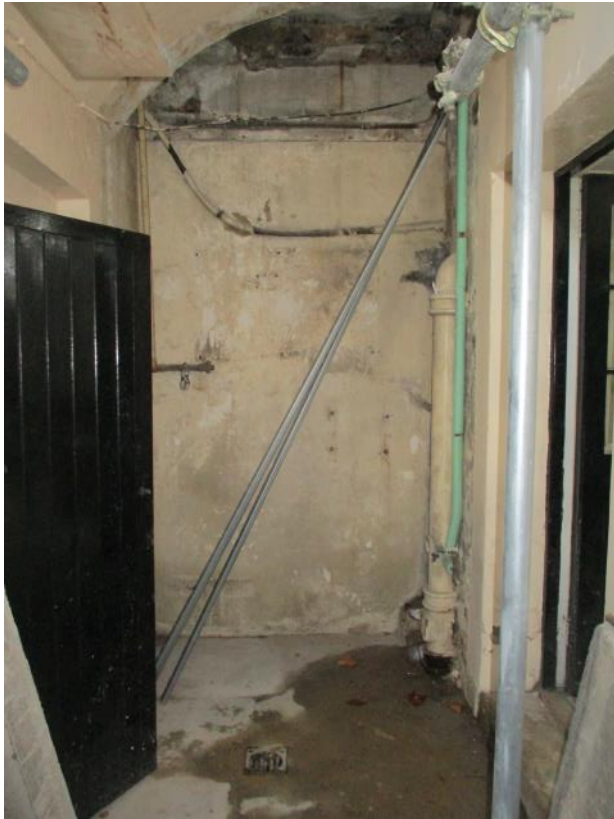
**Fig 23:**

Lightwell access passageway, north end; showing locations for proposed building services inlet cupboard

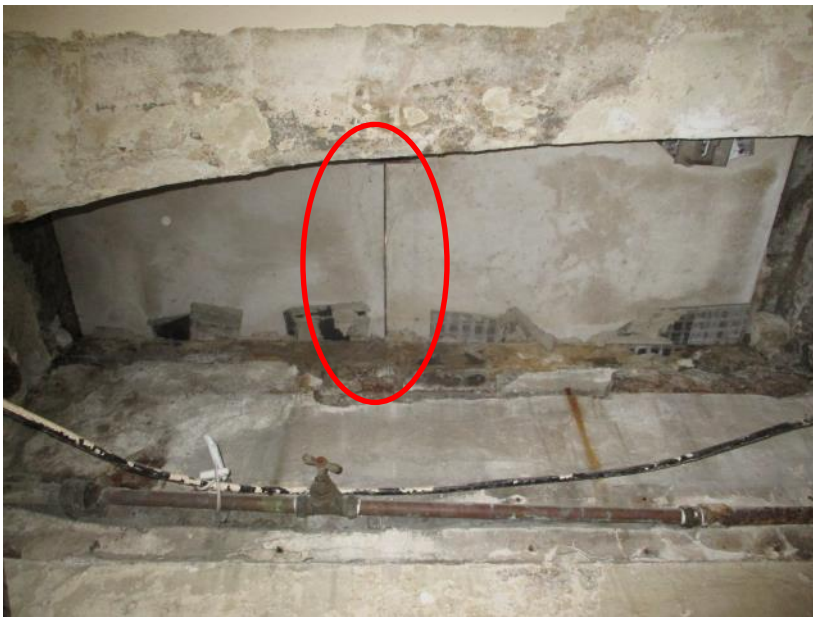
**Fig 24:**

H+R understand that gas meters and other building services, valves and controls are to be installed in a cupboard at the north end of the vault access passageway/lightwell. The soffit in this location was formed from horizontal paving slabs to the north of the arched structure supporting the access stairs to 55 Cumberland Terrace at upper ground floor level. Gaps in the slabs had been temporarily sealed with waterproof silicone materials, pending further waterproofing works. Walls on the north, east and west sides of the cupboard recess were detailed with cement render and decorative paint or limewash finishes. It was not possible to tell whether the render was of a waterproof type but the absence of focussed salt efflorescence indicated that the render did not include waterproof additives. Localised detachment of the render was noted at low level in the north-east corner, where a rainwater downpipe or similar drain had previously been installed, preventing effective render application locally

North end of access passageway/ lightwell; showing underside of concrete paving slabs forming the soffit of the proposed services inlet cupboard. Note open joint between the slabs sealed with adhesive silicone at the time of inspection

Allowance should be made for installation of a remedial concrete soffit structure, detailed to exclude surface water draining from above. Consideration should be given to installing a new structural deck, subject to coordination with the neighbouring property owner, to allow inclusion of a suitable 'two-part' waterproof membrane, such as polyurea or a fibreglass resin system. If this proves impractical, the new or retained soffit structure should be treated with a suitable waterproof cementitious render, dressed a minimum 200mm down the walls forming the cupboard recess from the wall/soffit junction. Existing render should be retained and walls lined with a studded plastic vertical drainage and isolating membrane, with a 'coving' detail at the wall/soffit junctions. Water draining behind the membrane could discharge below a raised floor in the services cupboard or direct to existing hard landscape materials, from where water could flow to the adjacent surface drain. This would minimise the introduction of further cementitious materials whilst providing adequate levels of protection against penetrating damp. H+R can provide further advice on remedial detailing if required.

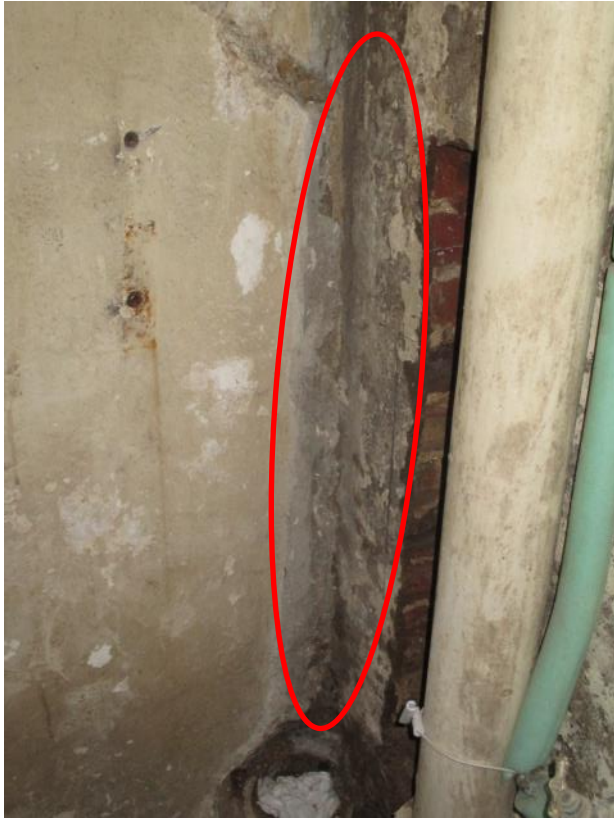
**Fig 25:**

North-east corner of proposed services inlet cupboard; showing detached and incomplete render application, where a vertical drainage or soil/vent pipe had been removed on previous refurbishment

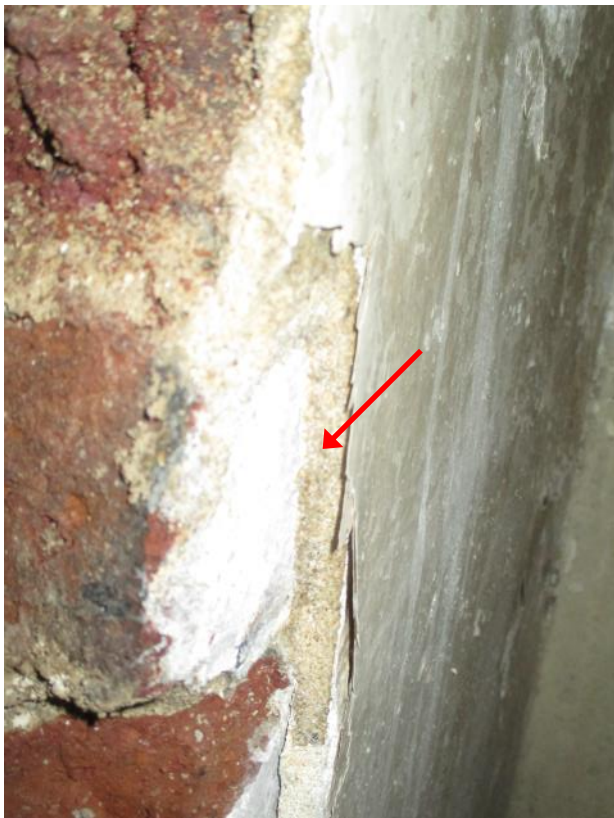
**Fig 26:**

Building services inlet cupboard, west side; showing build-up of cement render and decorative finishes applied to brickwork locally

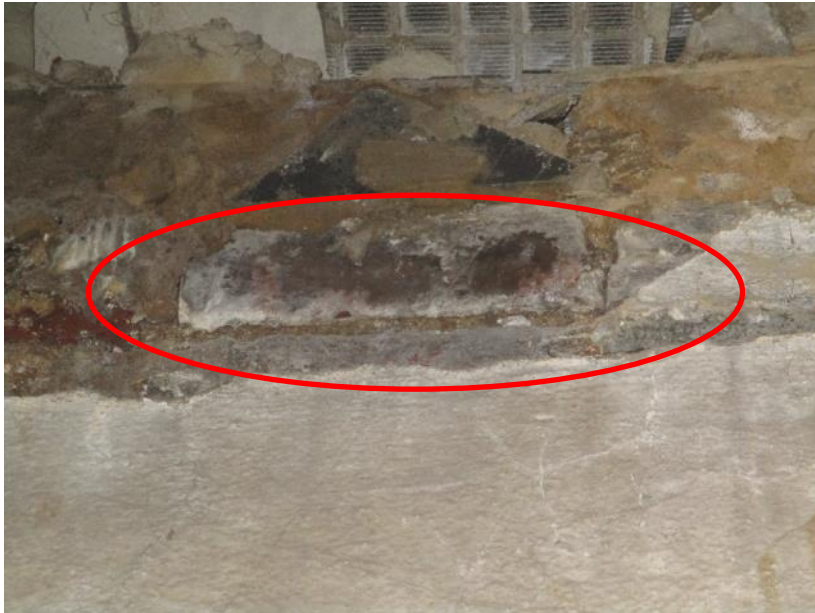
**Fig 27:**

Proposed building services inlet cupboard, north side; showing salt efflorescence affecting brickwork above the wall render at high level indicating intermittent drainage of surface water through the structure

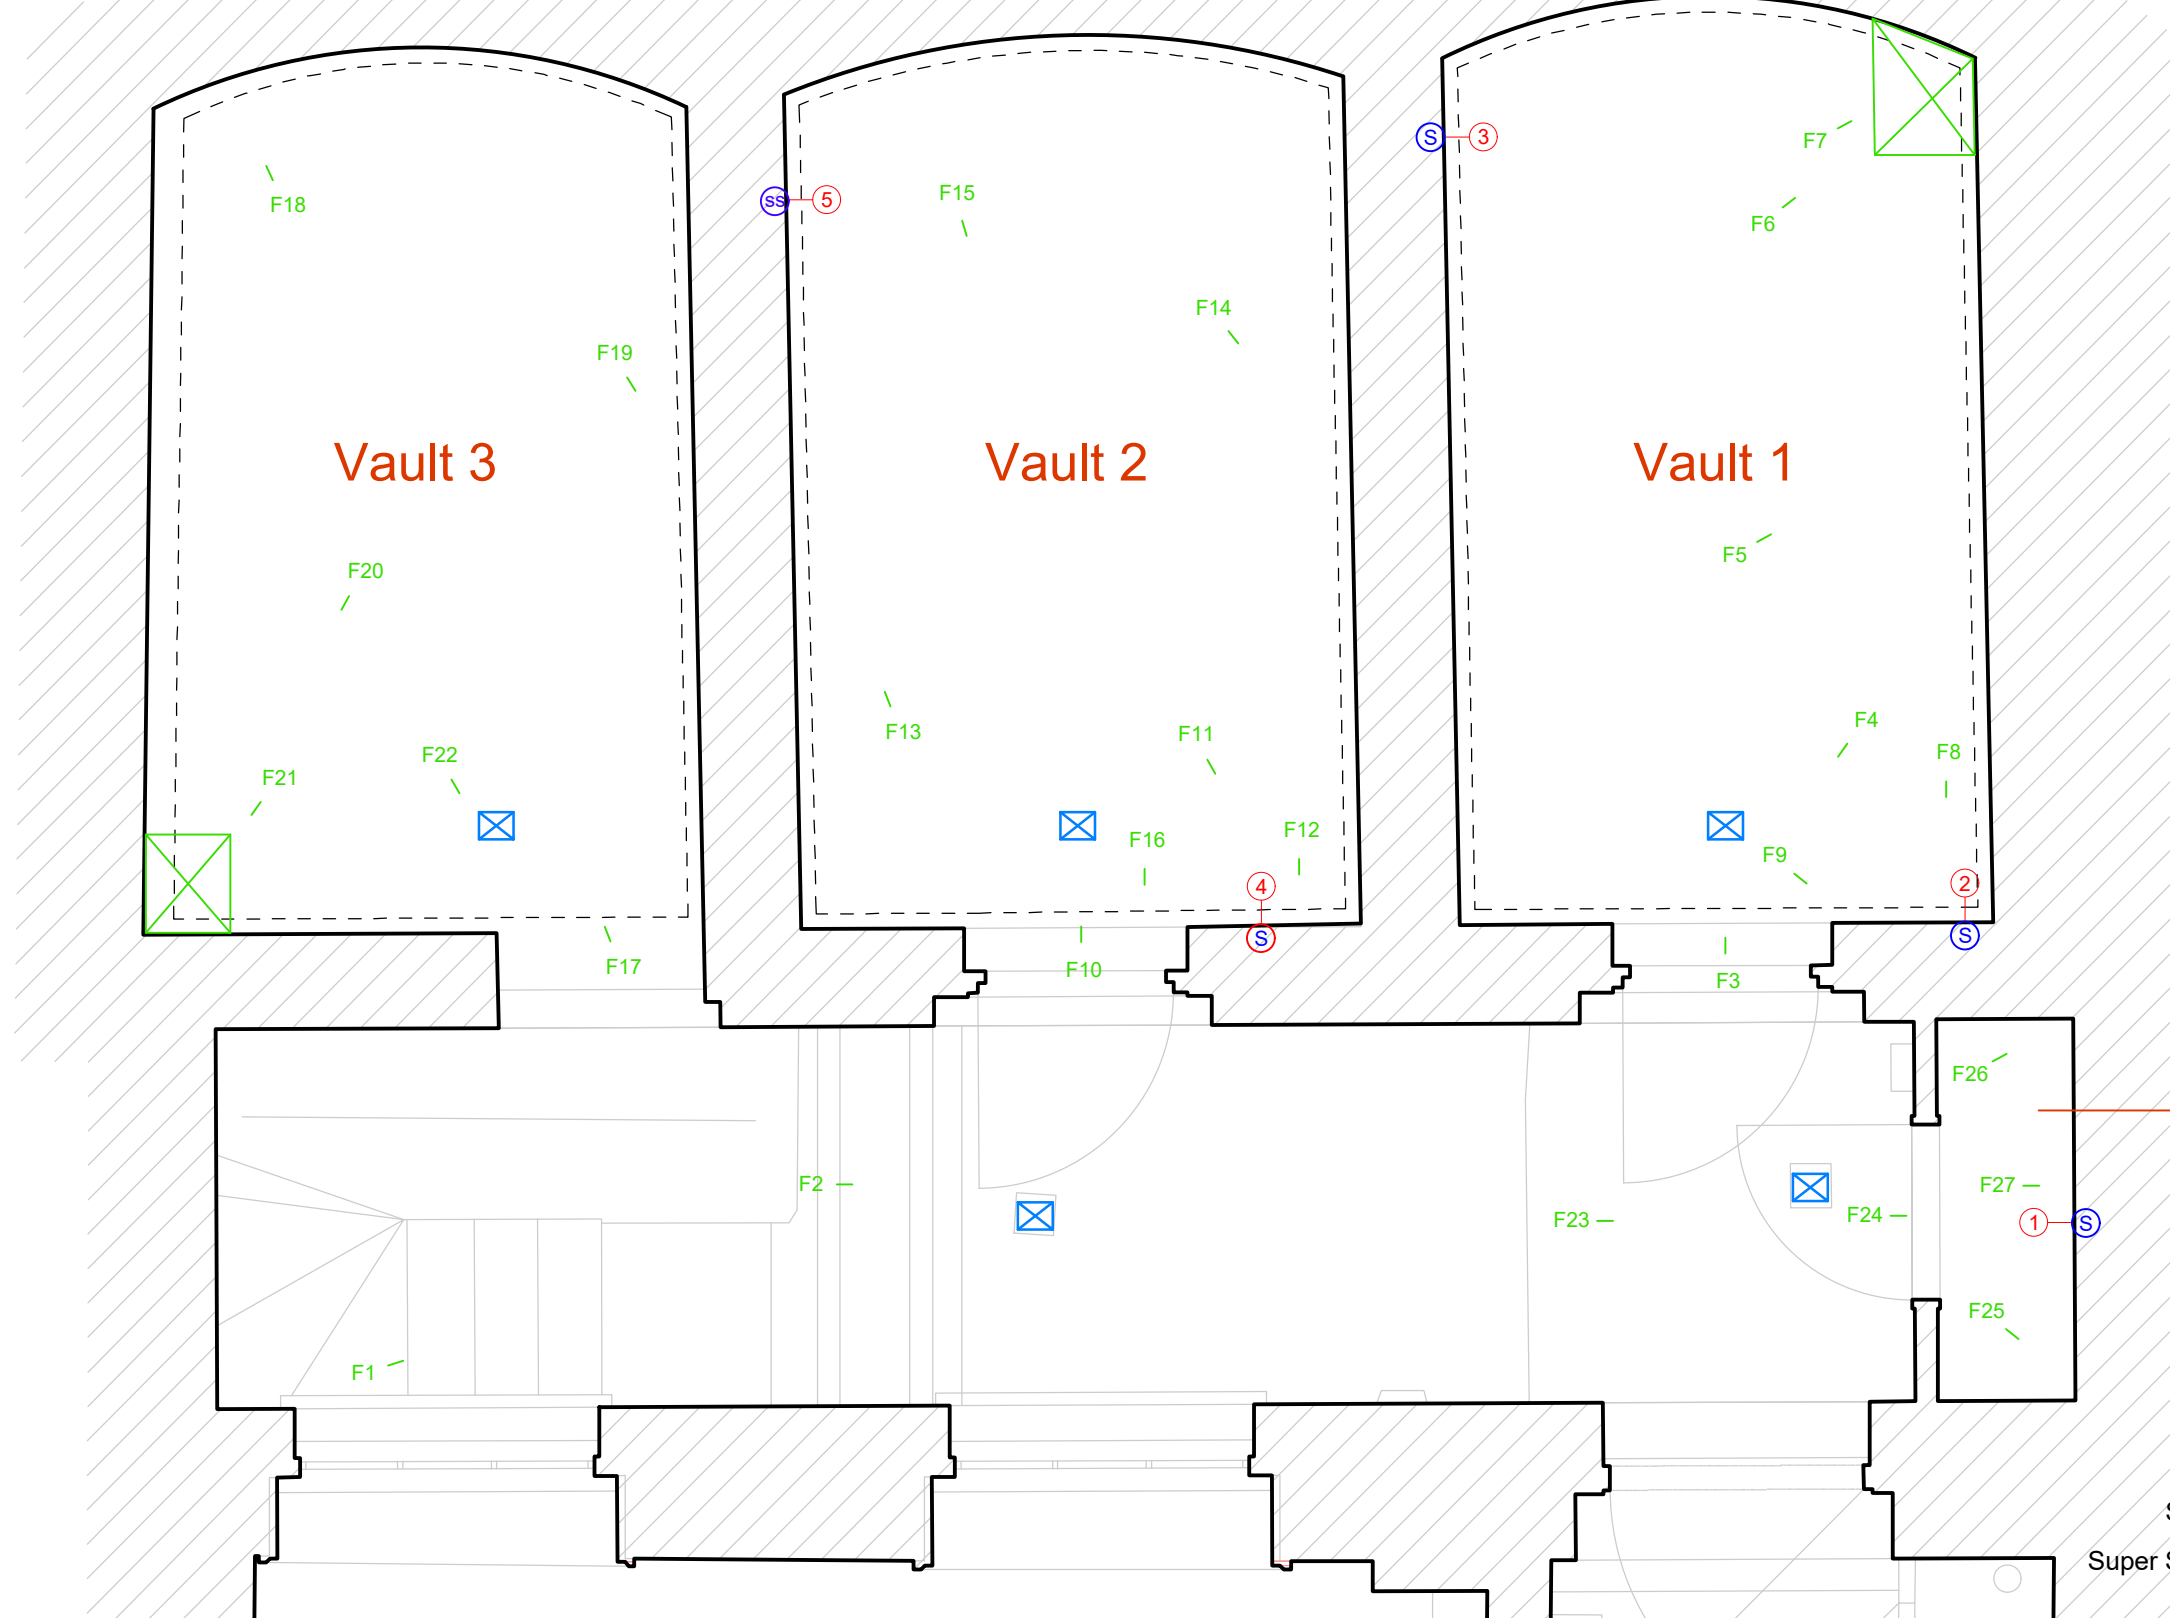
All samples were classified as saturated (8% to 20% available moisture content) or super-saturated (greater than 20% available moisture content). These results were consistent with previous results, as described in H+R Site Note 3, dated 9 July 2021 and were typical of below ground structures of this age and method of construction
