Hutton + Rostron Environmental Investigations Limited

55 Cumberland Terrace, Mews: Timber Visual Strength Grading

Site note 2 for 25 June 2021, job no. 154.11

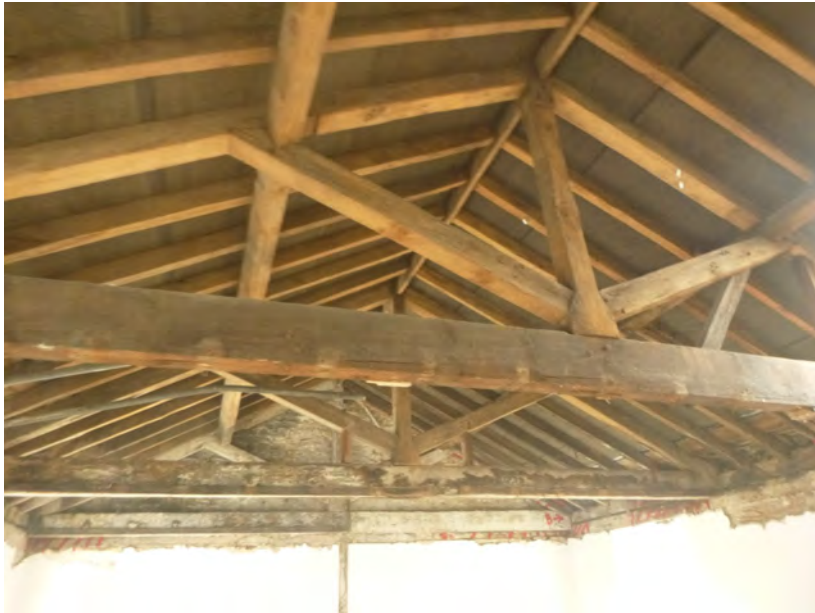
Fig 1:

Visual strength-grading, roof structures; showing general view of exposed roof timbers formed of 4 no. trusses of kingpost assembly. All timbers apparently of European Redwood with good access for strength grading assessment

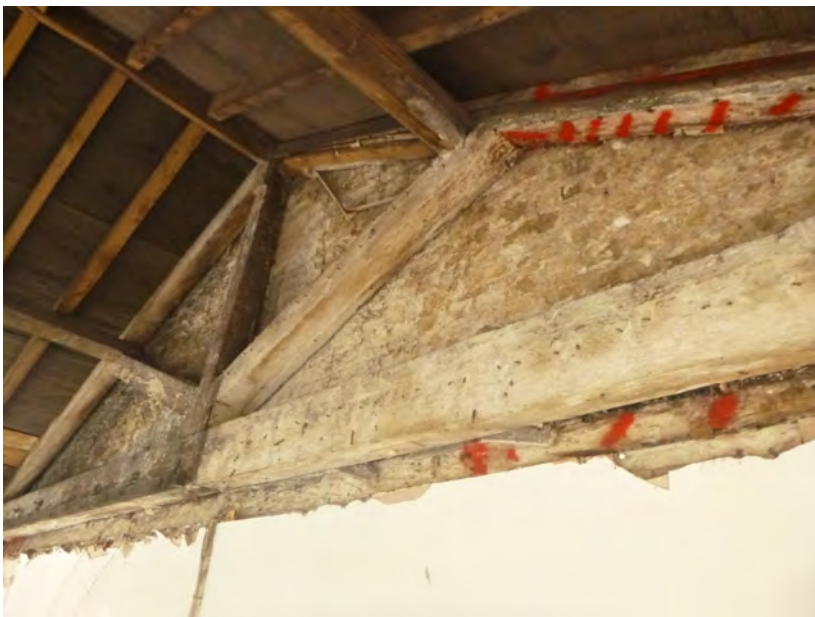
Fig 2:

Visual strength-grading, roof structures; showing truss 1. Note limited to poor visual access of timber surfaces from historic build-up of paint layers

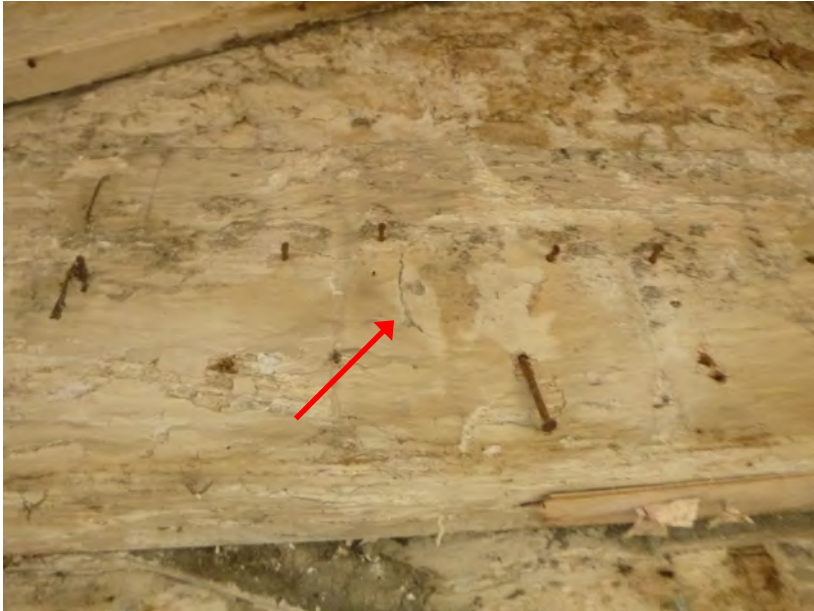
Fig 3:

Visual strength-grading, roof structures; showing some evidence for large knot location to truss tie beam 1, however, knot largely concealed by generations of paint build-up. Timber cannot be visually graded

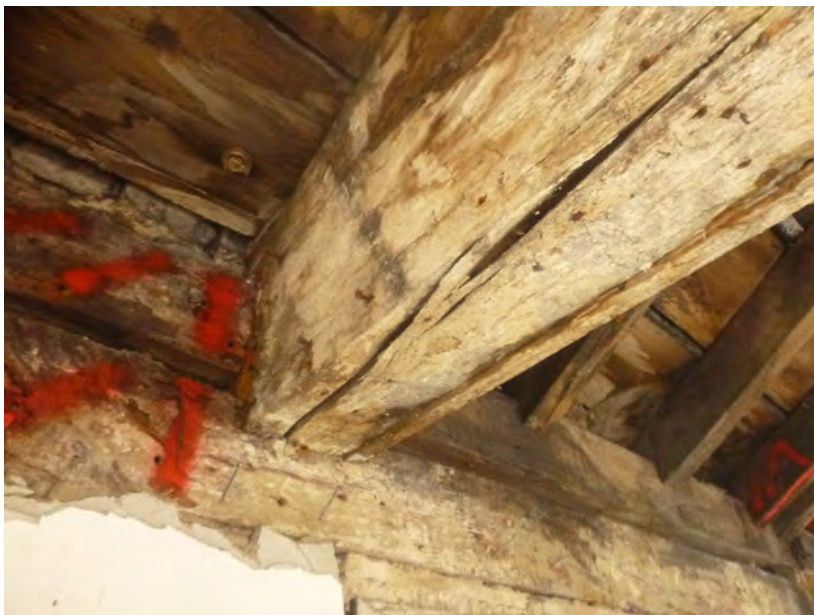
Fig 4:

Visual strength-grading, roof structures; showing west bearing end of truss tie beam 2 subject to moderate slope of grain and heart shake, however, slope of grain did not exceed 1 in 6 gradient. Timber graded C16

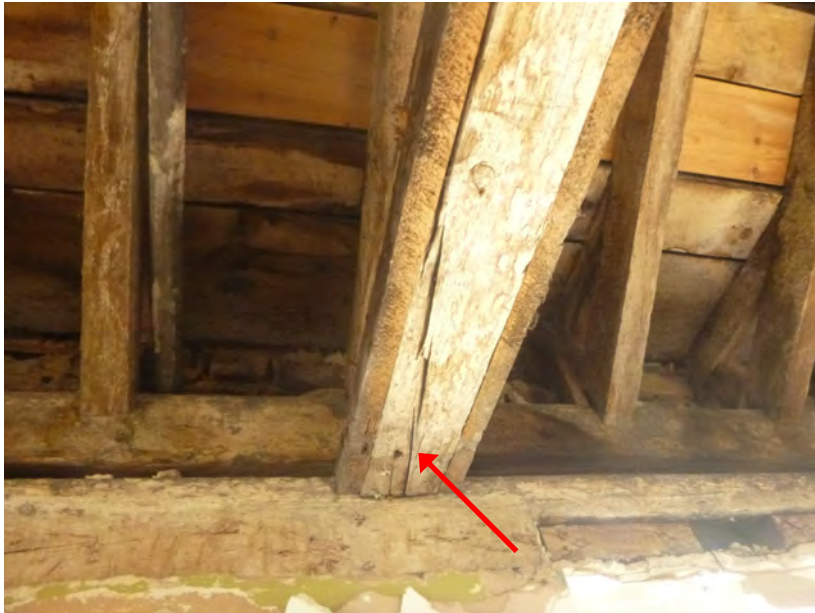
Fig 5:

Visual strength-grading, roof timbers; showing east bearing end of truss tie beam 2 showing moderate slope of grain at bearing end, however, slope of grain did not exceed parameters for strength-reducing weakness. Timber graded C16

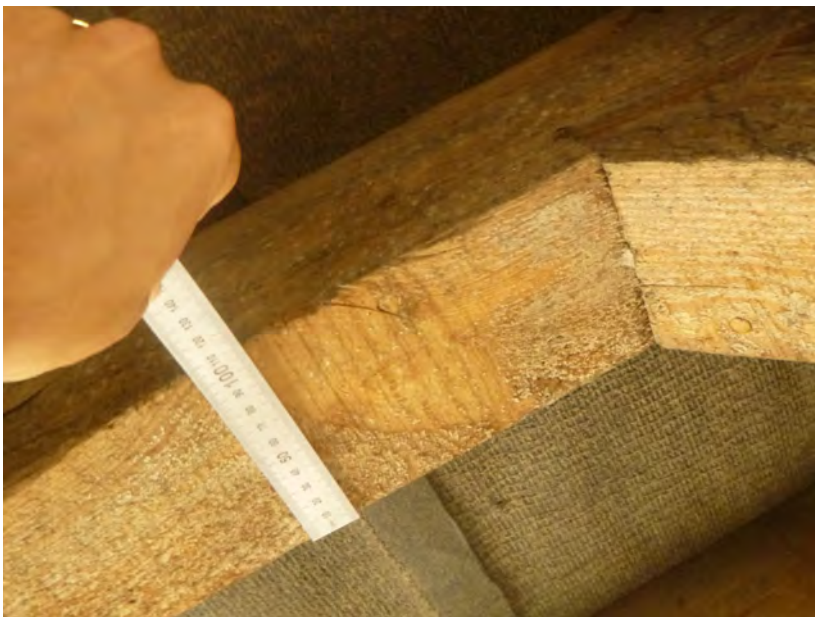
Fig 6:

Visual strength-grading, roof timbers; showing principal rafter to truss tie beam 2 east pitch subject to excessive through knot. Timber graded UG (Ungradable)

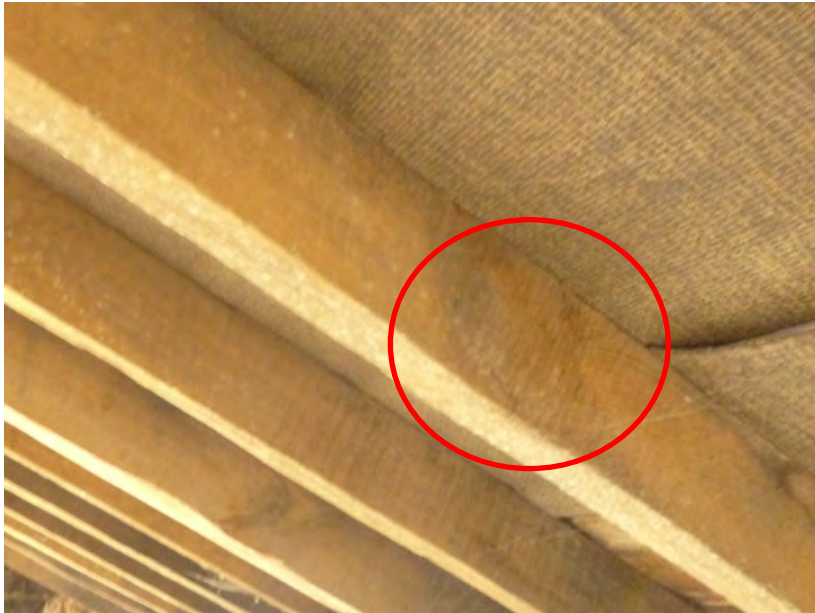
Fig 7:

Visual strength-grading, roof timbers; showing view of common rafter east pitch between trusses 2 and 3 subject to excessive through knot at approximately 60% of section size. Timber graded UG (Ungradable)

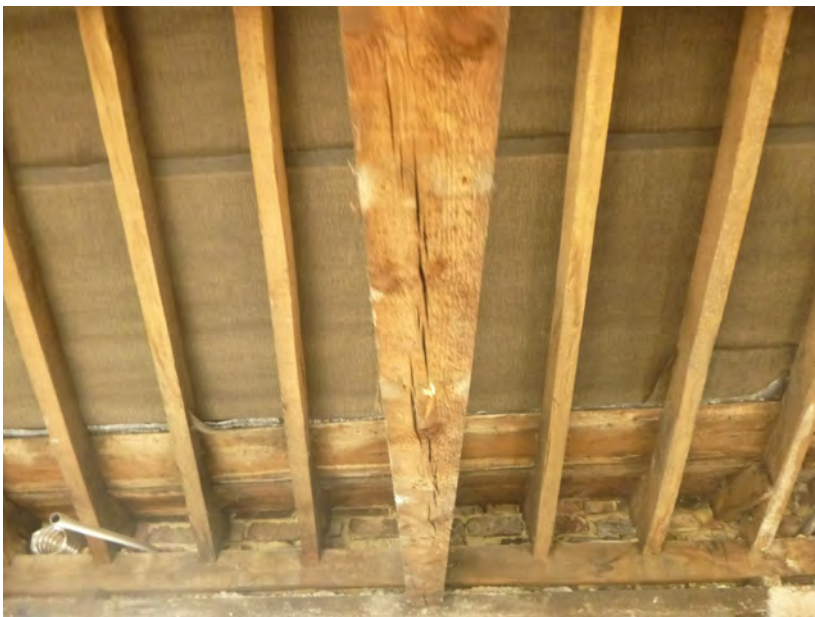
Fig 8:

Visual strength-grading, roof timbers; showing sporadic heart shake checking to the underside of truss tie beam 3, however, timber failed due to excessive notching to opposing west end of beam

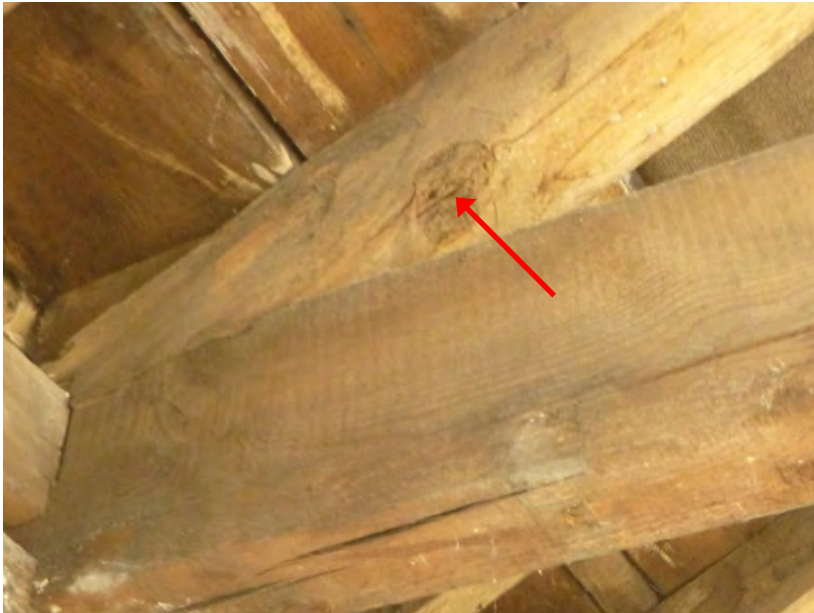
Fig 9:

Visual strength-grading, roof structures; showing excessive arris through knot to east principal rafter to truss 3. Principal rafter graded UG (Ungradable)

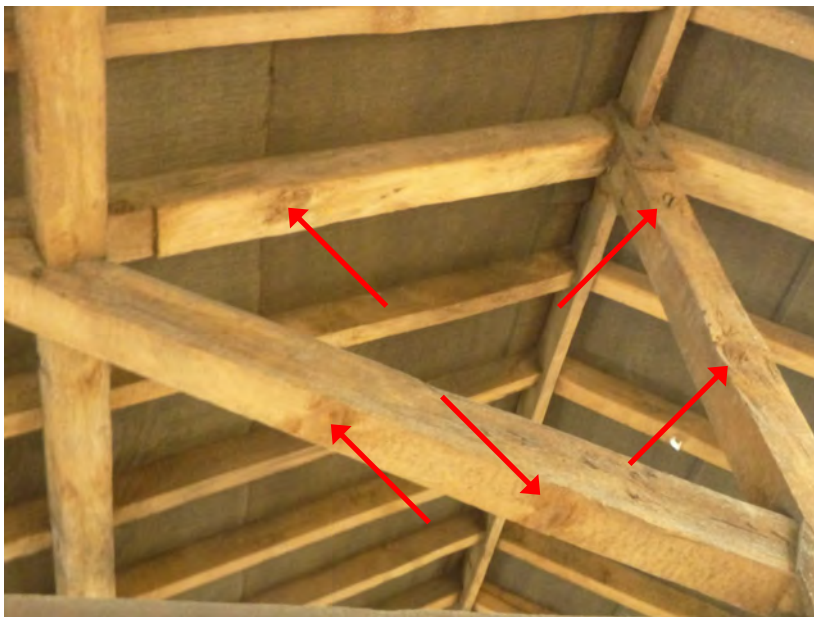
Fig 10:

Visual strength-grading, roof timbers; showing multiple significant large section through knots to all principal timbers forming truss tie beam 3 including raking struts, principal rafter and kingpost. Entire truss graded UG (Ungradable)

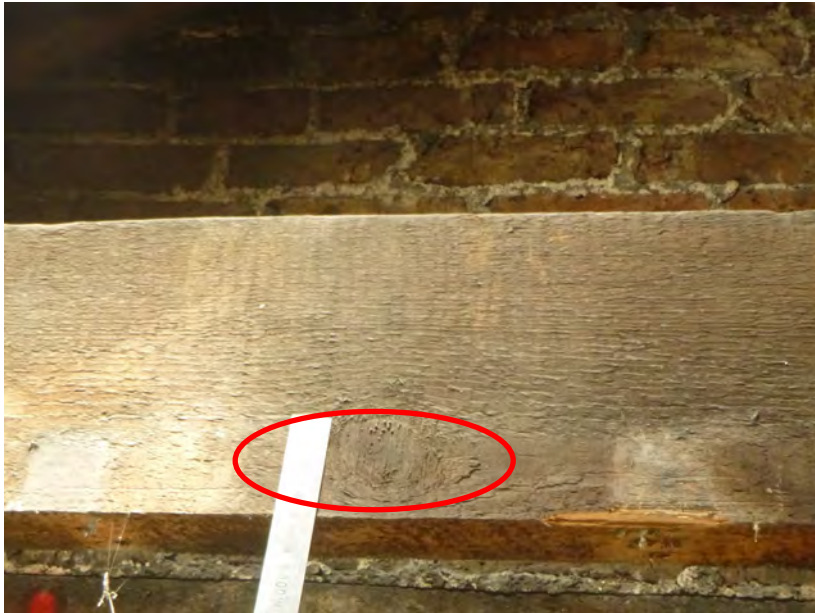
Fig 11:

Visual strength-grading roof timbers showing small through knots to side face of truss tie beam 4 at approximately nearing the 40mm as typically found throughout the remaining sections of timber which is not deemed a strength-reducing characteristic. Tie beam graded SS (Special Structural) or C24 grade

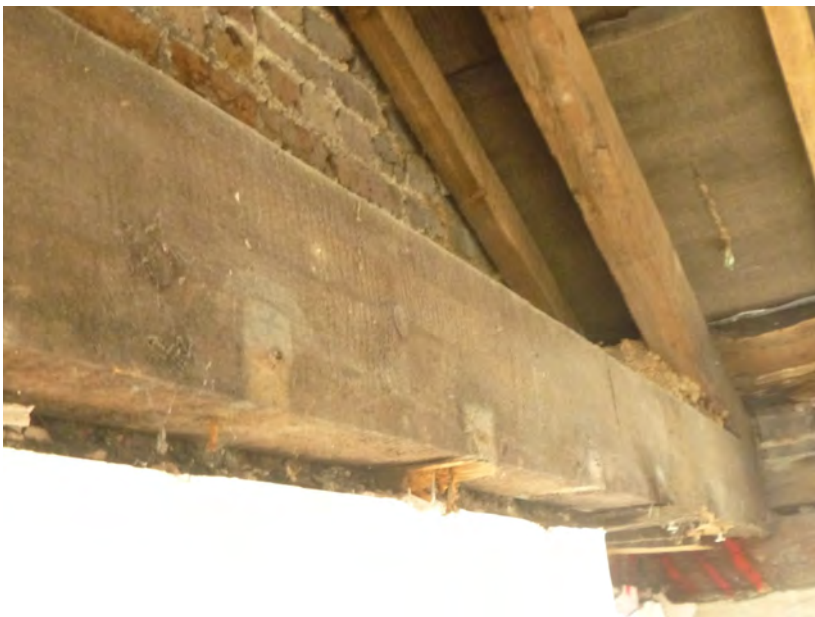
Fig 12:

Visual strength-grading, roof timbers; showing general view of truss 4 tie beam. Note good straight grain growth without any apparent strength-reducing characteristics. Timber graded SS (Special Structural) or C24

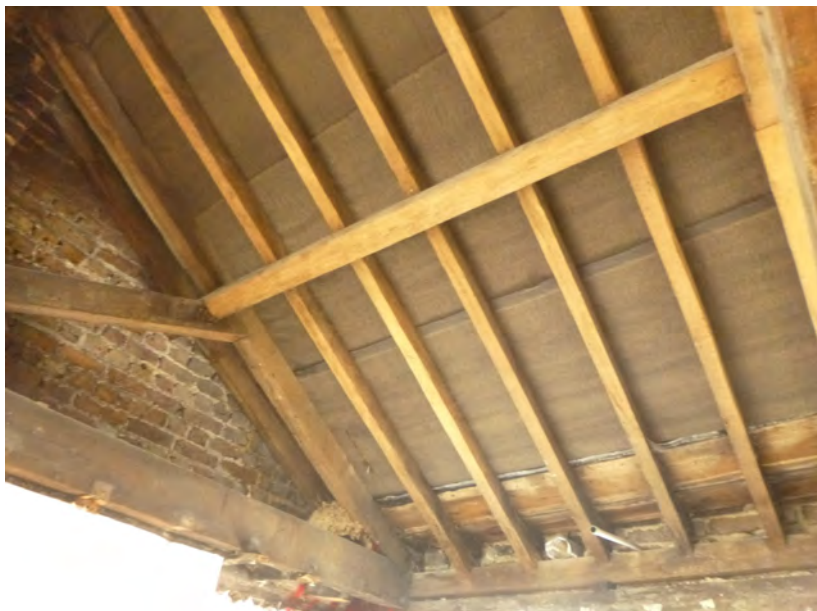
Fig 13:

Visual strength-grading; roof timbers; showing general view of east pitched common rafter assembly at north east area. Note timbers generally of reasonable condition with limited strength-reducing characteristics. Majority of common rafters were graded as GS (General Structural) or C16 grade excepting 10% which were graded UG (Ungradable)

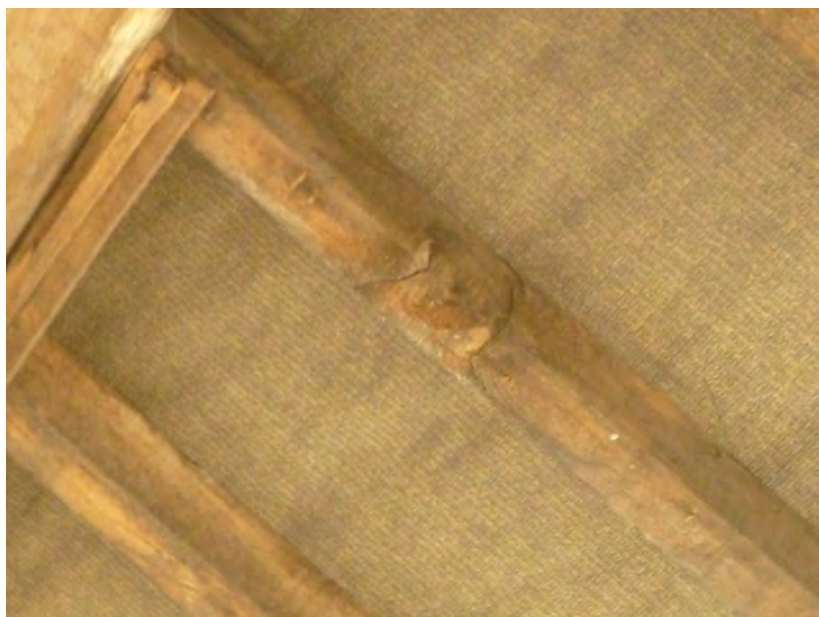
Fig 14:

Visual strength-grading, roof timbers; showing failed or UG (Ungradable) timber to west pitch south west corner between trusses 1 and 2

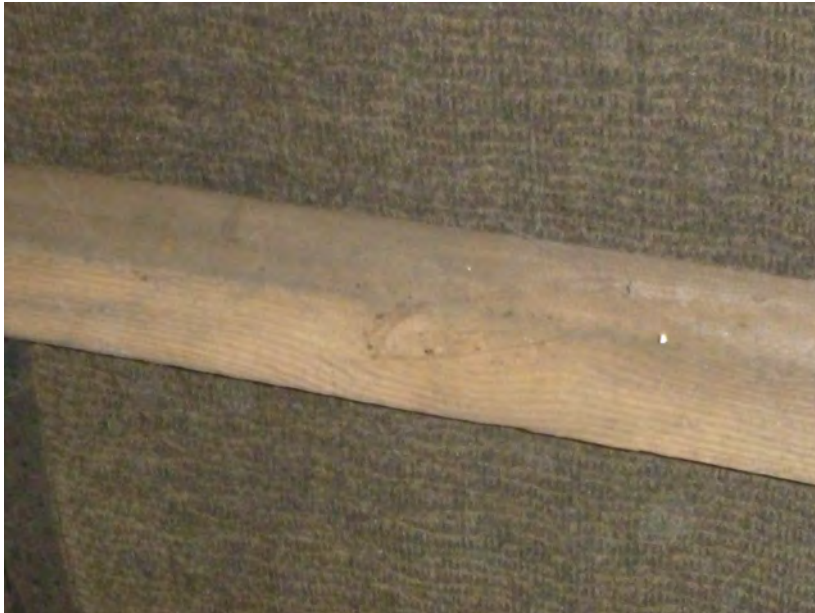
Fig 15:

Visual strength-grading, roof structures; showing typical common rafter subject to moderate through arris knot which, although deemed a strength-reducing characteristic, was not large enough to grade it as UG (Ungradable). Timber graded C16 or GS (General Structural)

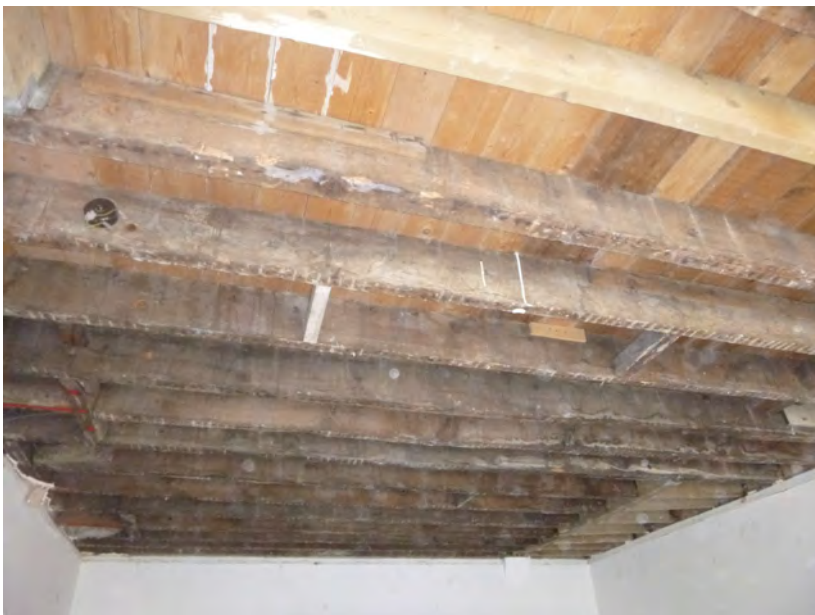
Fig 16:

Visual strength-grading, first floor; structures showing view in general of south room 17 no. floor joists spanning north/south between masonry walls. All timbers were assessed for their strength-reducing characteristics such as knot margins, slope of grain, wane and rate of growth

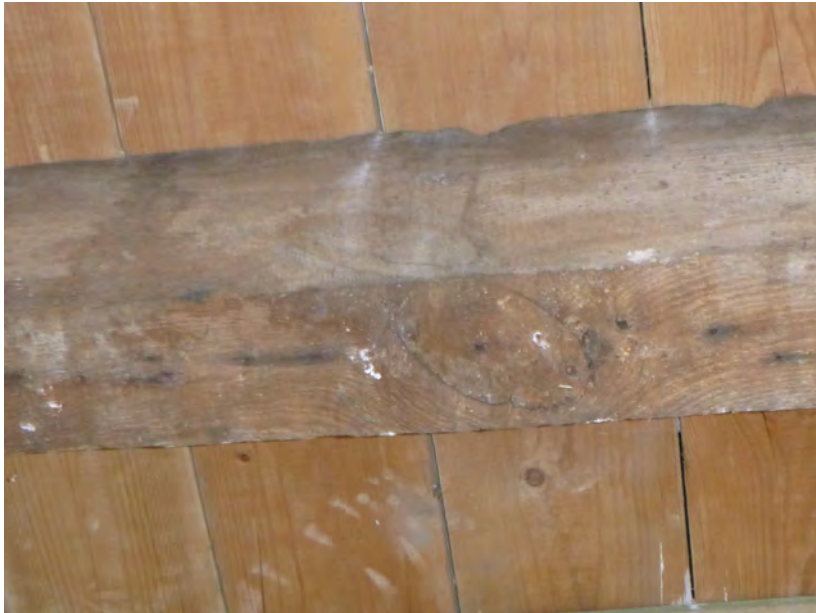
Fig 17:

Visual strength-grading, first floor; showing typical floor joist at east perimeter wall subject to excessive through knot at bottom face. Timber graded UG (Ungradable)

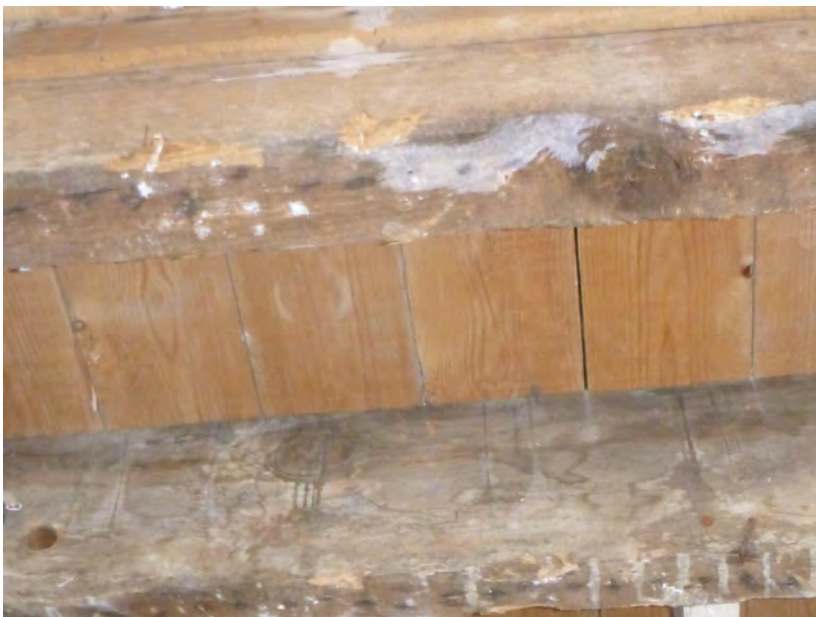
Fig 18:

Visual strength-grading, first floor; structures showing 2 no. floor joists at east area subject to excessive knot margins to their upper and lower faces. Timbers graded UG (Ungradable)

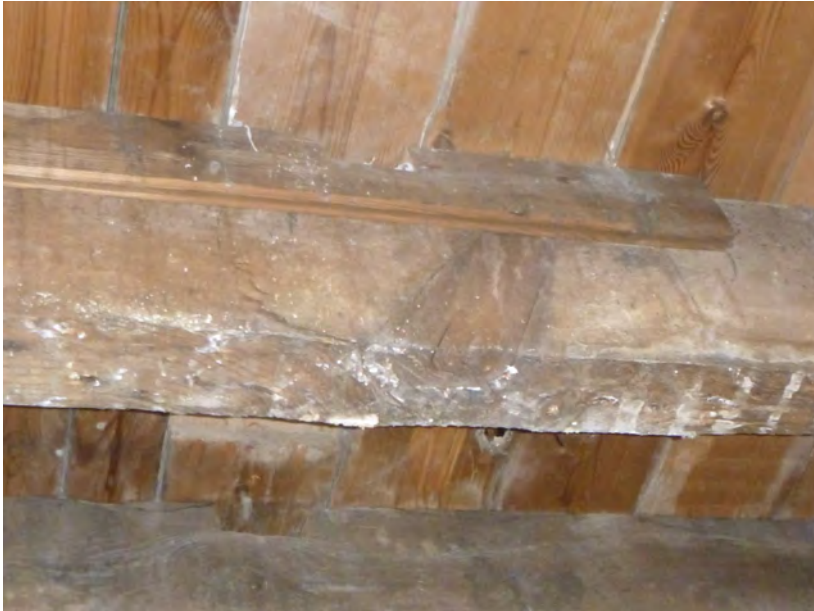
Fig 19:

Visual strength-grading, first floor; structures showing large splay knot to side of face to floor joists. Timber borderline between C16 and UG (Ungradable)

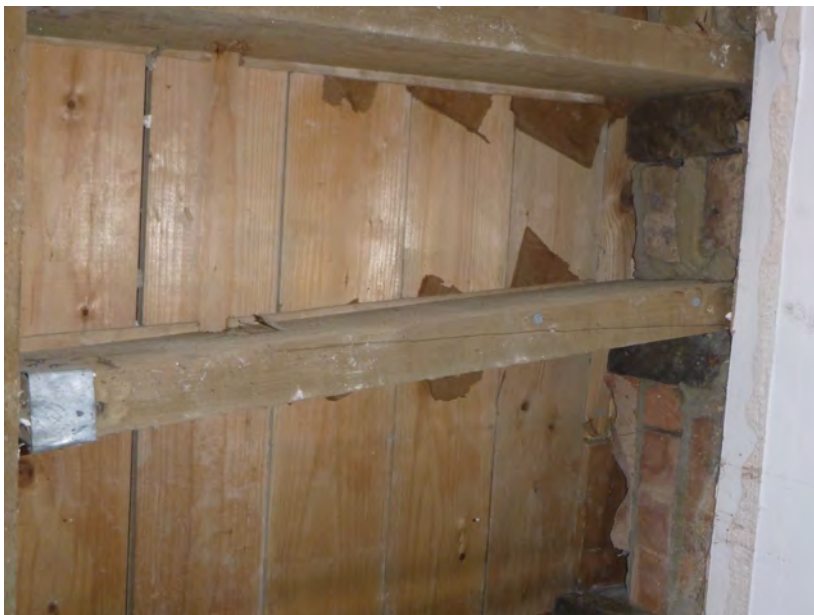
Fig 20:

Visual strength-grading, first floor; structures showing modern addition remedial floor joists subject to excessive slope of grain and structural cracking or fissure. Timber graded UG (Ungradable)

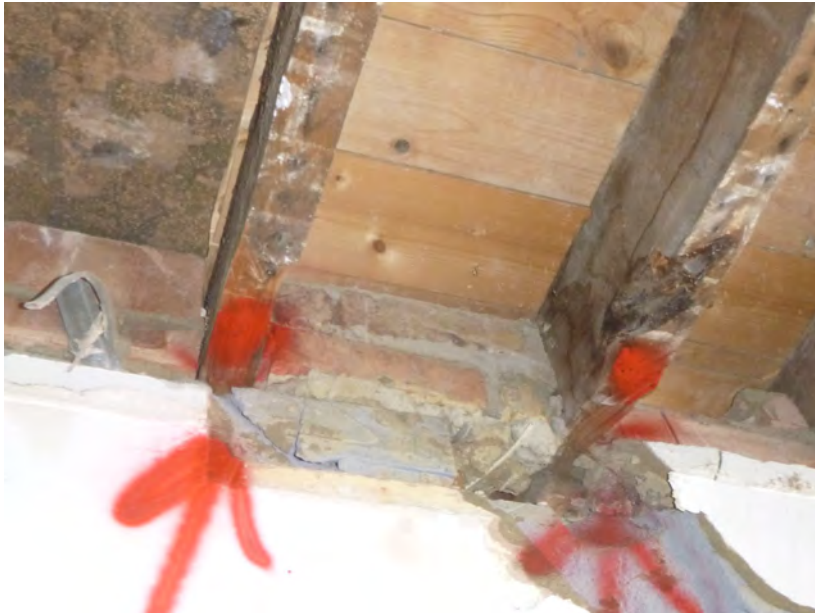
Fig 21:

Visual strength-grading, first floor; structures showing 2 no. floor joists embedded into internal party wall subject to excessive mechanical damage or failure at inherent grain weaknesses within timbers. Timbers graded UG (Ungradable)

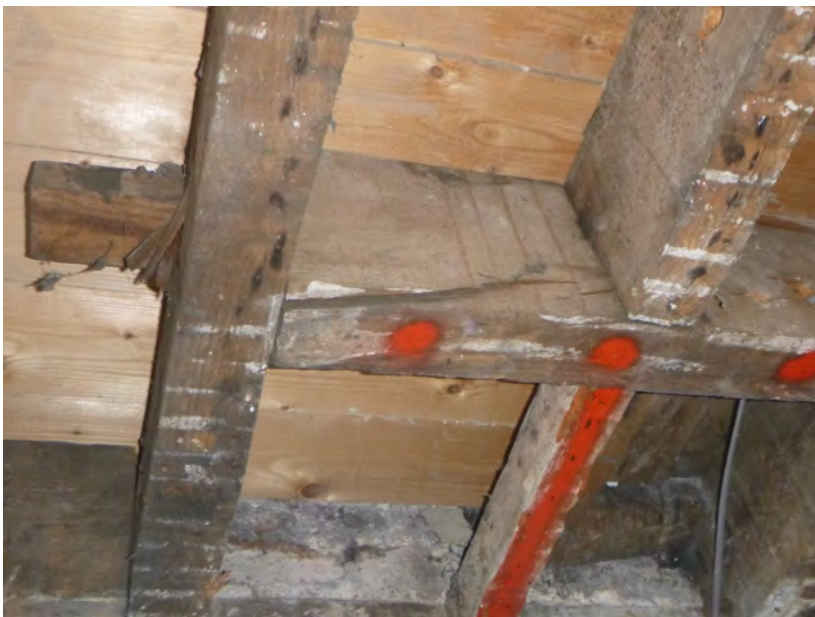
Fig 22:

Visual strength-grading, first floor; structures showing trimmer joist at central south wall subject to excessive slope of grain and structural fissure to timber. Timber graded UG (Ungradable)

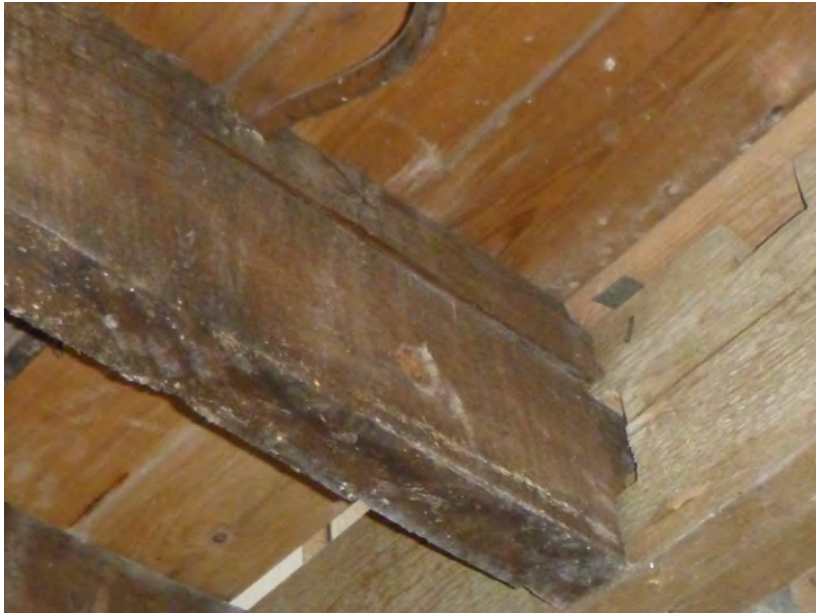
Fig 23:

Visual strength-grading, first floor;
showing floor joists with excessive knot
margin

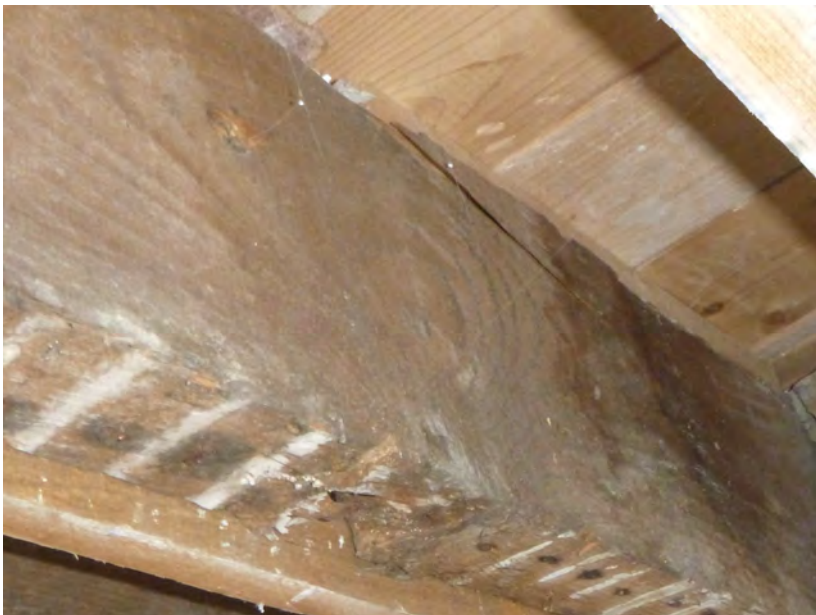
Fig 24:

Visual strength-grading, first floor;
showing floor joists to south room
subject to excessive knot margin as well
as slope of grain to upper face. Timber
graded UG (Ungradable)

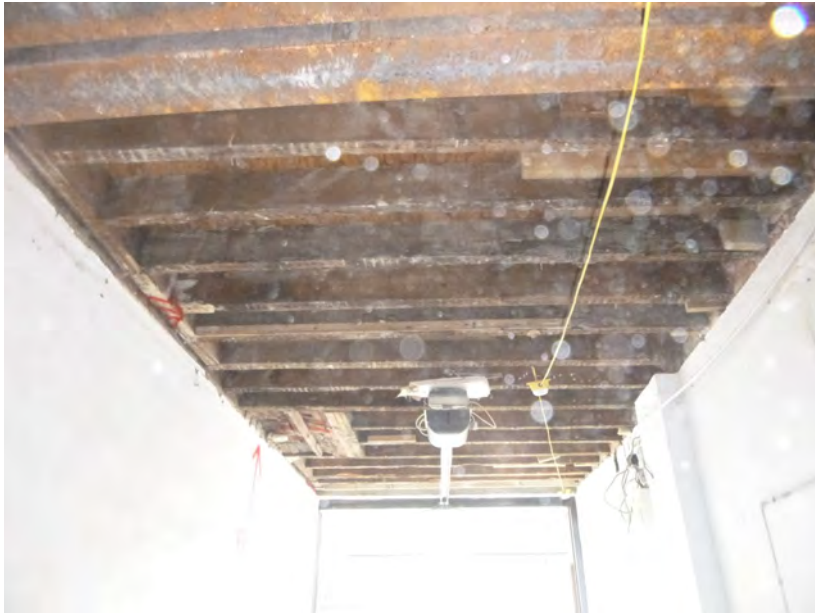
Fig 25:

Visual strength-grading, first floor; showing north room carport in general looking east. Note majority of floor joists appear to be of poor quality converted timbers with approximately 11 of the 70 no. floor joists spanning north/south graded UG (Ungradable)

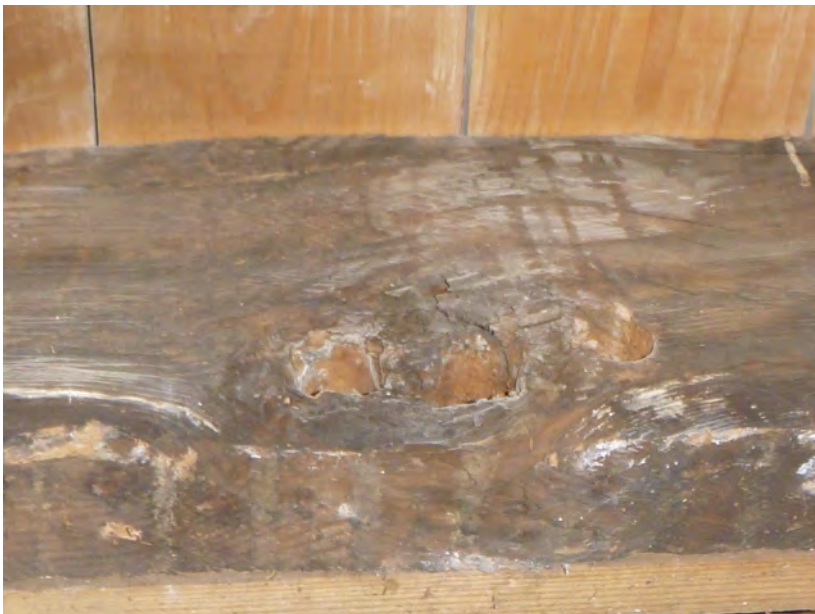
Fig 26:

Visual strength-grading, first floor structures; showing 1 no. floor joist at west area subject to excessive knot margin as well as multiple service holes. Timber graded UG (Ungradable)

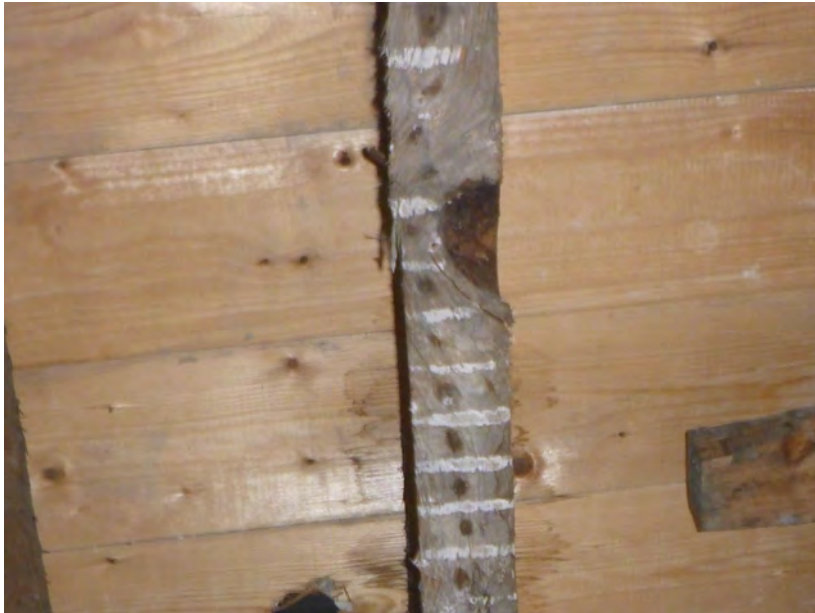
Fig 27:

Visual strength-grading, first floor structures; showing joist at central area of the room subject to loss of section from knot location as well as excessive slope of grain which represents an innate strength-reducing characteristic within the timber. Timber graded UG (Ungradable)

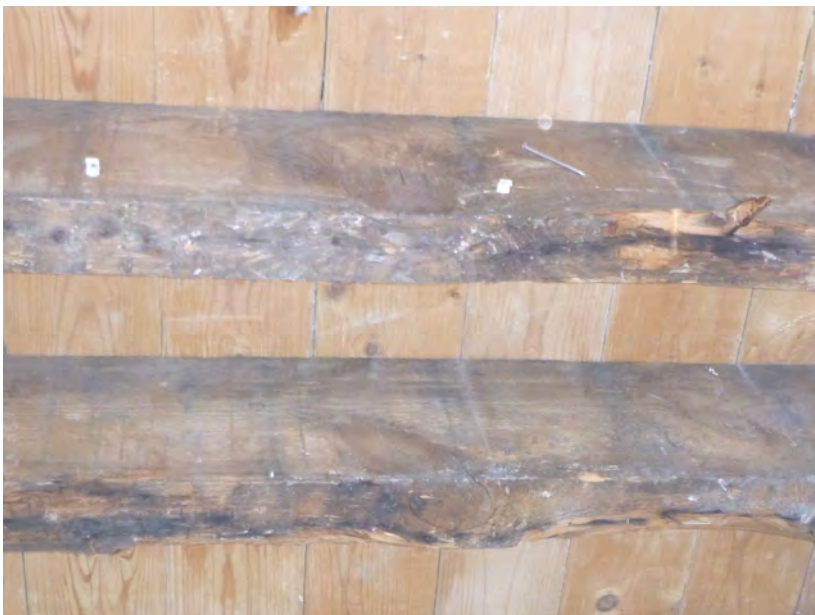
Fig 28:

Visual strength-grading, first floor structures; showing 2 no. floor joists at north area adjacent to bressummer rolled steel joist subject to excessive knot margins. Both timbers graded UG (Ungradable)

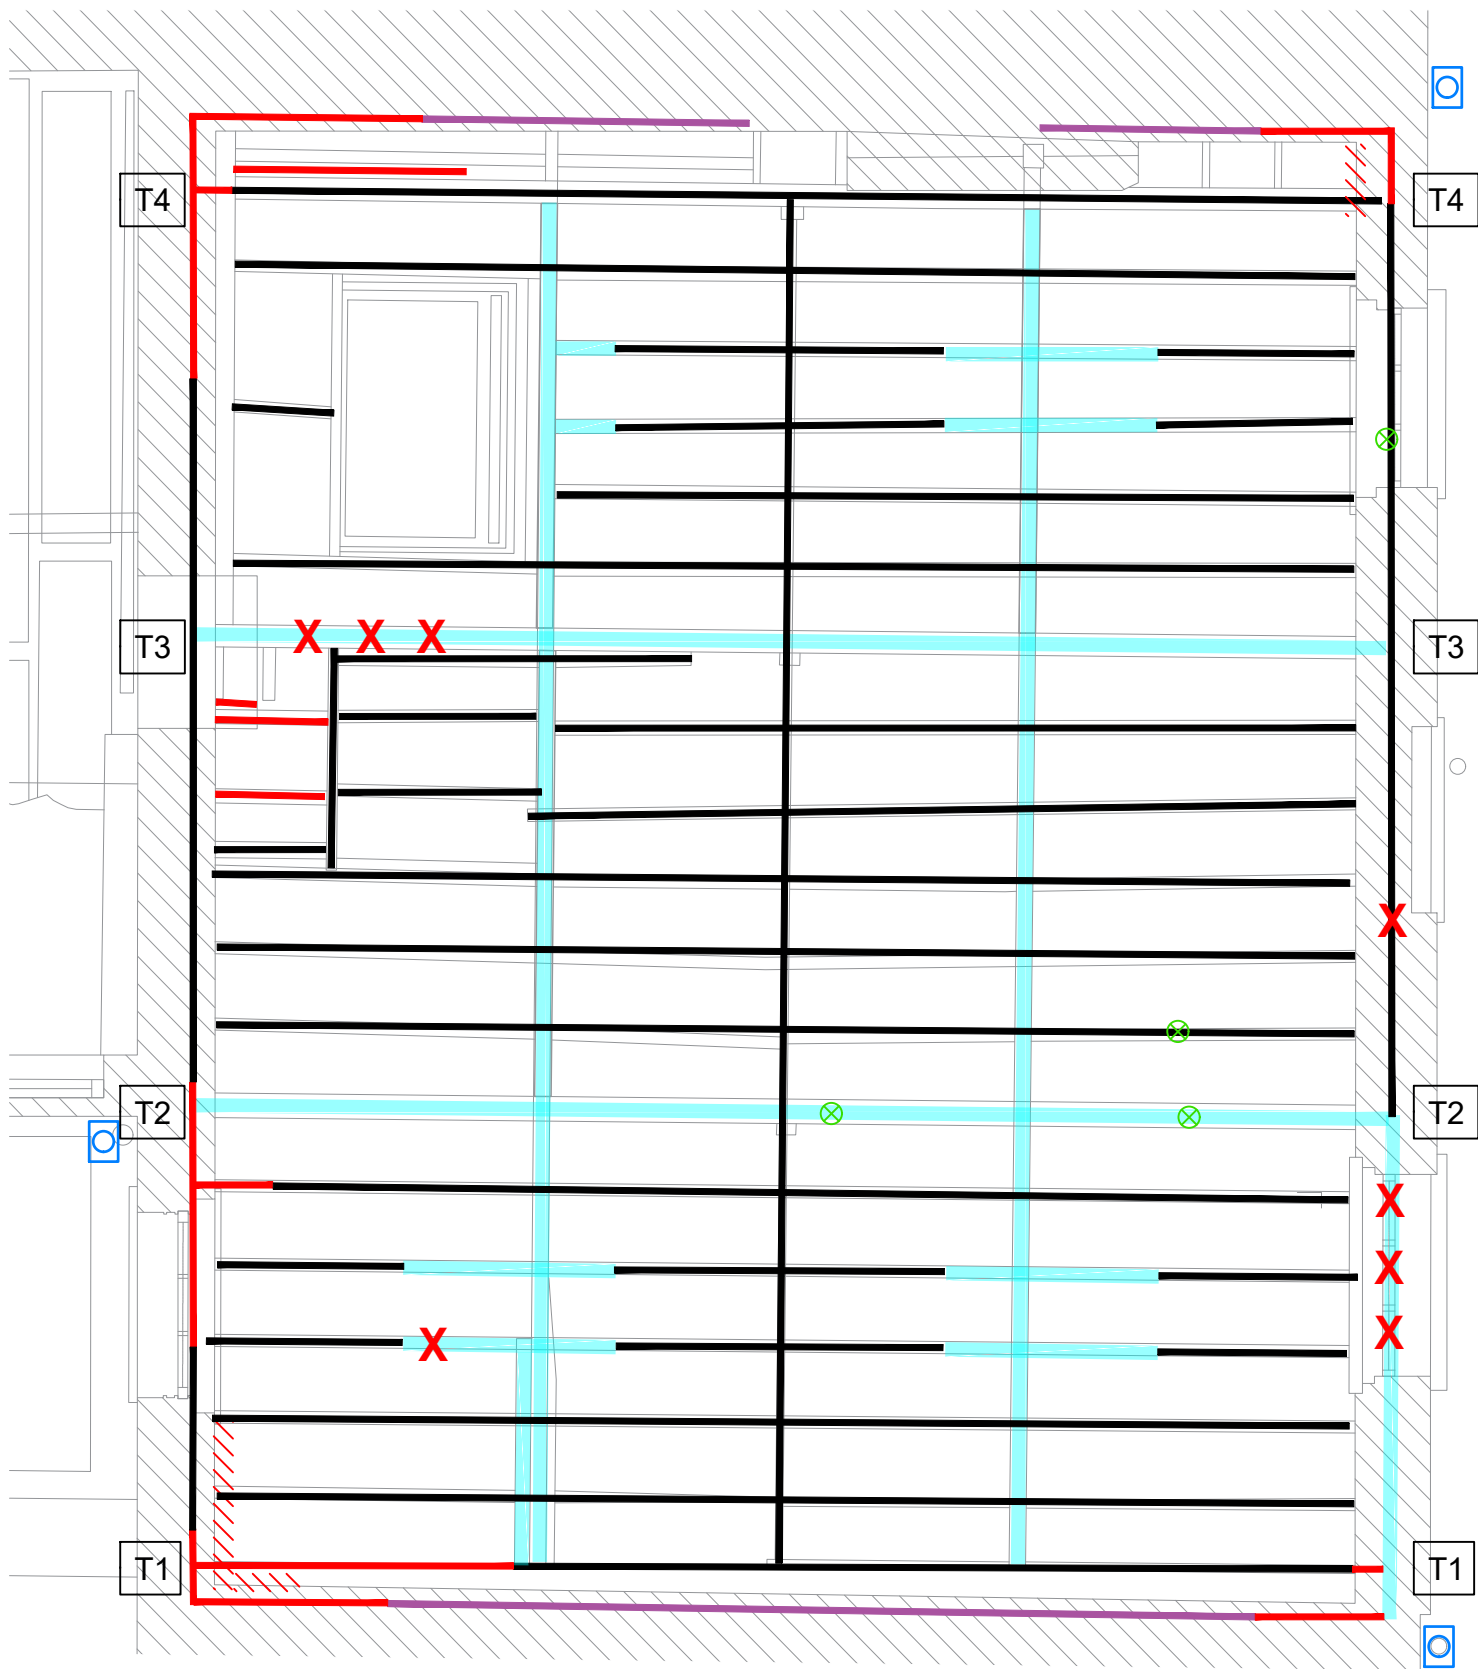
55 Cumberland Terrace, Mews, Roof Visual Strength Grading Assessment 25 June 2021

steel lintel carrying internal opening at west end of carriageway, timber packer directly above and timber plate/lintel embedded in masonry at floor level

solid lintel over carriage door opening

non-historic masonry wall carrying floor joists at mid-span

area of replaced timber floor structure

steel lintel carrying window to the south-east
