## PROPOSED SCOPE OF WORK

## PROPOSED FRONT ELEVATION (EAST)

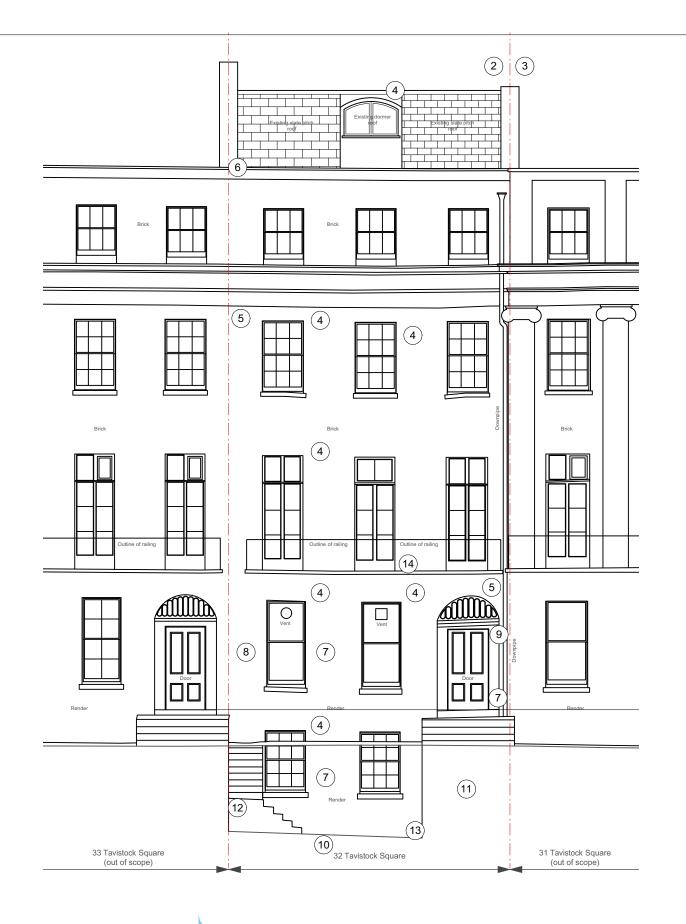
Proposed Works: Existing rooflight to be reduced in size to increase clearance between upstand and parapet wall to introduce suitable flashing detail in order to address suitable flashing detail.

Proposal Works Local repairs required to third floor parapet to adress failing lead flashing, pointing and spalled brickwork all of which are contributing to internal water ingress.

Proposed Works: Local repairs required to third floor parapet concrete coping to address a number of defects within the concrete, including large cracks, exposed reinforcement and DPC.

Proposed Works - Local repairs needed to timber window elements to address failed or failing components.

Proposed Works: Rebuild existing stuccy render detailing across princiapl facade to address various areas of failed, spalled and genearlly degraded render detailing.

Proposed Works: Bituminous waterproof covering to be reapplied to front gutter course and parapet coping to reinstate waterproofing coating.

Proposed Works: Re-render principal elevation from basement to first floor level to addres large areas of saturated render.

Proposed Works: Decorate all previously painted external surfaces to address poor decorative condition and restore the building's appearance.

Proposed Works: Masonry wall adjacent front door should be rebuilt to match original profile and affected surfaces re rendered.

Proposed Works: Repair defective below ground drainage and introduce new hardstanding and drainage to light well. Works are vital to address excess ground water and halt ongoing movement of the building.

Proposed Works: Rebuild failing pier brickwork beneath modern concrete lintel. Orginal bricks and surrounding plaster are saturated and failing underneath modern engineering bricks.

Proposed Works: Access stairs to lightwell should be repaired including steelwork and finishes.

Proposed Works: Reinstate missing brickwork from foundations - assumed to have been removed in the past for services.

Replace failed asphalt waterproofing to first floor balcony. Further investigations required to establish extent of corrosion to cast iron cantilevered members.
