### PROPOSED SCOPE OF WORK

# **EXISTING & PROPOSED LIGHTWELL**

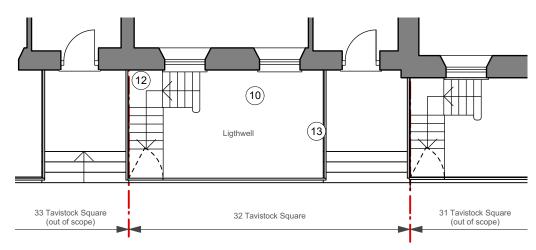
## **EXISTING LIGHTWELL**

Proposed Works: Repair defective below ground drainage and introduce new hardstanding and drainage to light well. Works are vital to address excess ground water and halt ongoing movement of the building.
