# Heritage, Design & Access Statement

For proposed repairs to the listed building at:

32 Tavistock Square

For: Birkbeck University of London

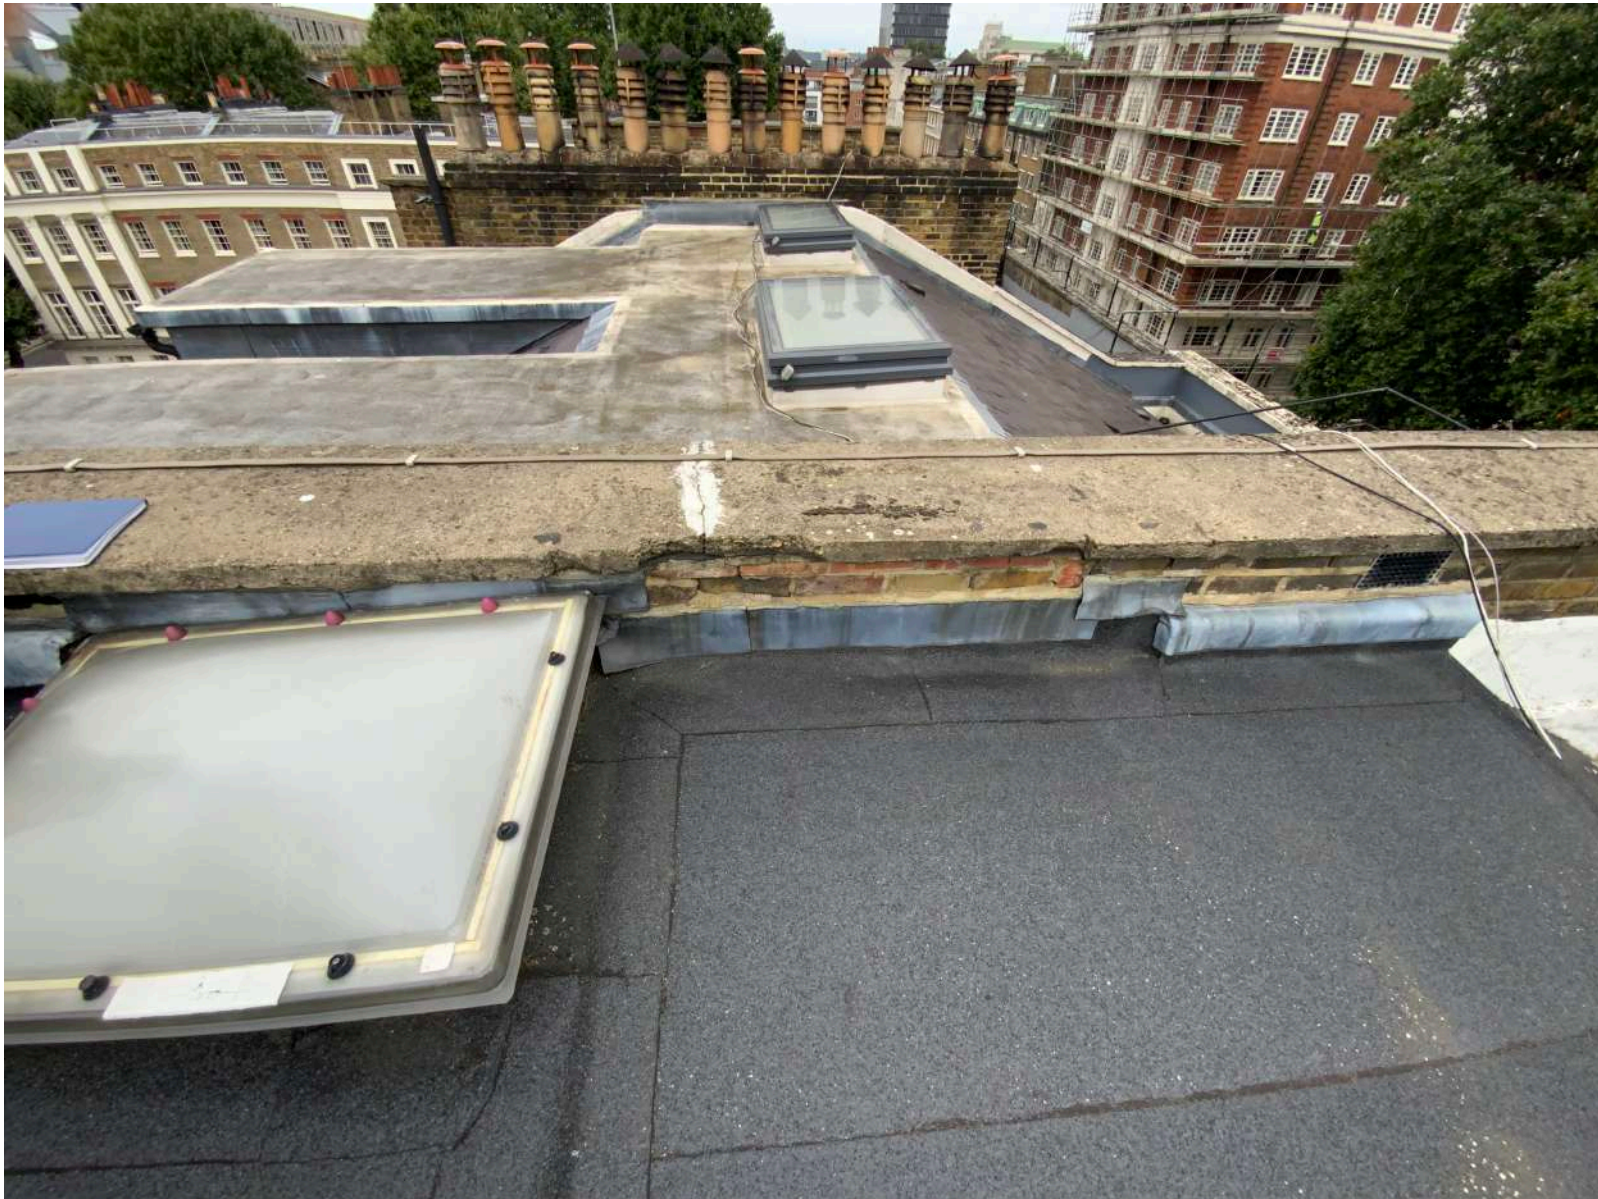
**Justification:** To rectify ongoing water ingress at roof level.

**PHOTOGRAPH PAGE NO. 1 -**  
**(Item No.1 - Roof Repairs)**

**Proposal:** Existing rooflight to be reduced in size to increase clearance between upstand and parapet wall to introduce suitable flashing detail.

- Poly carbonate dome roof light removed and cleared from site.
- Install narrower polycarbonate dome roof light to match the existing profile and height.
- Infill redundant section of roof to allow min 200mm clearance between roof light and parapet wall.
- Apply new bituminous felt built up roof system to marry in with existing - note roof covering c5 years old. New installation and detailing to suit.

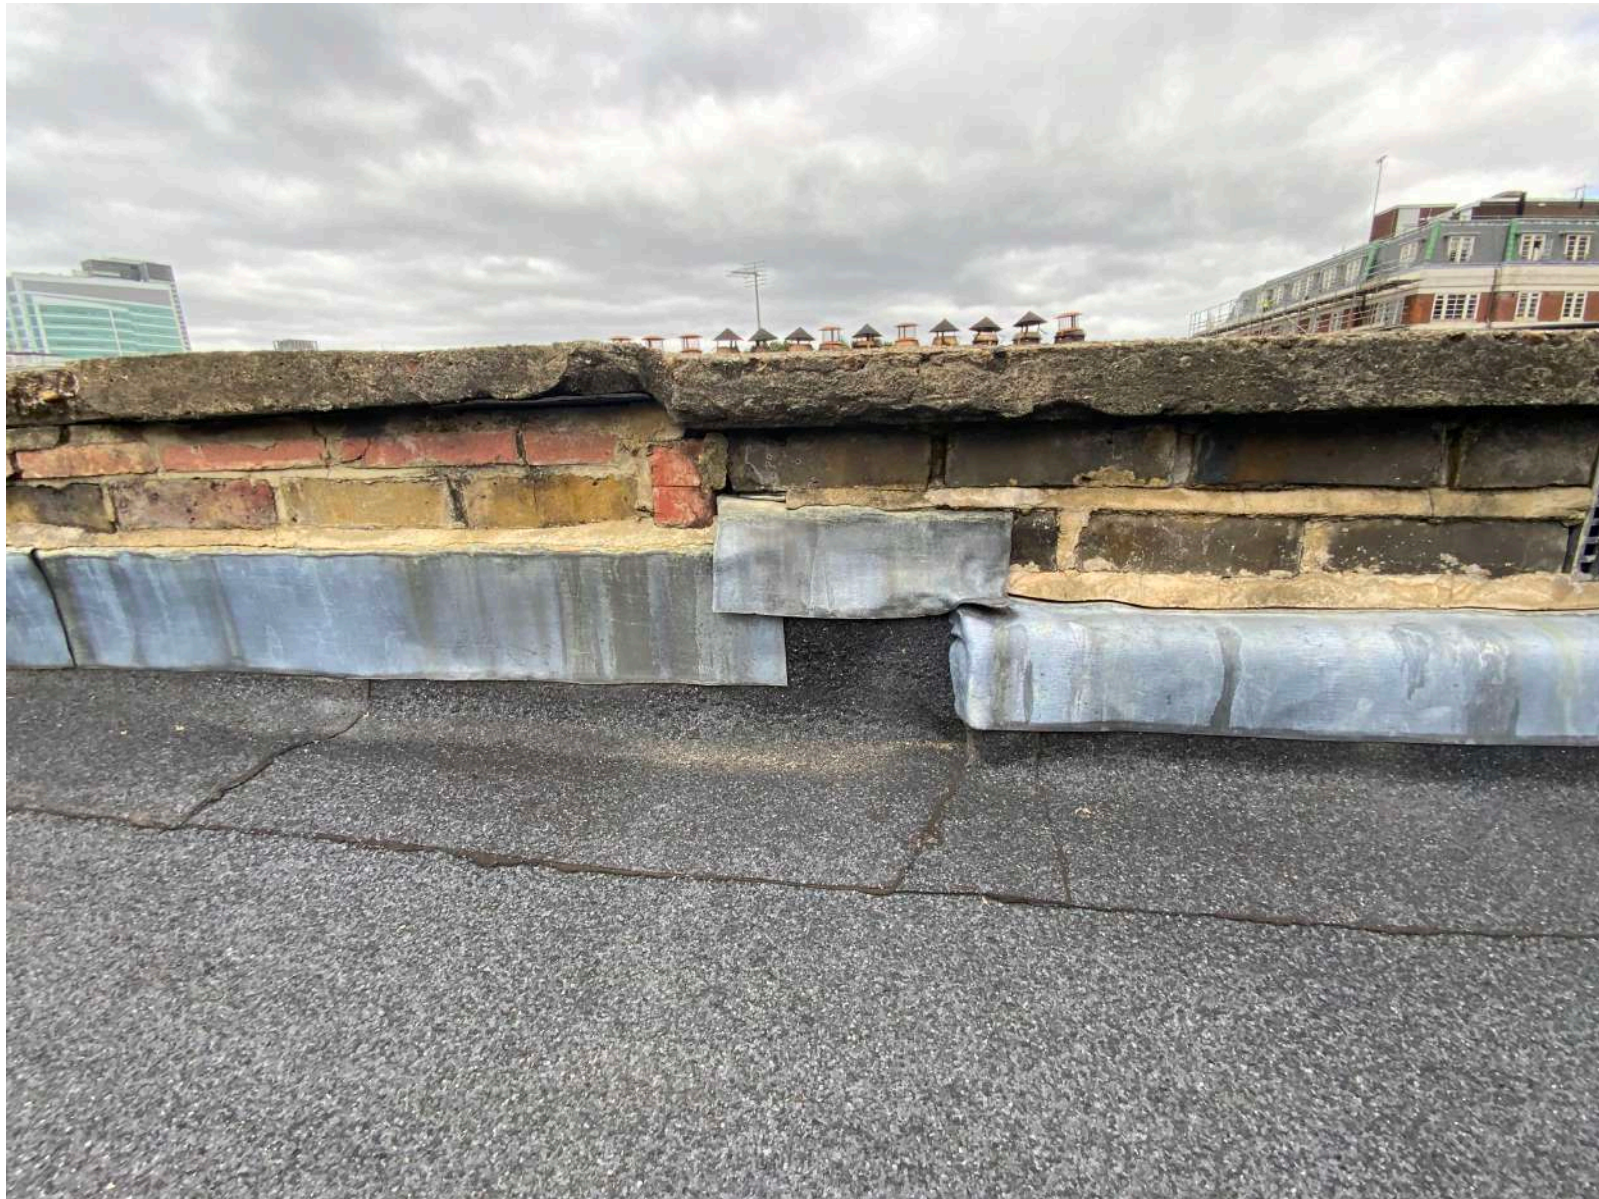
**Justification:** Existing flashing, pointing and brickwork in poor condition and are all contributing to internal water ingress.

**PHOTOGRAPH PAGE NO. 2 -**  
**(Item No.2 - Parapet Repairs)**

**Proposal:** Local repairs required to third floor parapet.

- Carefully remove all lead flashing. Replace with new code 4 lead chased into brickwork and pointed in with a lime mortar mix.
- Spalled and missing bricks to be replaced where required with counterparts to match existing composition and size.
- Parapet to be repointed in full with a suitable lime mortar mix. Colour and profile to match existing.

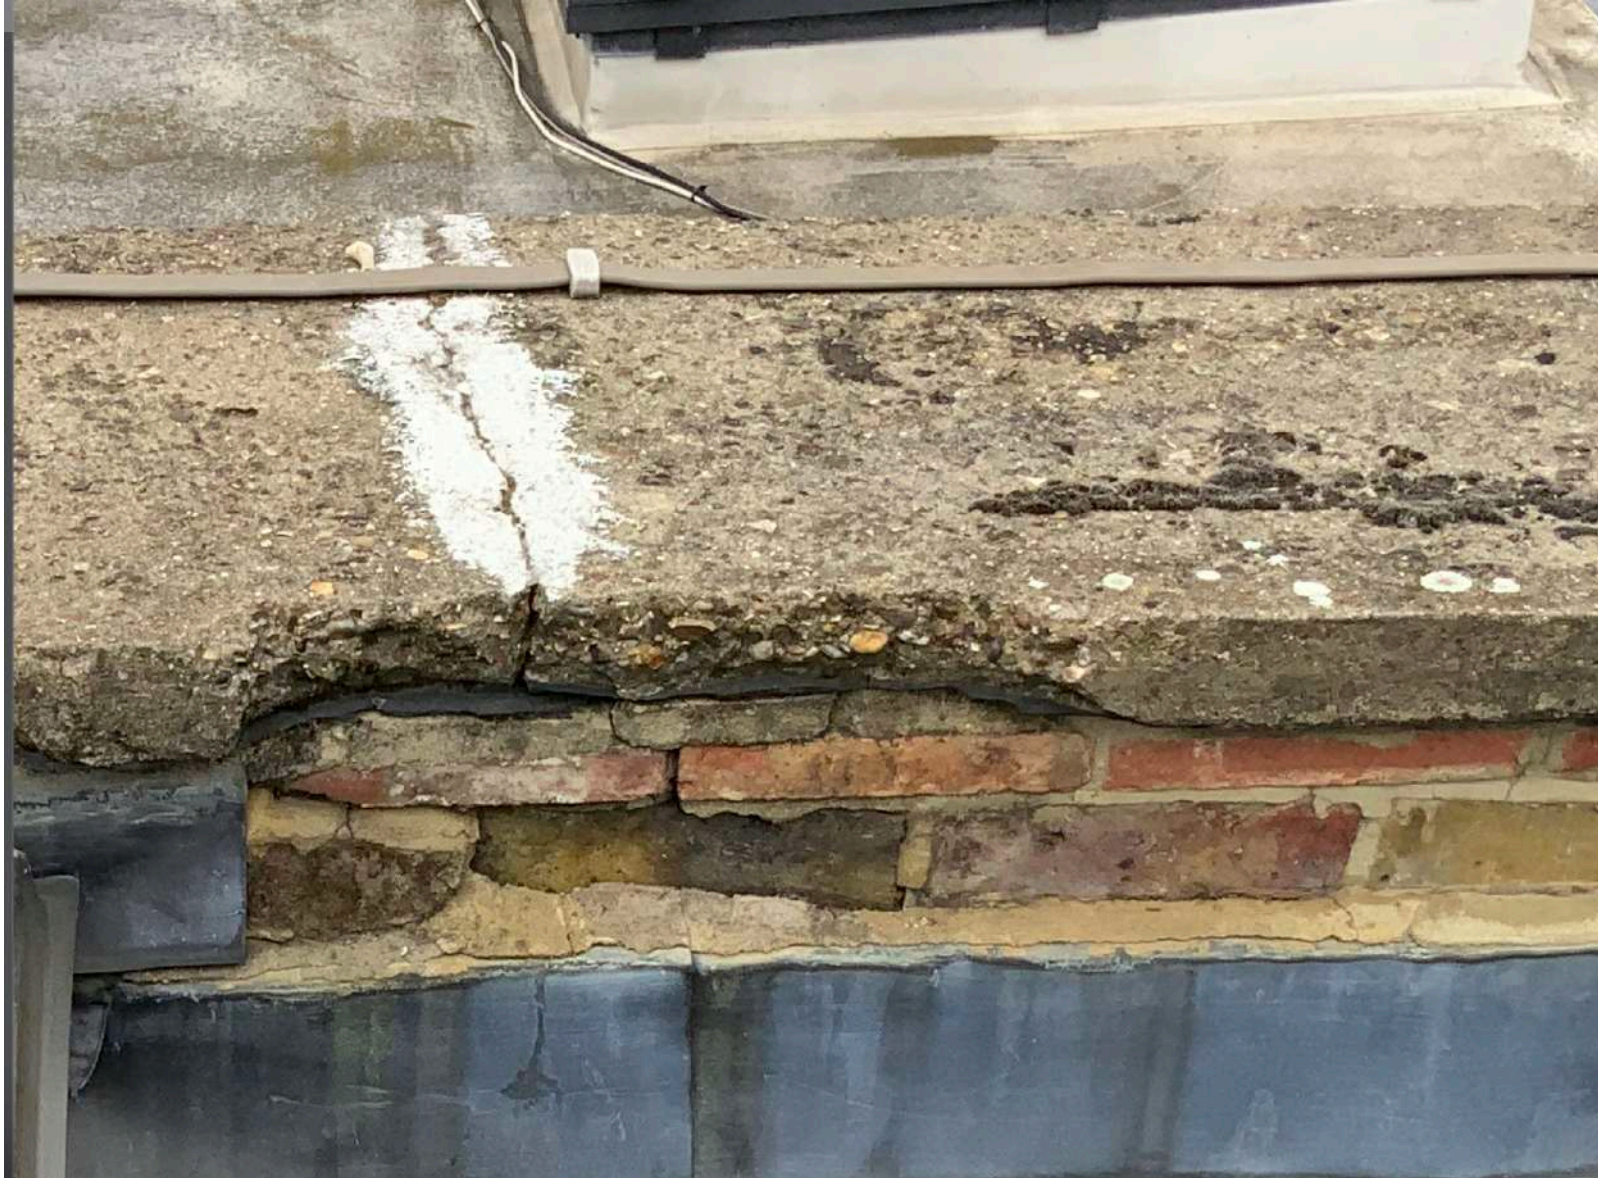
**Justification:** To address a number of defects within the concrete, including large cracks, exposed reinforcement and DPC.

**PHOTOGRAPH PAGE NO. 3 -**  
**(Item No.3 - Repairs to Concrete Coping)**

**Proposal:** Local repairs required to third floor parapet concrete coping.

- Resin repairs required to concrete splits to leave weathertight.
- Concrete coping to be decorated in with adjoining buildings with masonry paint - colour: to match surrounding parapets.
- Expose slate DPC to assess completeness. Undertake repairs as required following further investigation.

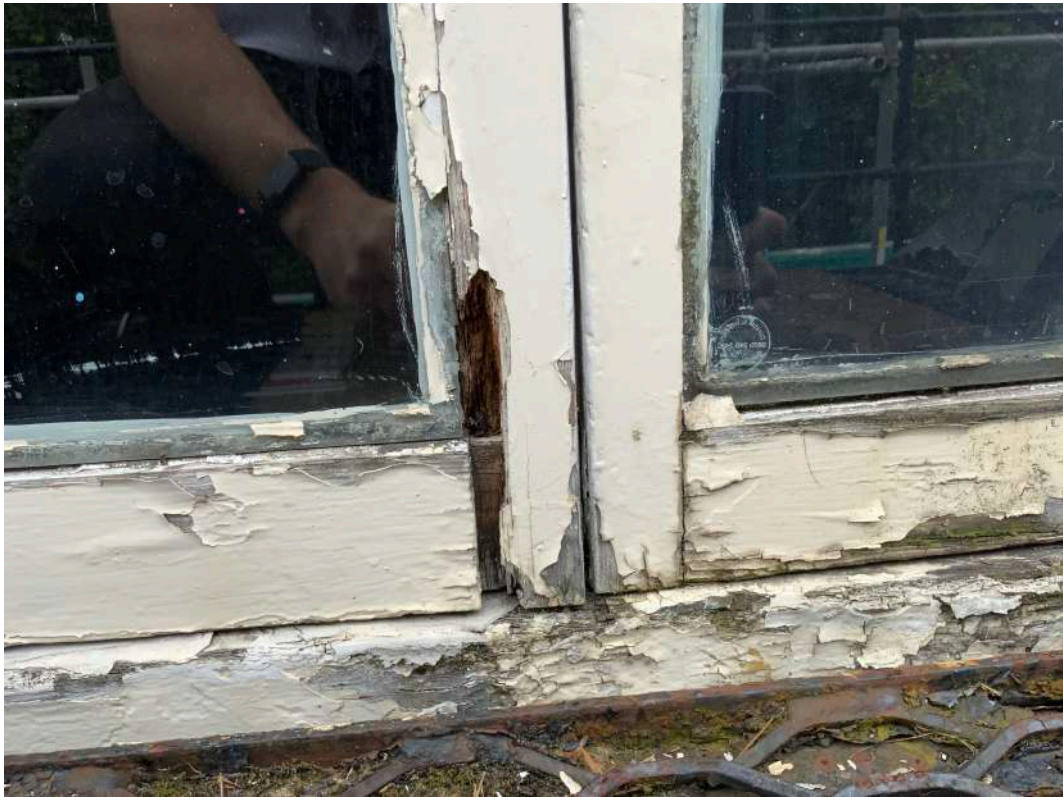
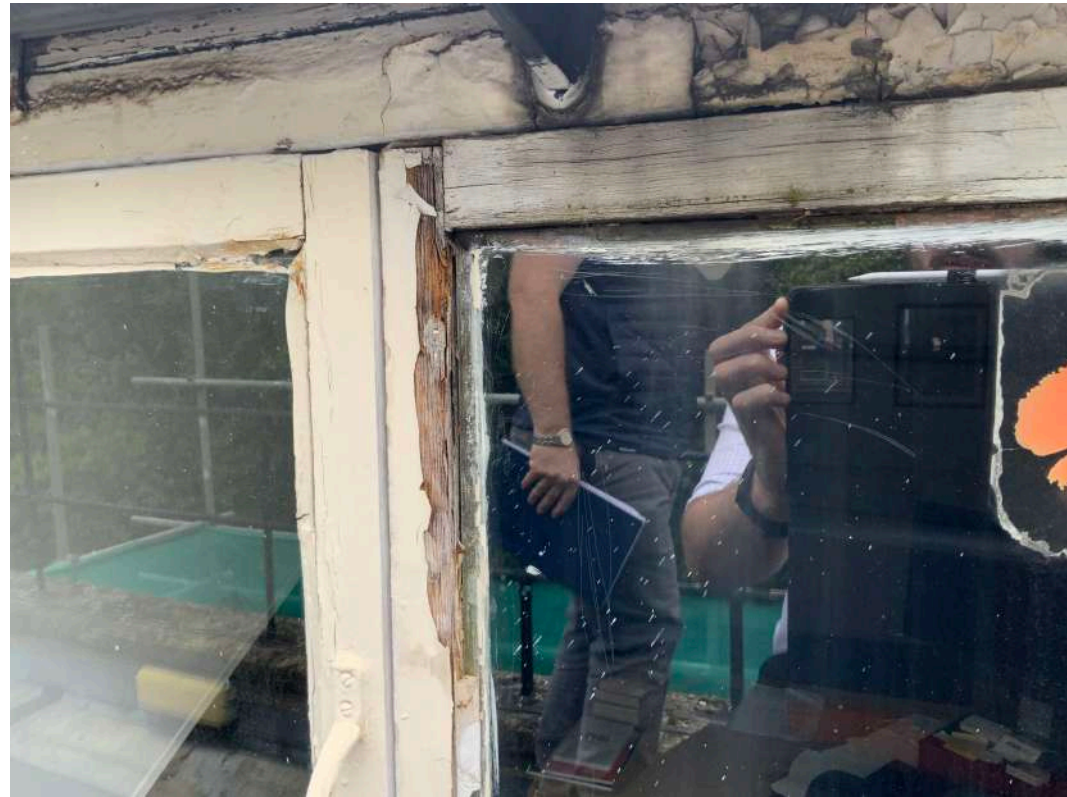
**Justification:** To address a number of failed or failing timber components within the existing windows.

**PHOTOGRAPH PAGE NO. 4 -**  
**(Item No.4 - Window Repairs)**

**Proposal:** Local repairs needed to timber window elements.

- Principal of repair is to retain as much as possible. Scrape back only as necessary until a sound substrate is achieved. Well seasoned hardwood to be spliced in where possible.

- Note it is believed that all windows can be repaired but will require further assessment from scaffold when provided.
- Putty to be replaced where missing with linseed oil product.
- Replace cracked glazing.
- Ease and adjust where required to leave fully operational.

All windows are to be externally decorated with a high quality external timber gloss for further protection.

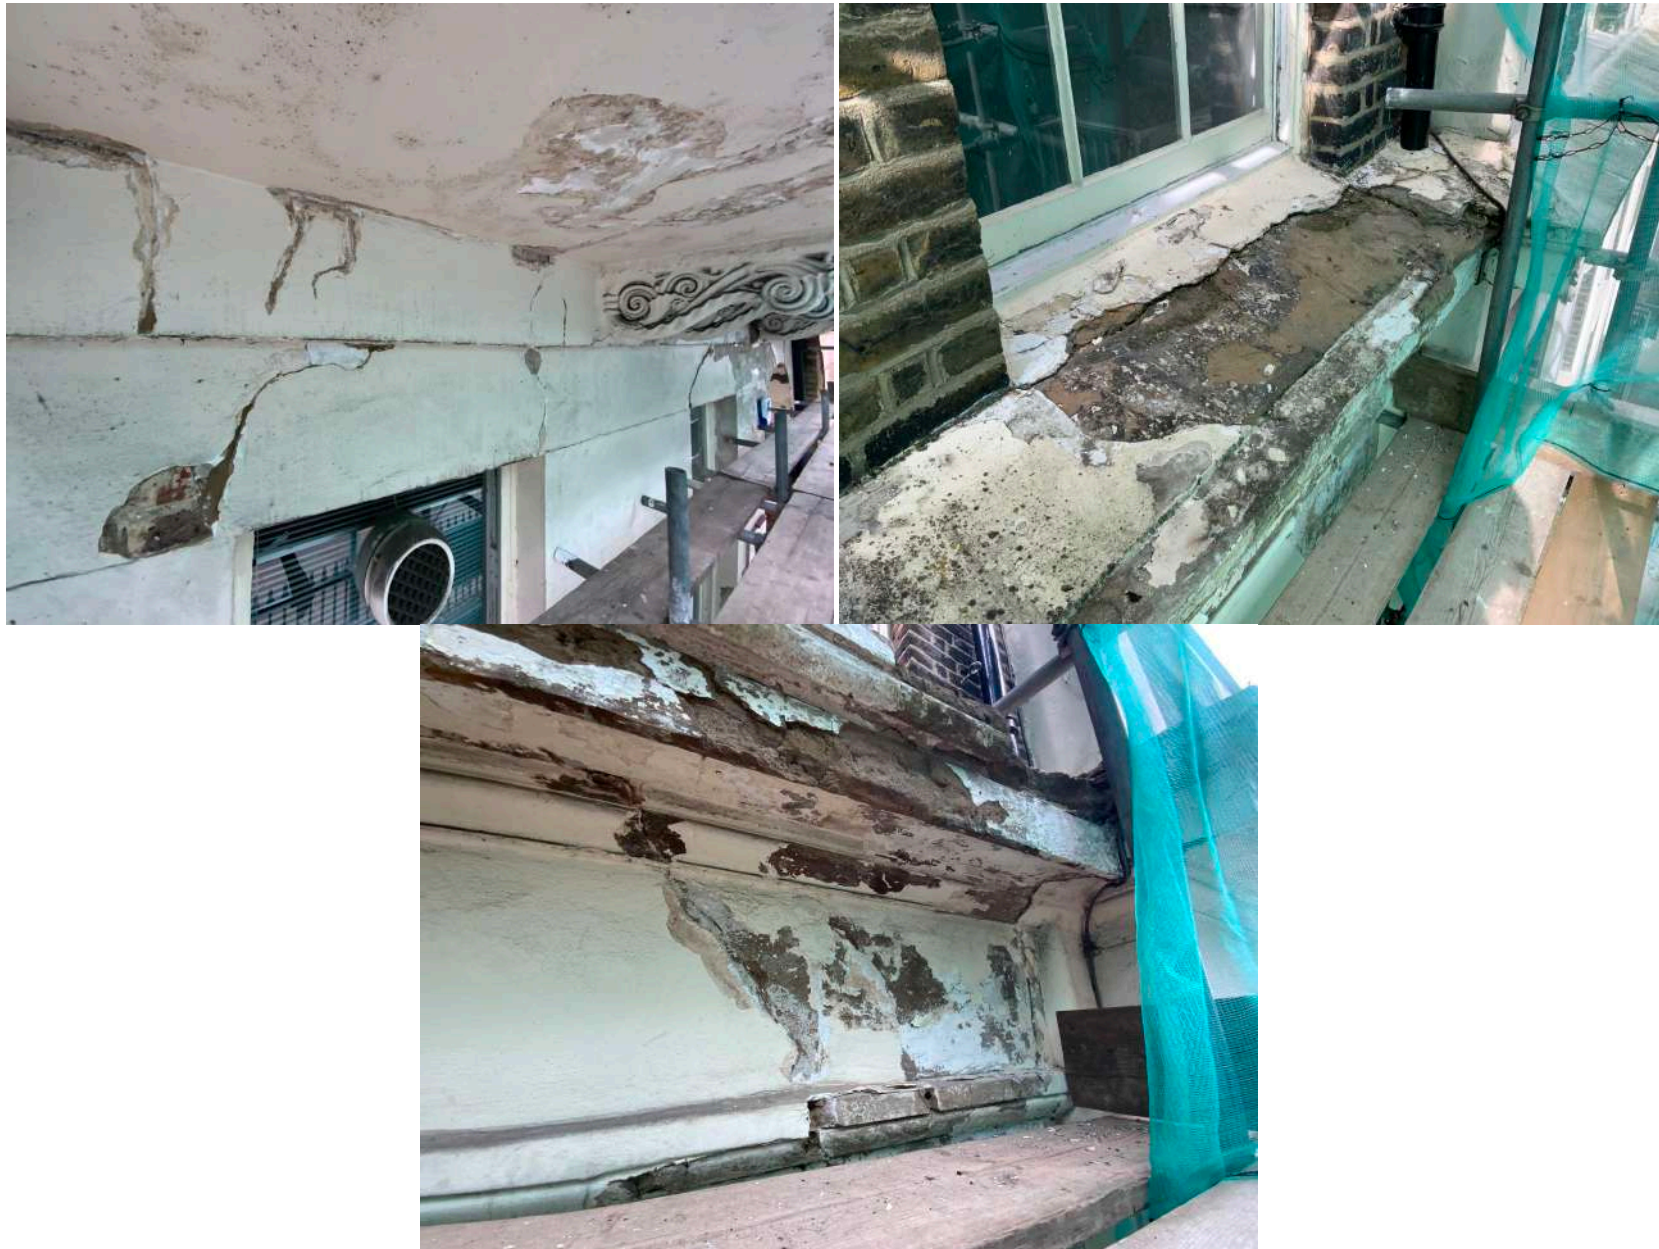
**Justification:** To address various areas of failed, spalled and generally degraded render detailing.

**PHOTOGRAPH PAGE NO. 5 -**  
**(Item No.5 - Stucco Render Repairs)**

**Proposal:** Rebuild existing stucco render detailing across principal facade.

- Cracks to stucco render are to receive 2 part epoxy resin repairs prior to rebuilding / reshaping the profile with a suitable lime based render mix (build up to be agreed with the conservation officer).
- Detailed survey to be provided by a specialist heritage masonry repair contractor / consultant prior to undertaking works when access is provided.
- Note all previously painted surfaces to be decorated on completion.

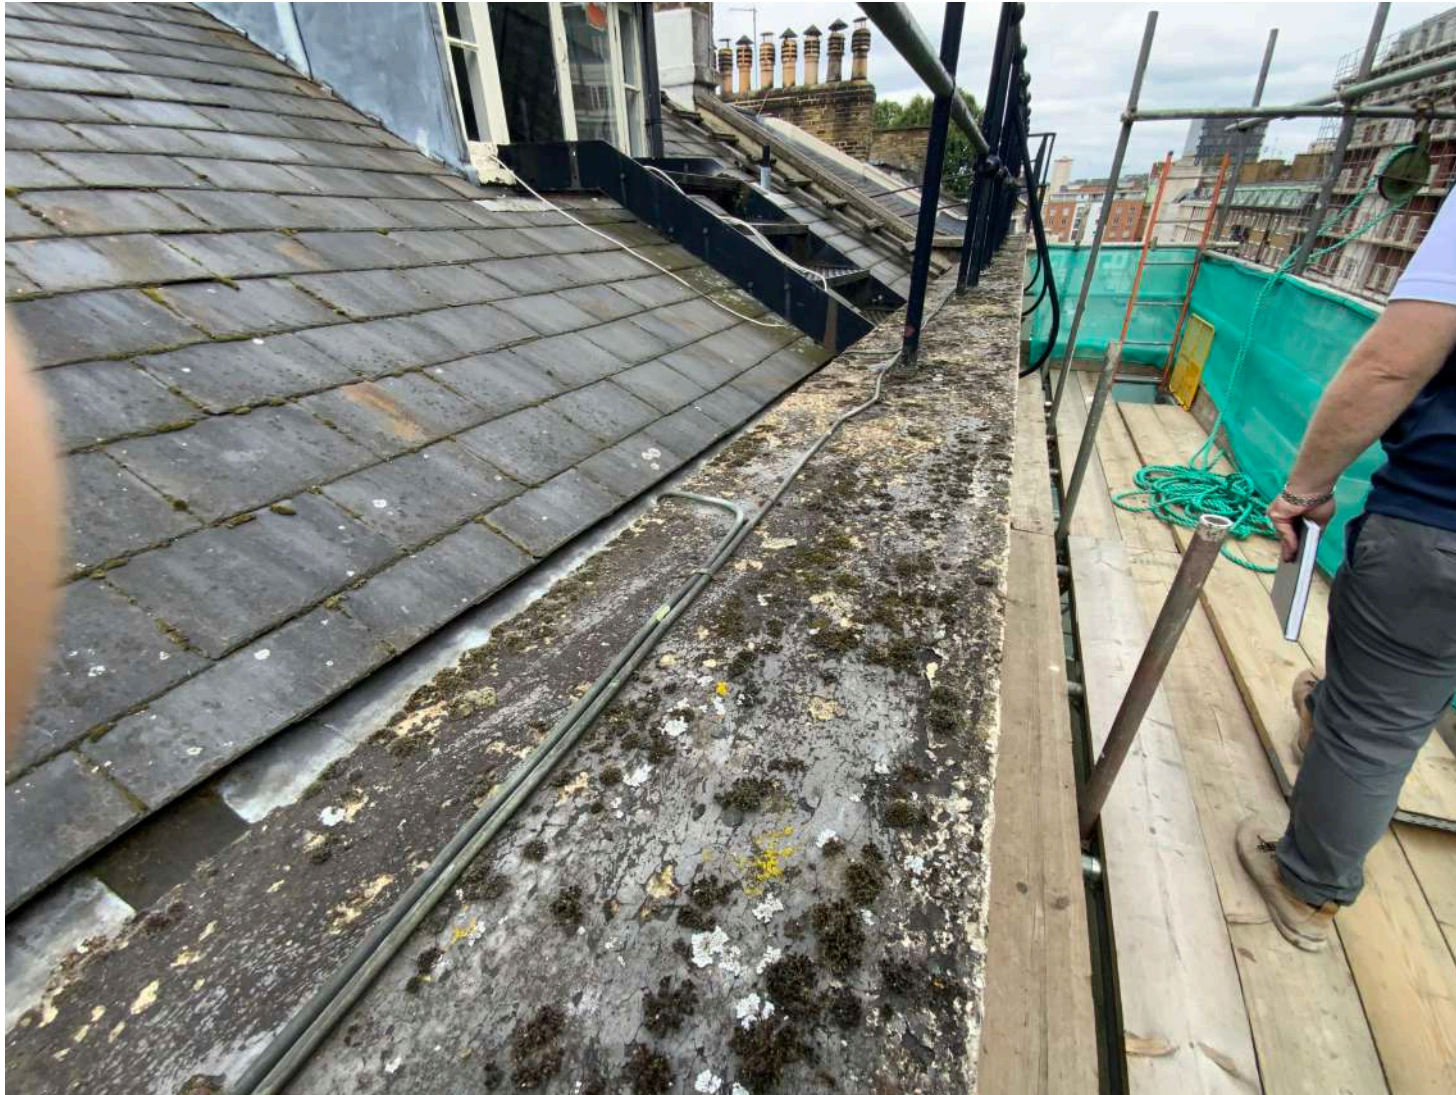
**Justification:** Existing waterproof coating subject to UV degradation and general weathering.

**PHOTOGRAPH PAGE NO. 6 -**  
**(Item No.6 - Front Parapet Wall)**

**Proposal:** Bituminous waterproof covering to be reapplied to front gutter course and parapet coping.

- Remnants of existing coating to be removed and substrate prepared for new application.
- New waterproof coating applied to gutter course and parapet coping. Self terminating. Triflex or similar. To be agreed with the Conservation Officer.

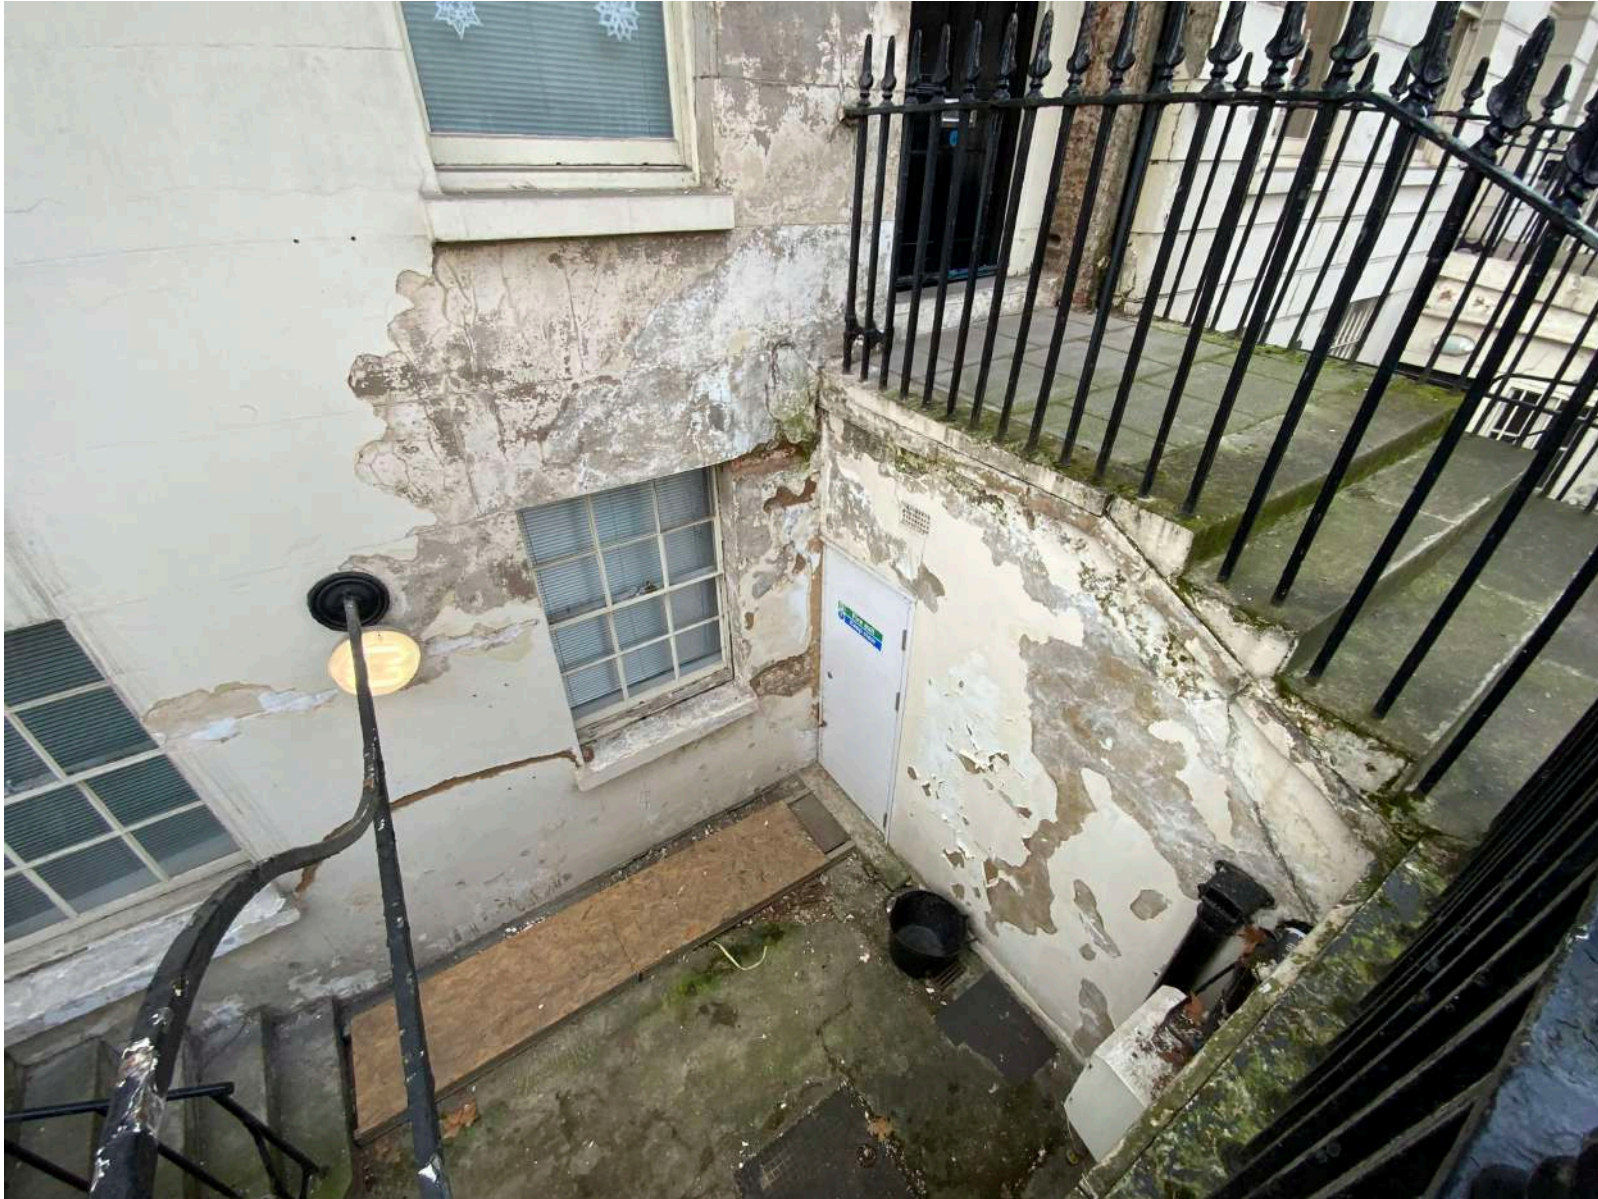
**Justification:** External walls at basement to first floor level, the decorative string course at third floor level and the roof level parapet are finished with a painted render. Large areas of render have been damaged by the

dampness cause by a failing downpipes, and is in poor condition. Principal is to retain as much as possible but a large proportion of render must be removed entirely and replaced.

**PHOTOGRAPH PAGE NO. 7 -**  
**(Item No.7 - Saturated and damaged render)**

**Proposal:** Re-render principal elevation from basement to first floor level.

- All live, overly saturated or loose render is to be hacked off the external elevation and the masonry behind checked for further damage (note potential need to replace brickwork behind render on a like for like basis) following removal of render).
- Substrate to be prepared accordingly.
- Re apply suitable render mix to external elevations ensuring seamless blend with the existing with a suitable lime based render mix (build up to be agreed with the conservation officer).
- Original details to be replicated with new render.
- Decorate with breathable silicate based mineral paint to match the existing colour.

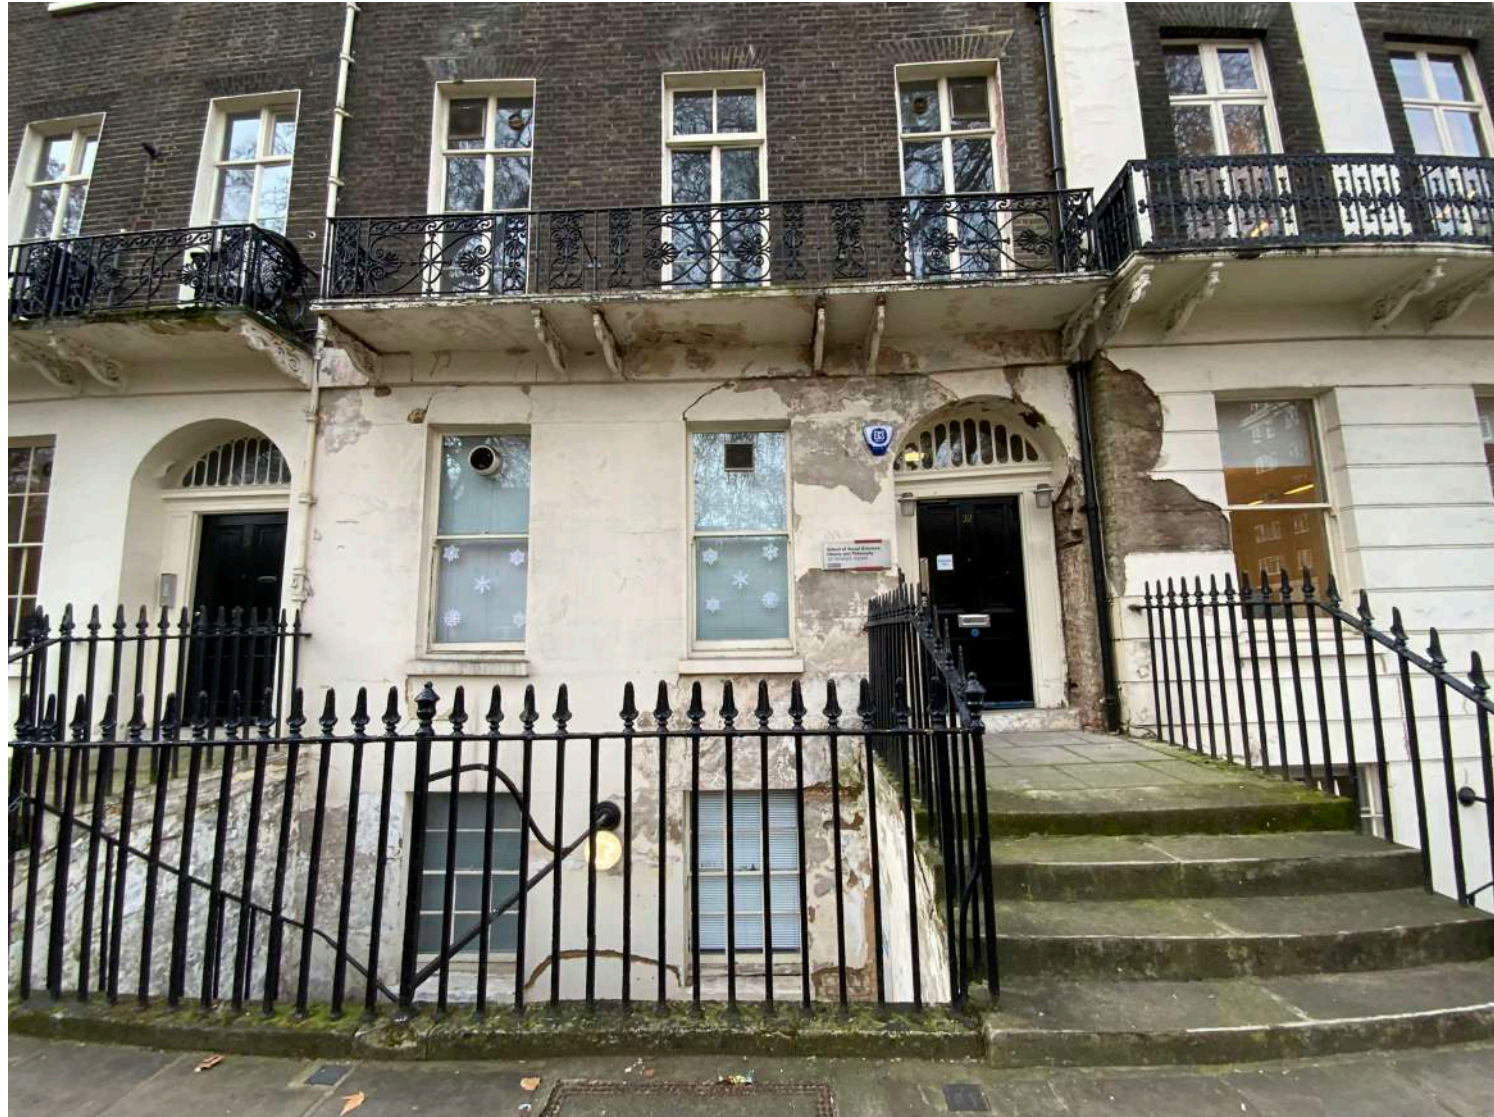
**Justification:** Decorative condition is poor and requires full redecoration to restore the building's appearance and provide protection from the elements.

**PHOTOGRAPH PAGE NO. 8 -**  
**(Item No.8 - Existing Previously Painted Masonry)**

**Proposal:** Decorate all previously painted external surfaces.

- Previously painted non breathable surfaces should be removed before being decorated to match the existing appearance.
- Decorate with breathable silicate based mineral paint to match the existing colour.

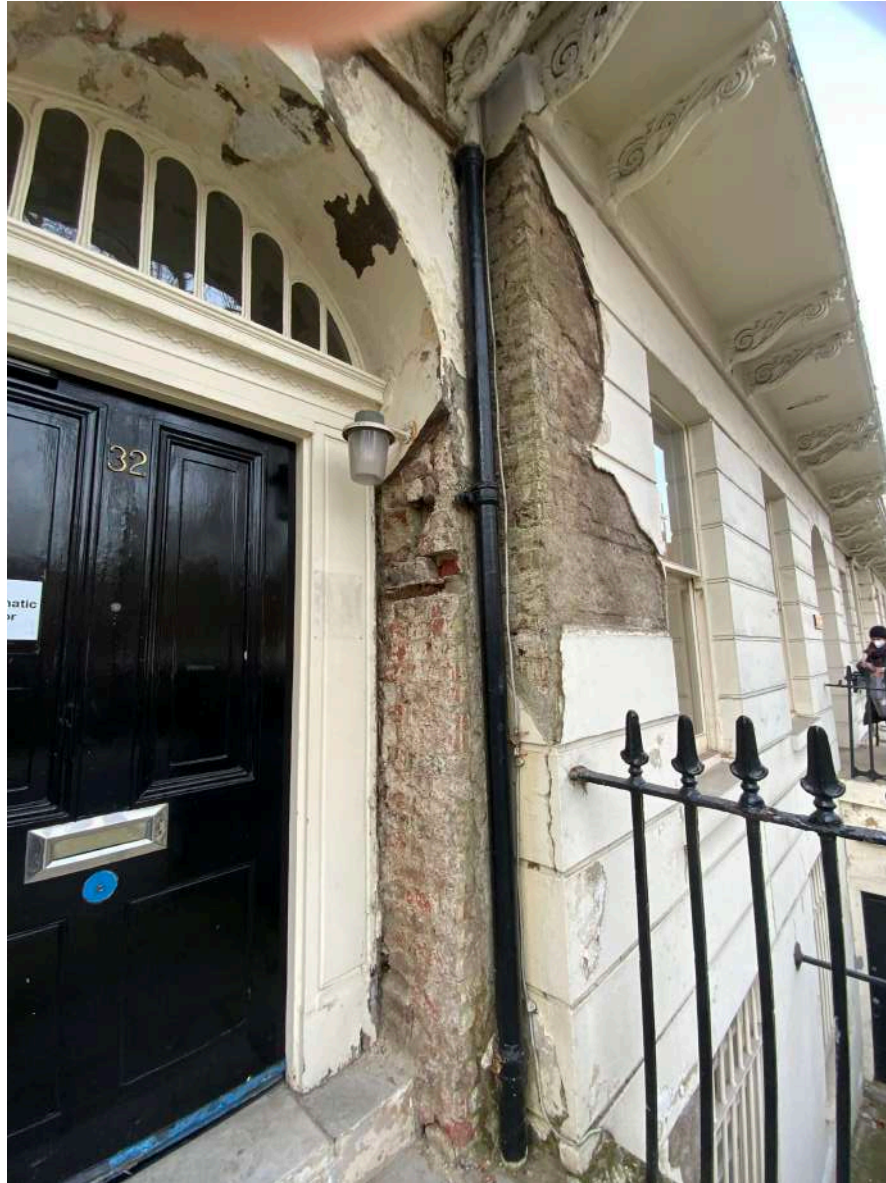
**Justification:** Prolonged water damage (a result of a blocked downpipes) has saturated the render and damaged the brickwork underneath.

**PHOTOGRAPH PAGE NO. 9 -**  
**(Item No.9 - Damaged Brickwork and Render Adjacent Door)**

**Proposal:** Masonry wall adjacent front door should be rebuilt to match original profile and affected surfaces re-rendered.

- Wall to be rebuilt utilising existing bricks where possible, and reclaimed counterparts to match the existing in every respect (where practicable) including a suitable lime mortar mix.
- Re render on completion to blend in seamlessly with existing retained surfaces and replicate original detailing to suit.
- Decorate with breathable silicate based mineral paint to match the existing colour.

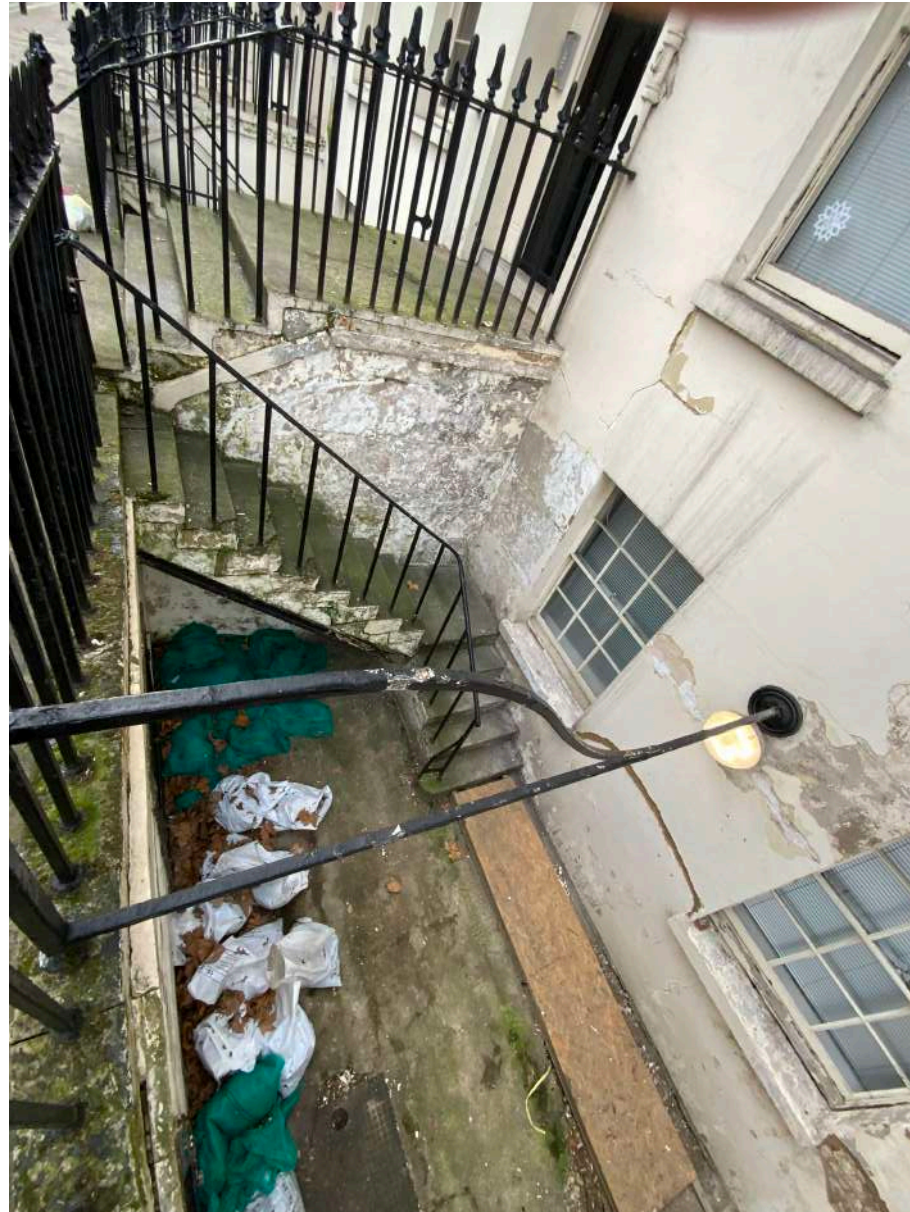
**Justification:** Below Ground Drainage Survey identified damaged pipework beneath light well hardstanding. Excess ground water is the likely cause of historic movement and should be addressed immediately to prevent further movement.

**PHOTOGRAPH PAGE NO. 10 -**  
**(Item No.10 - Location of Lightwell Drainage Repairs)**

**Proposal:** Repair defective below ground drainage and introduce new hardstanding and drainage to light well.

- Lift and remove existing concrete base to front elevation light well
- Undertake repairs to defective drains in this area to prevent historic and ongoing settlement;
- Provide new sub-base and stone flag flooring to light well (materials to be agreed with Conservation Officer)
- Introduce surface water gulley to light well to prevent future flooring

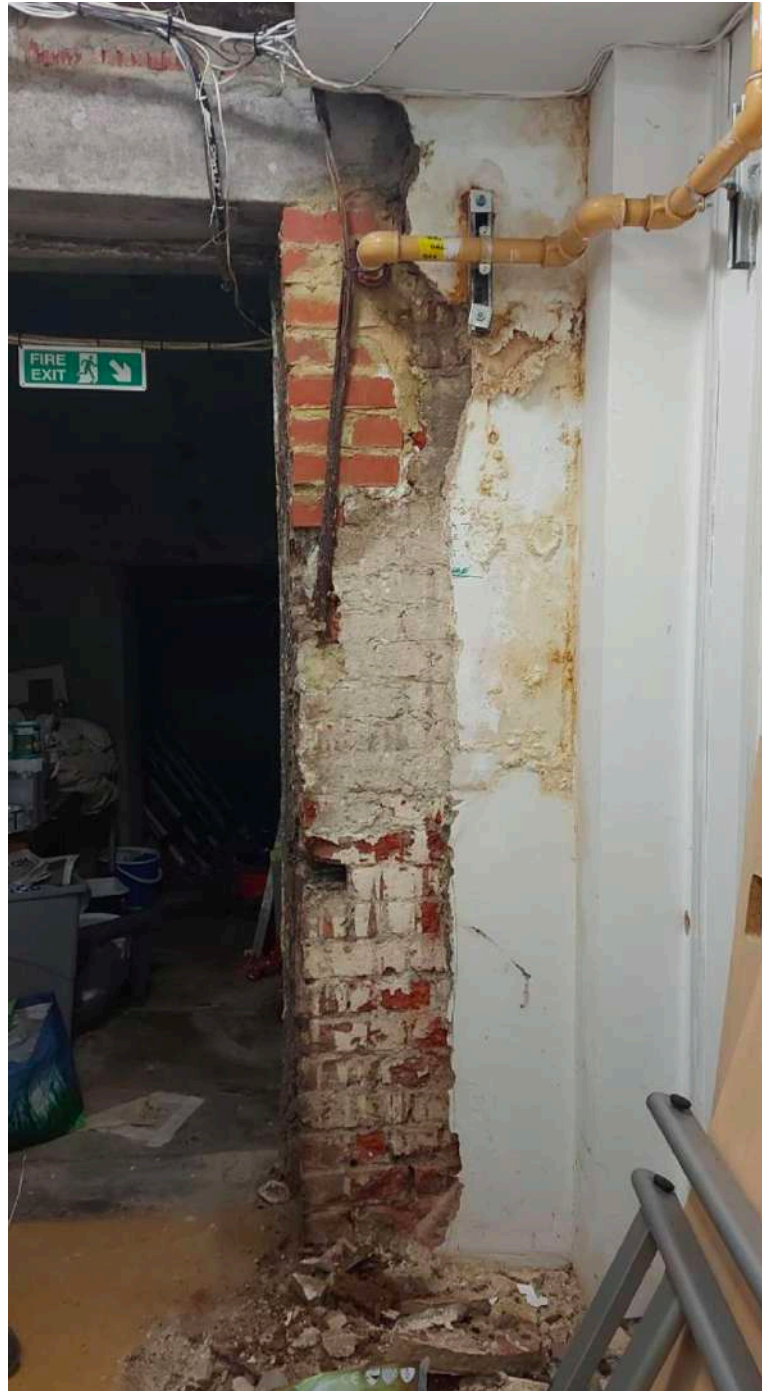
## PHOTOGRAPH PAGE NO. 11 -

**Justification:** Original bricks and surrounding plaster are saturated and failing underneath modern engineering bricks (previous repair - unknown date) and a concrete lintel to presumably replace the original timber lintel. Structural Engineer has recommended the following urgent remedial works:

(Item No.11 - failing original brickwork  
Beneath pier)

**Proposal:** Rebuild failing pier brickwork beneath modern concrete lintel.

- Lintel be temporarily propped
- Modern engineering brickwork to be retained as disturbing them may cause further harm. Original failing brickwork to be removed (but retained where possible) and the pier rebuilt utilising bricks to match the existing original arrangement (reclaimed or made to suit) in a suitable lime mortar mix.

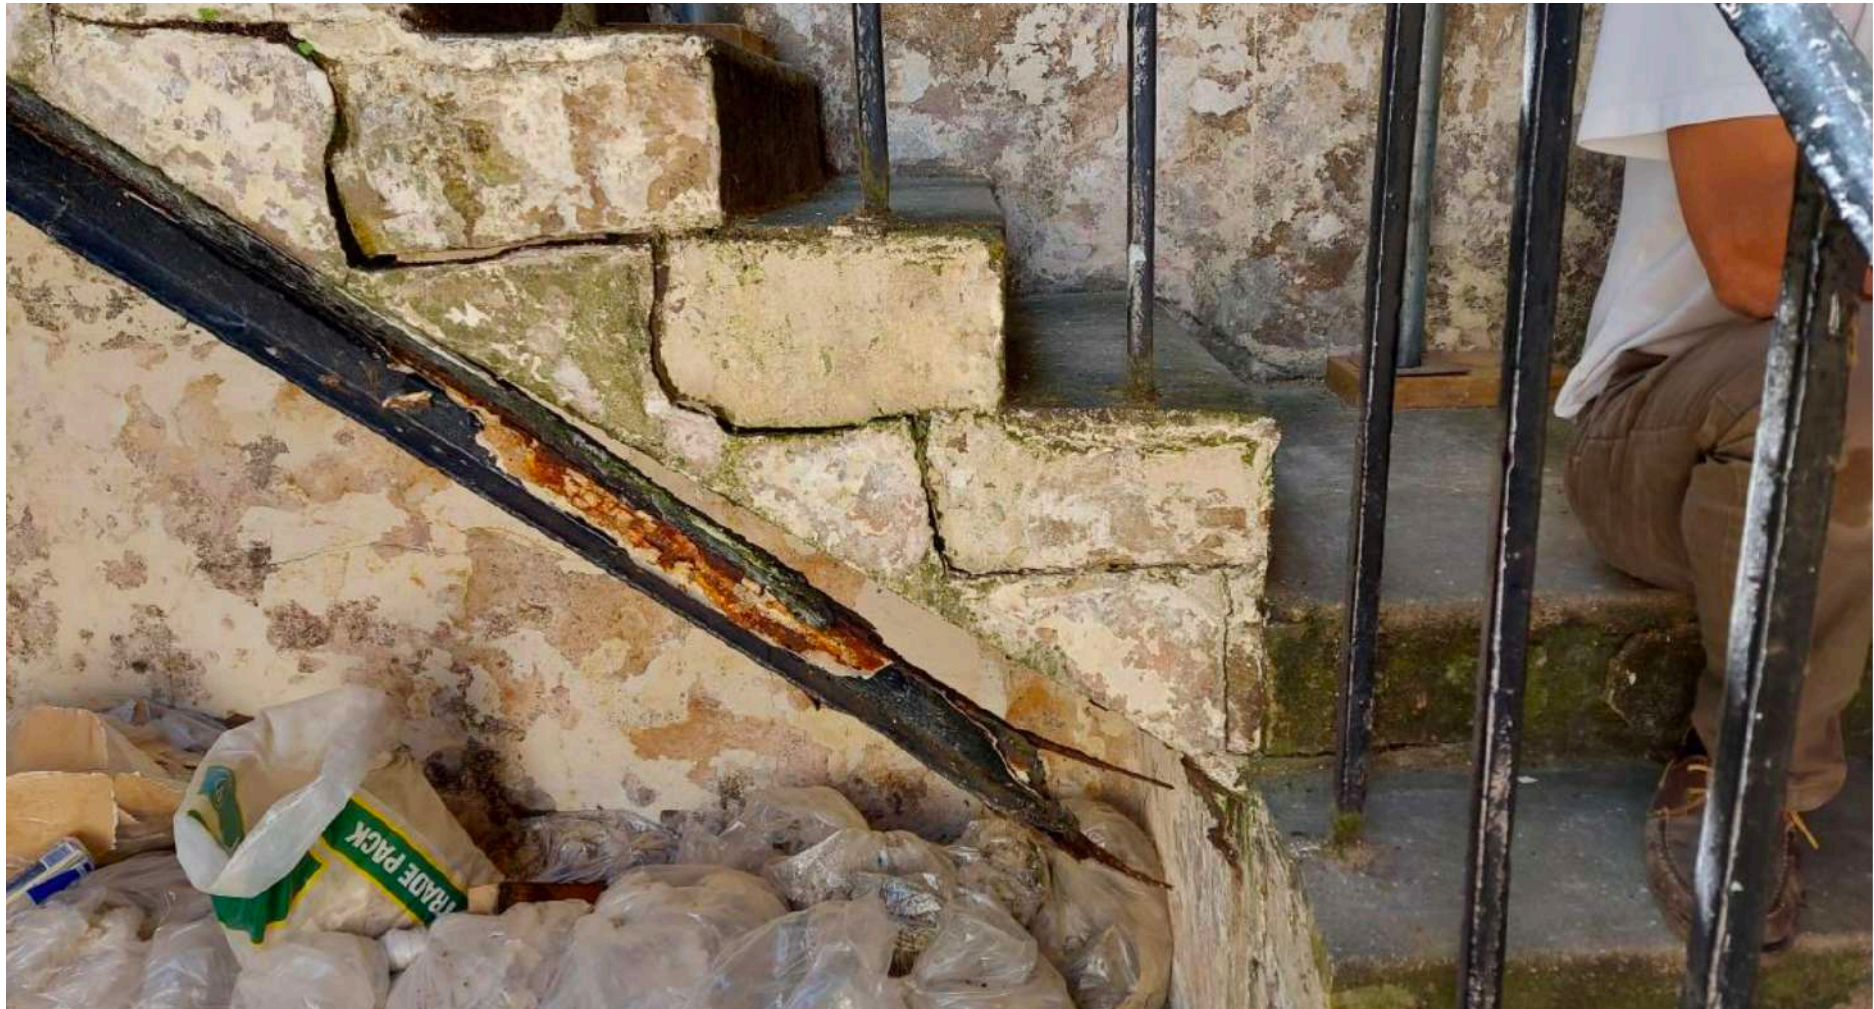
## PHOTOGRAPH PAGE NO. 12 -

**Justification:** The external stone staircase to the basement (light well) is supported at its edge by a rolled steel joist which is corroded beyond repair. Movement occurring to staircase as a result. Urgent repairs required to prevent further damage.

(Item No.12 - Steel joist to  
external stair)

**Proposal:** External stairs should be repaired including steelwork and finishes.

- Carefully remove existing cast iron beam embedded in stairs that is corroding and causing movement
- Provide new galvanised steel beam of same section / dimensions, painted back and bed securely in place with lime based mortars
- Lift and re-form existing steps with new lime mortar
- Repair cracks to wall render below steel beam, using agreed lime render
- Redecorate all wall surfaces with breathable silicate based mineral paint to match the existing colour.
