# Heritage, Design & Access Statement

For proposed repairs to the listed building at:

32 Tavistock Square

For: Birkbeck University of London

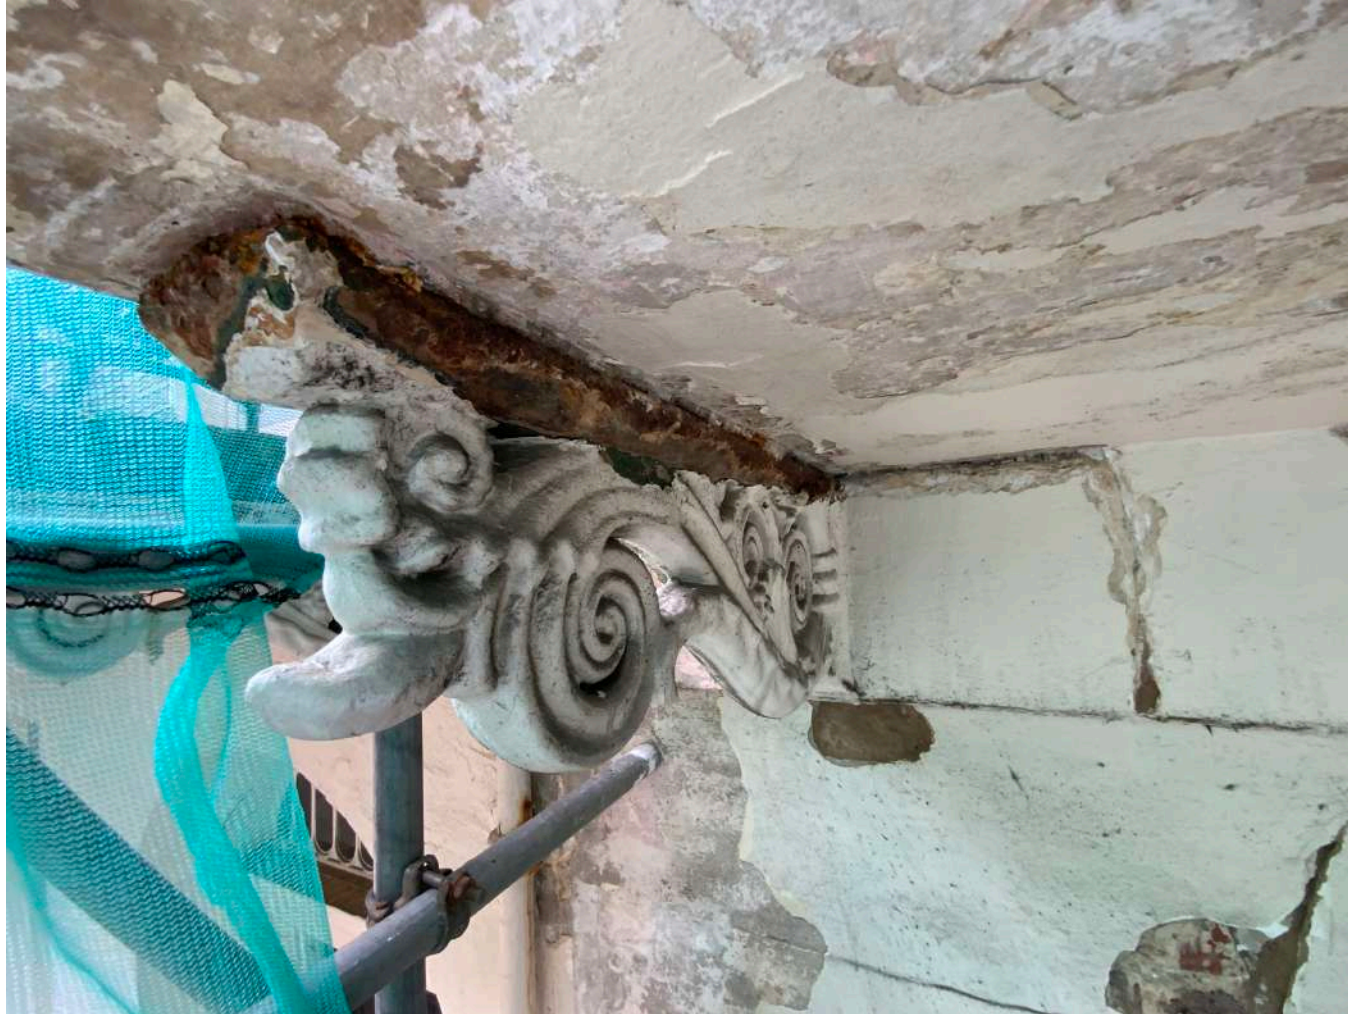
## PHOTOGRAPH PAGE NO. 13 -

**Justification:** Settlement to the front elevation wall has had an impact on the balcony structure and the asphalt waterproofing is failing, resulting in rainwater ingress above the main front entrance and damaged internal finishes. Cast iron structural components within the deck are therefore at risk of failure due to prolonged exposure to water. Further investigation is required to identify extent of damage.

(Item No.14 - First Floor Balcony - corroded brackets)

**Proposal:** Replace failed asphalt waterproofing to first floor balcony. Further investigations required to establish extent corrosion to cast iron cantilevered members.

- Remove roof finishes back to deck to expose cast iron components.
- Re-application of liquid waterproofing system to balcony. Self terminating Triflex or similar system. Colour to match existing. To be agreed with the Conservation Officer.
- Assess condition of cast iron components following further investigations and address as required. To be agreed with the Conservation Officer.

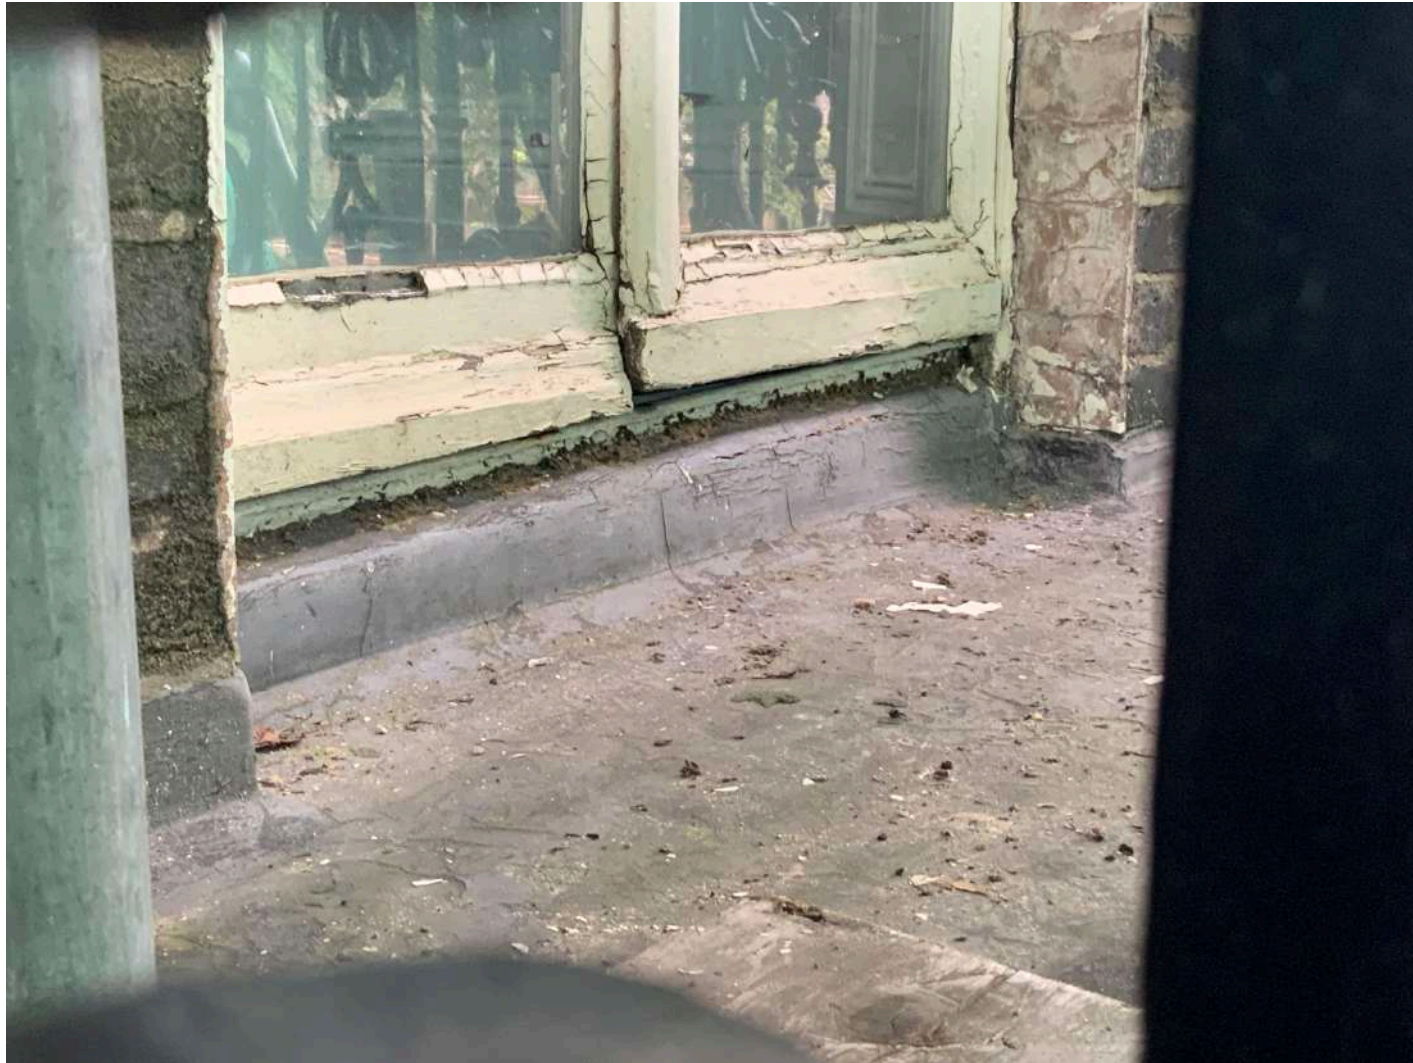
**PHOTOGRAPH PAGE NO. 14 -**

**(Item No.14 - First Floor Balcony - failed waterproofing and up stand)**
