## Tree Condition and Decay Assessment Prepared for

71 Avenue Road  
St John's Wood  
London  
NW8 6HP

Prepared by  
A.C. Kimberlee BSc (Hons) Arboriculture, M Arbor A, PTI.

Date: 23<sup>rd</sup> January 2022

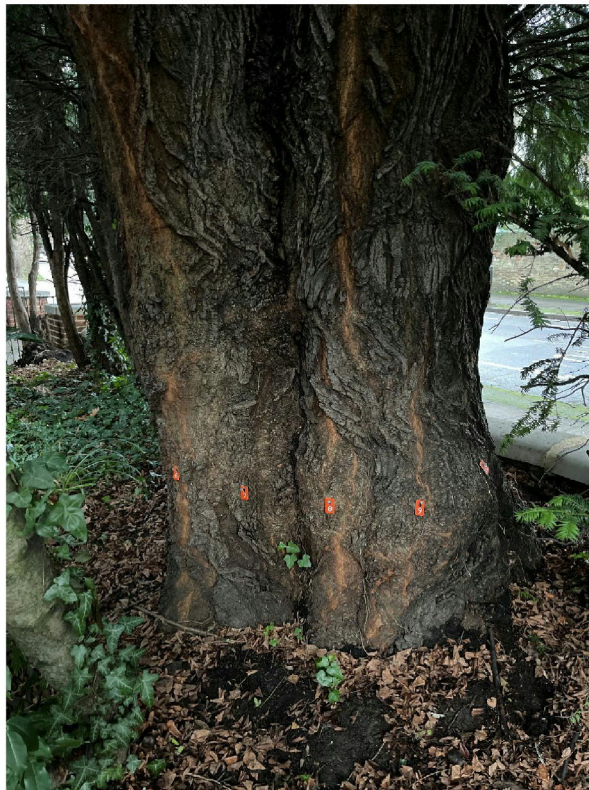
- 4.1 T1 is a large mature Small Leaved Lime (*Tilia cordata*) growing close to the main road along Avenue Road in St John's Road, London. The tree is multi-stemmed with three main stems which arise at approximately 2 metres from ground level. The unions between the stems appear to be included with no signs of instability, cracking, or decay. Prior to the survey a companion lime tree failed at the base and fell onto Avenue Road (May 2020), the cause of which was attributed to the presence of fungal decay in the main trunk (*Kretzschmaria deusta*). As the tree did not appear to exhibit any signs of this fungus prior to its failure, it was advised that T1 should be assessed for decay using a PiCUS tomograph and a Resistograph.

Photograph 1: T1 Lime with included union and reactive growth at base.

- 4.3 The presence of the included unions and significantly crown raised canopy would most likely increase the risk of failure of the stems at the main unions. The presence of any decay in the main trunk would further increase the risk of the stems failing. The findings of the decay assessment are detailed in section 5.0 below.
- 4.4 The risk associated with unpredictable branch loss due to factors such as summer branch drop cannot be quantified. Should these trees lose additional, relatively healthy and structurally sound branches within the period covered by this report, I

Tree No.	Species	Observations	Recommendations	Work Priority
T1	Small Leaved Lime	<ul style="list-style-type: none"> <li>• 3 stems arising at approximately 2 metres from ground level.</li> <li>• Included unions which appear to be stable with no signs of cracking.</li> <li>• Tall drawn up stems which have had previous pruning/ crown thinning and raising throughout.</li> <li>• Minor reduction to laterals branches growing towards property.</li> <li>• No signs of fungal fruiting bodies or decay at base.</li> <li>• Previous companion lime failed over main road.</li> <li>• PiCUS and Resistograph decay test carried out</li> </ul>	<ul style="list-style-type: none"> <li>• Reduce via thinning in height by approximately 2-3 metres by removing dominant leaders.</li> <li>• Install flexible bracing system (4 tonne) between main stems at a height of approximately 9-10 metres</li> </ul>	<p><b>Medium - Works recommended within 6 months</b></p>

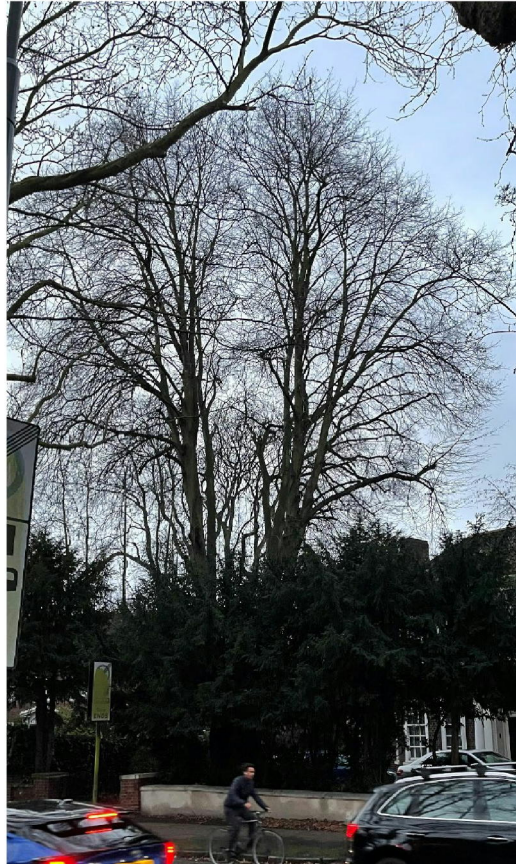
or on the main trunk of the tree. The lower and mid crown has been substantially crown raised (lower branches removed) up to approximately 9-10 metres from the ground level and the upper crown thinned.

Photograph 2: T1 Lime tree street view

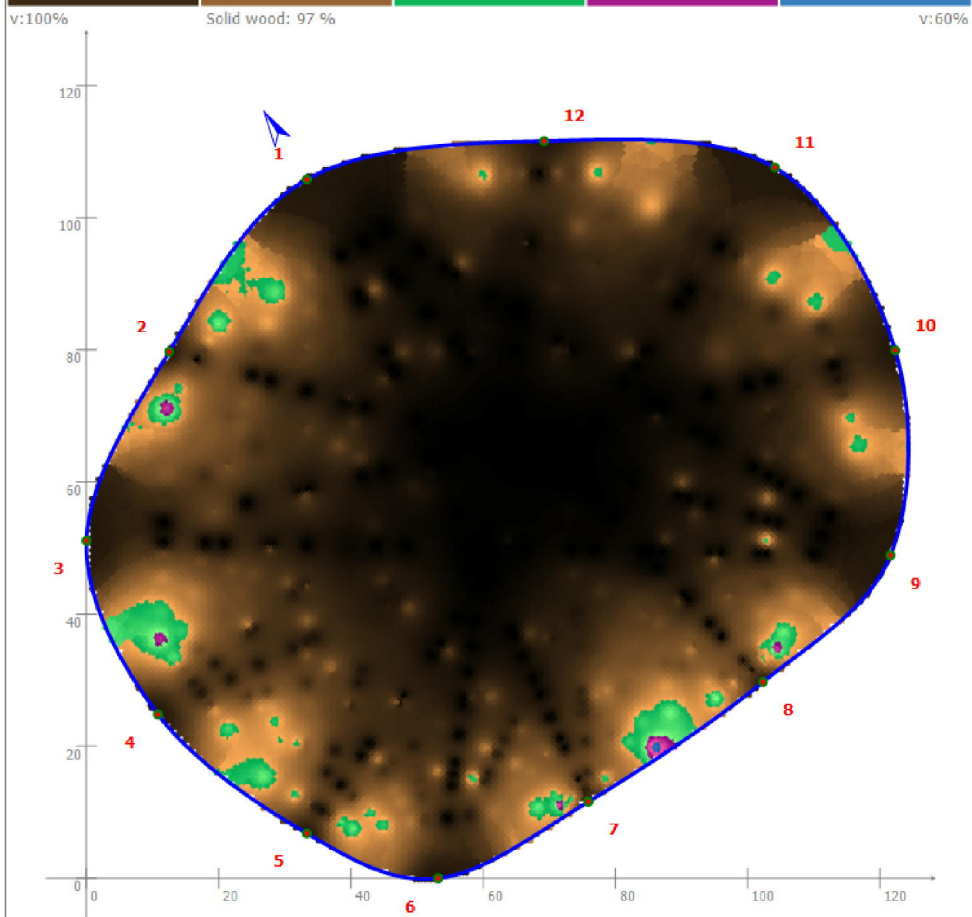
Picus:

- A PiCUS assessment was undertaken to ascertain the extent of decay in the main trunk and in order to assess the risk of failure from the base of the tree. The imagery (Appendix 2) indicates that at the point of the decay test there is approximately 97% of sound wood recorded. The PiCUS tomograph imagery showed no evidence of dysfunctional wood/decay with the trunk of the tree where the decay test was carried out. Areas on the tomograph showing up as green and pink colours and normally associated with dysfunctional wood or areas of decay are most likely attributed to included unions and deep inward buttresses.

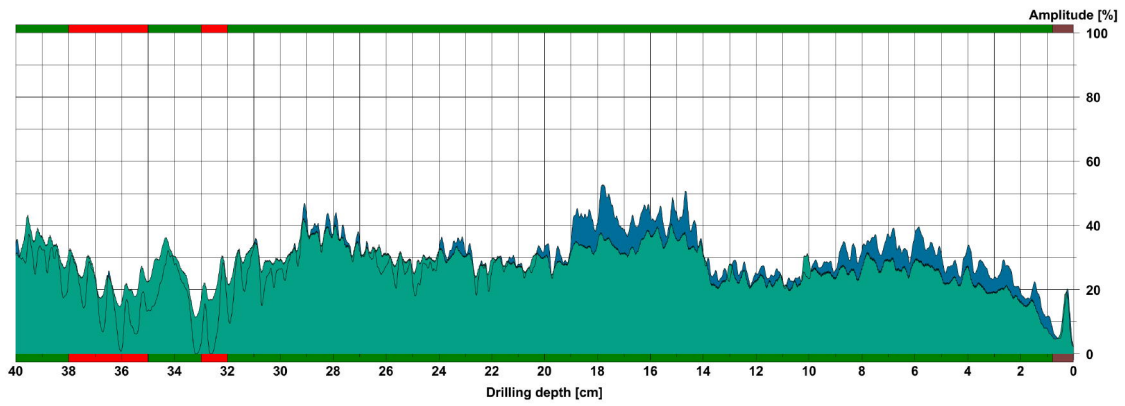
71 Avenue Road 0.5m N

- The first test was carried out at the base of the northern side of the main trunk. This test showed good resistance drilling through the tree until reaching 320-340 mm and 360-380 mm depth where the resistance drops rapidly. The drop in resistance may indicate the drill passing through an included union between stems or possible decay.
- The second test on the eastern side of the tree was drilled and showed a good resistance throughout the test to the full depth of 400 mm.
- The third drill test carried out on the southern side of the trunk indicated good resistance throughout the test with a slight drop in resistance at depths of 320 and 350 mm. This could be where the drill passed through an included union between the stems.
- The fourth test was carried out on the western side of the main trunk and showed good resistance throughout the test to the maximum depth of 400mm.

From 0,00 cm to 0,80 cm	: Bark
From 0,80 cm to 32,00 cm	: Sound wood
From 32,00 cm to 33,00 cm	: Decay
From 33,00 cm to 35,00 cm	: Sound wood
From 35,00 cm to 38,00 cm	: Decay
From 38,00 cm to 40,00 cm	: Sound wood

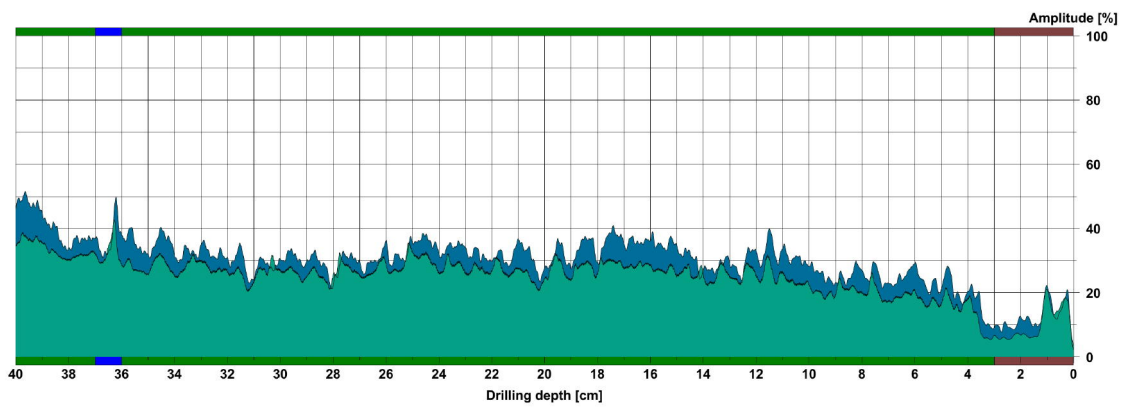
71 Avenue Road 0.5m E

From 0,00 cm to 3,00 cm	: Bark
From 3,00 cm to 36,00 cm	: Sound wood
From 36,00 cm to 37,00 cm	: Reaction Wood
From 37,00 cm to 40,00 cm	: Sound wood

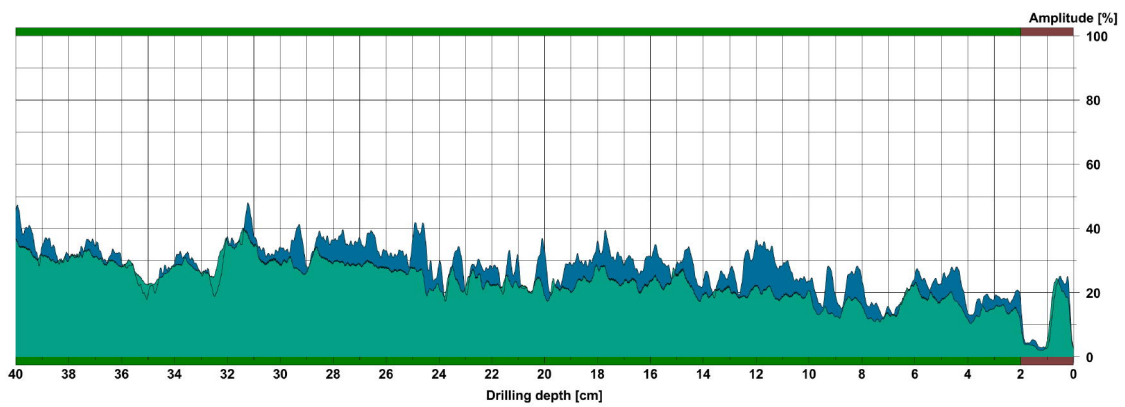
71 Avenue Road 0.5m S

From 0,00 cm to 2,00 cm	: Bark
From 2,00 cm to 40,00 cm	: Sound wood

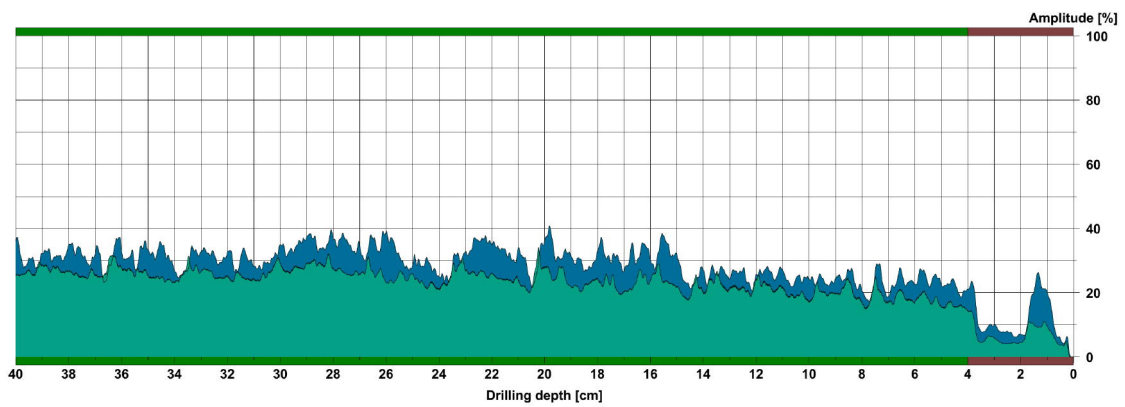
71 Avenue Road 0.5m W

■	From 0,00 cm to	4,00 cm	: Bark
■	From 4,00 cm to	40,00 cm	: Sound wood
