Tree Survey & Hazard Assessment Report

9th March 2022

Palmers Lodge
40 College Crescent
London
NW3 5LB

AS/MF/038/22

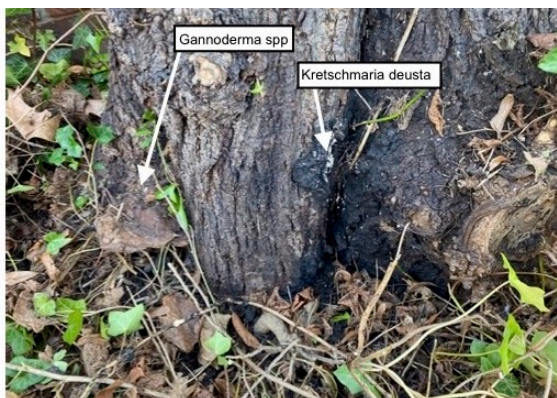
- Fungal fruiting bodies at base to south and west
- To west *Ganoderma spp* fruiting bracket at base
- To south *Kretschmaria deusta* fruiting brackets extending to 300mm height.
- Testing with sounding mallet confirms significant cavity at base to south / west
- Main stem bifurcates at 3.5m - sound. Balanced managed branch framework 5-14m with cyclical reduction points lapsed 2 years. Ivy to 3m height

Kretschmaria deusta fruiting bodies extending to 300mm height and *Ganoderma* to north at base of tree

5.4 The identified fungus *Kretschmaria deusta* is a simultaneous 'soft rot' which in advanced stages, can as described within *Fungi on Trees*, Watson, G. & Green, T. (Arboricultural Association, 2011) leading to 'catastrophic brittle failure'. The advanced presence of the fungus where combined with location adjacent to the public highway provides clear evidence of the hazardous form of the tree in its current form.

6.1 The tree is proposed for removal to remove the current hazard. The removal of the tree for reasons of health and safety and to dispense with duty of care. A replacement planting is specified to provide replacement amenity value and canopy cover for the prominent location.

Fell to ground level and grind out stump to minimum 300mm below ground level

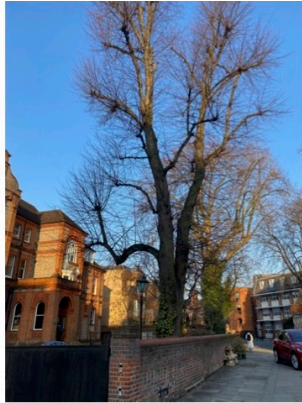
Tree T1 viewed to the north west from public highway

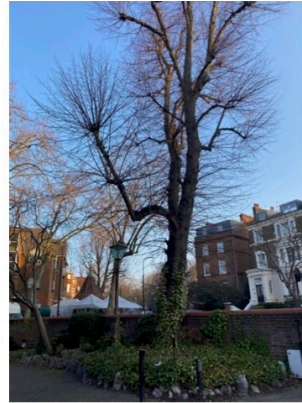
Tree T1 viewed to the north east from within site

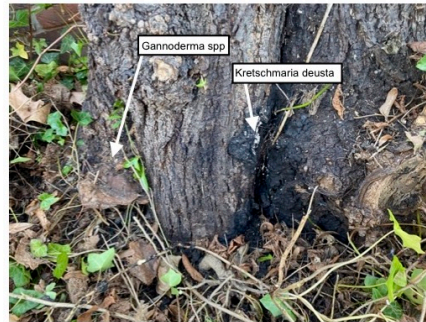
Base of tree showing fruiting bodies to north and west

Kretschmaria deusta fruiting bodies extending to 300mm height and Ganoderma to north at base of tree

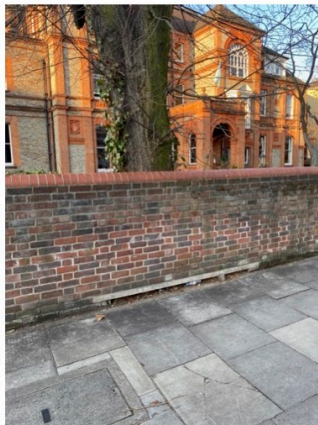
Lintel to wall accommodating tree T1

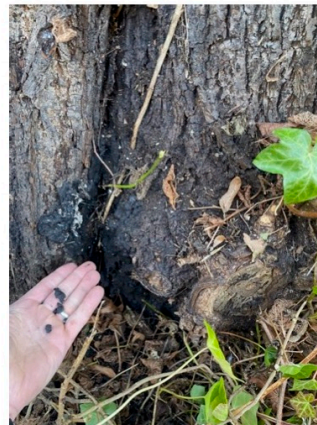
Kretschmaria deusta fruiting bodies extending to 300mm height
