Arboricultural Impact Assessment

Location: 2 Templewood, NW3 7XA

Prepared by Andy Nicol, 10th February 2022

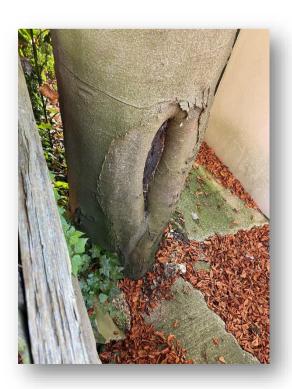
T1 – Basal Defect

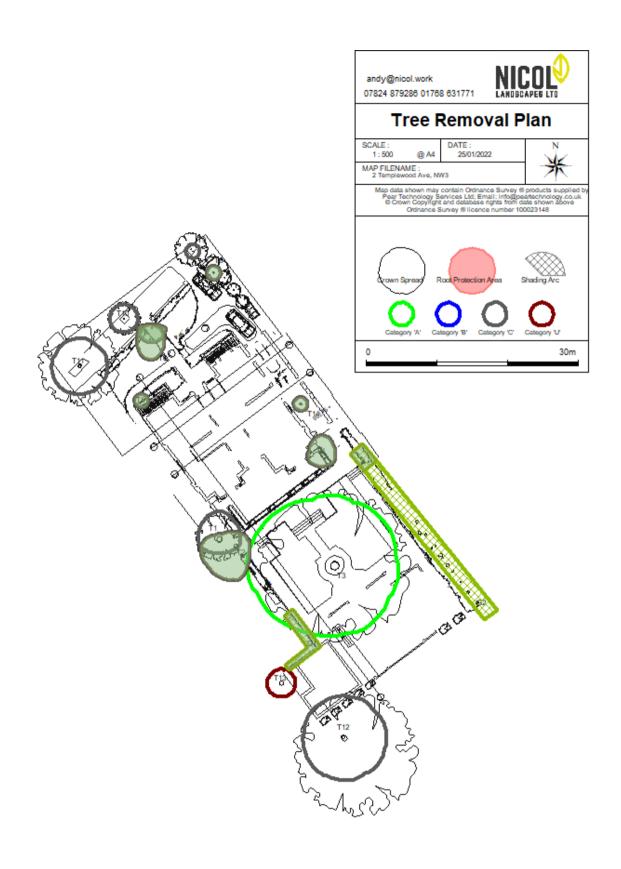
Tree Removal Plan

- Poor specimen/diseased/defective Category C trees marked for removal T2C, T4C, T5C, T6C, T7C, T8C, T14C
 - 7C removals
 - Total of 7 tree removals
 - Hedge removal

- The proposal to reposition the driveway entrance and the construction of a new garage will entail the removal of low-quality garden shrubs, trees, herbaceous borders and category C trees, easily compensated for with new planting and long-term management of the existing native trees. See Appendix 4 for Tree Removal Plan.
- No tree pruning to facilitate the construction is required.
