Tree Condition and Decay Assessment

43 Elsworthy Road
Primrose Hill
London
NW3 3DL

Date: 23rd January 2022

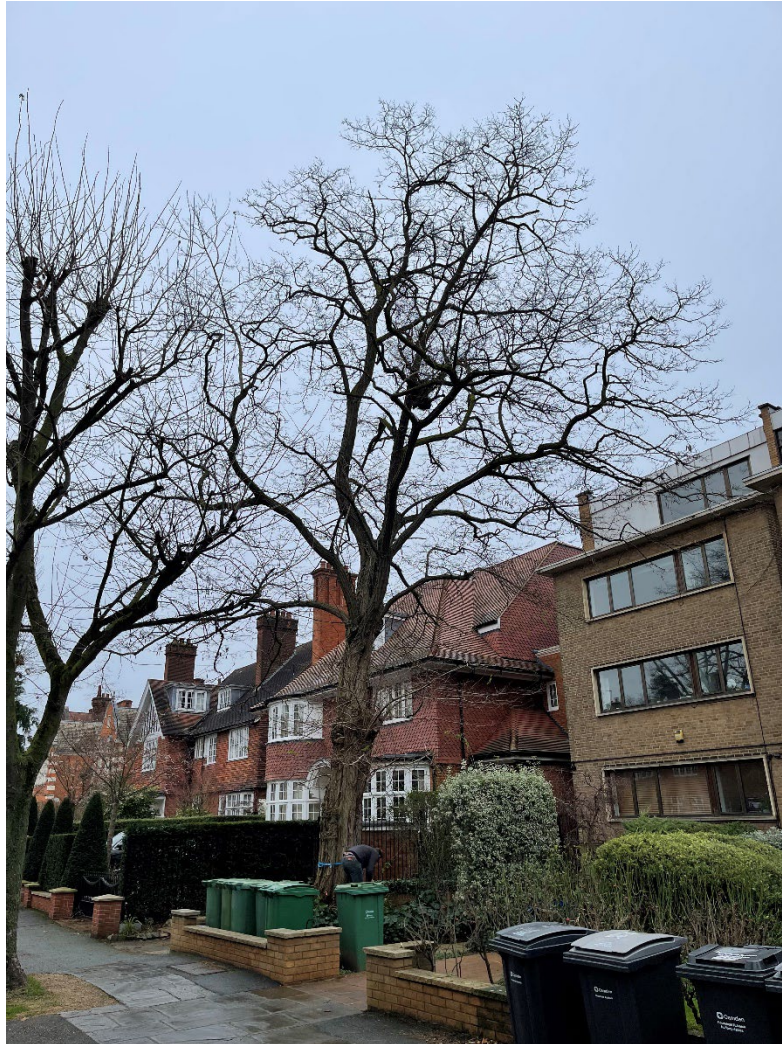
- 4.1 T1 is a mature Black Locust (*Robinia psuedoacacia*) which naturally leans towards the property at 43 Elsworthy Road. An adjacent street tree which has been regularly pollarded has caused T1 to lean towards the property at 43 Elsworthy Road with a crown bias to the south-east.

Photograph 1: T1 Black Locust leaning towards 43 Elsworthy Road

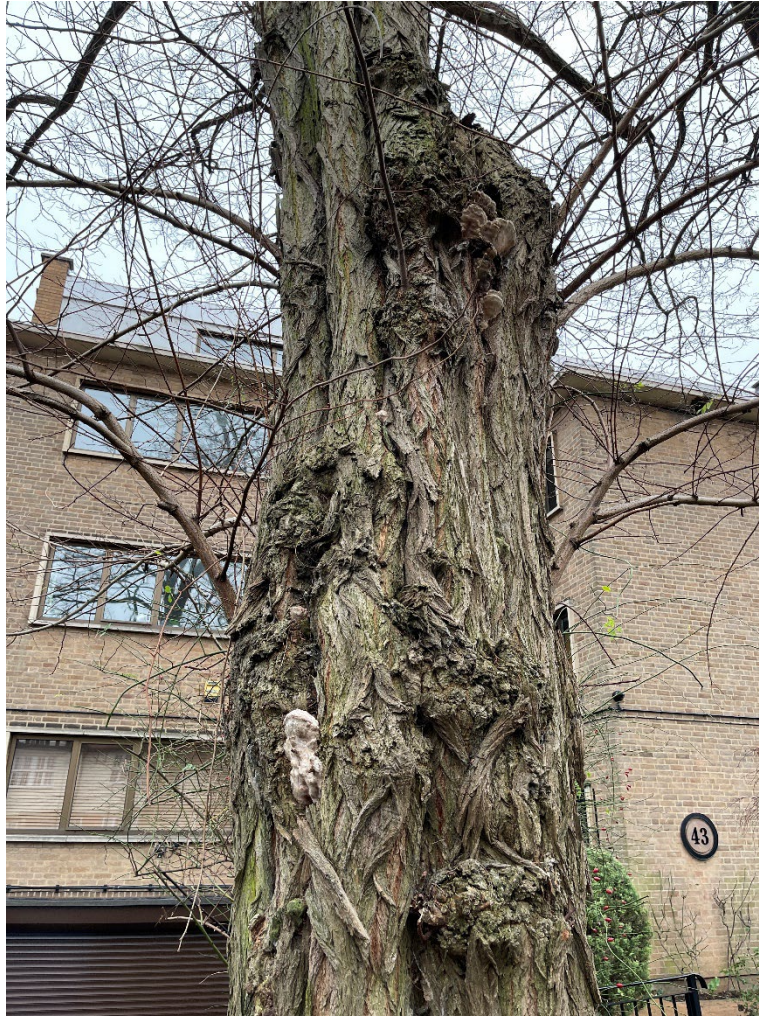
- 4.2 During the survey multiple fungal brackets (*Perenniporia fraxinea*) were observed growing on the main trunk at 1-3 metres around all aspects. Seasonal fungal was also observed growing at the base of the tree believed to be *Laetiporus sulphureus*. The main trunk was sounded with a nylon mallet which indicated significant internal hollowing and decay. In order to ascertain the extent of decay the PiCUS tomograph and a Resistograph has been used (findings are detailed below in section 5.0 of this report). The tree exhibited large reactive buttressing particularly on the northern and north-western sides of the tree.

Photograph 2: T1 Black Locust with multiple fungal brackets on main trunk.

Tree No.	Species	Observations	Recommendations	Work Priority
T1	Black Locust	<ul style="list-style-type: none"> • Mature tree leaning and crown bias to south. • Buttress growth formation around trunk particularly on northern, north-west and north-eastern aspects. • Multiple fungal brackets observed from 1 m to 4 metres on all aspects of main trunk (<i>Perinniporia fraxinea</i>) • Sounded with nylon mallet which indicated significant decay in main trunk and internal hollowing. • Picus and Resistograph test carried out. 	<ul style="list-style-type: none"> • The results of the decay tests indicate that the tree is extensively decayed with a high risk of failure. • Fell to near ground level. 	High/ Medium - Works recommended within 3 months

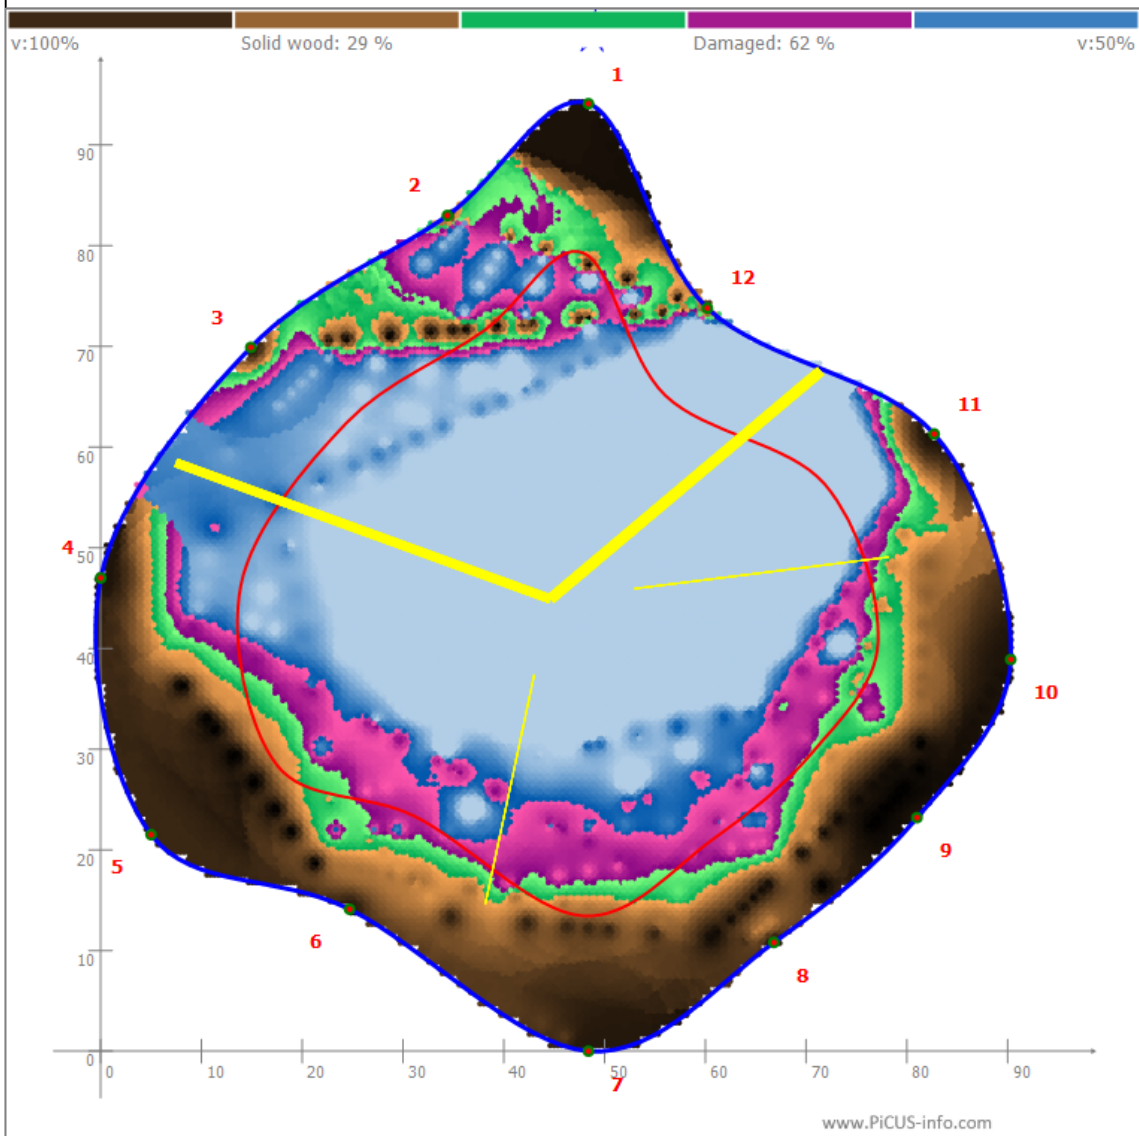
- A PiCUS assessment was undertaken to ascertain the extent of decay in the main trunk and in order to assess the risk of failure from the base of the tree. The imagery (see Appendix 2) indicates that at the point of the decay test there is approximately 29% of sound wood recorded. The PiCUS tomograph imagery showed evidence of significant dysfunctional wood/decay with the trunk of the tree where the decay test was carried out. Areas on the tomograph showing up as blue, white, green and pink colours are normally associated with dysfunctional wood or areas of decay. The tomograph shows significant damaged and decayed wood throughout the main trunk with only sound wood located on the buttresses to the north, south, south-east and south-western aspects. I believe that this amount of decay is present throughout the main trunk from ground level up to approximately 3-4 metres where decay fungi was observed. Given the heavy lean

of the tree towards the property and significant decay present throughout the main trunk. I believe this tree has a high probability of failure.

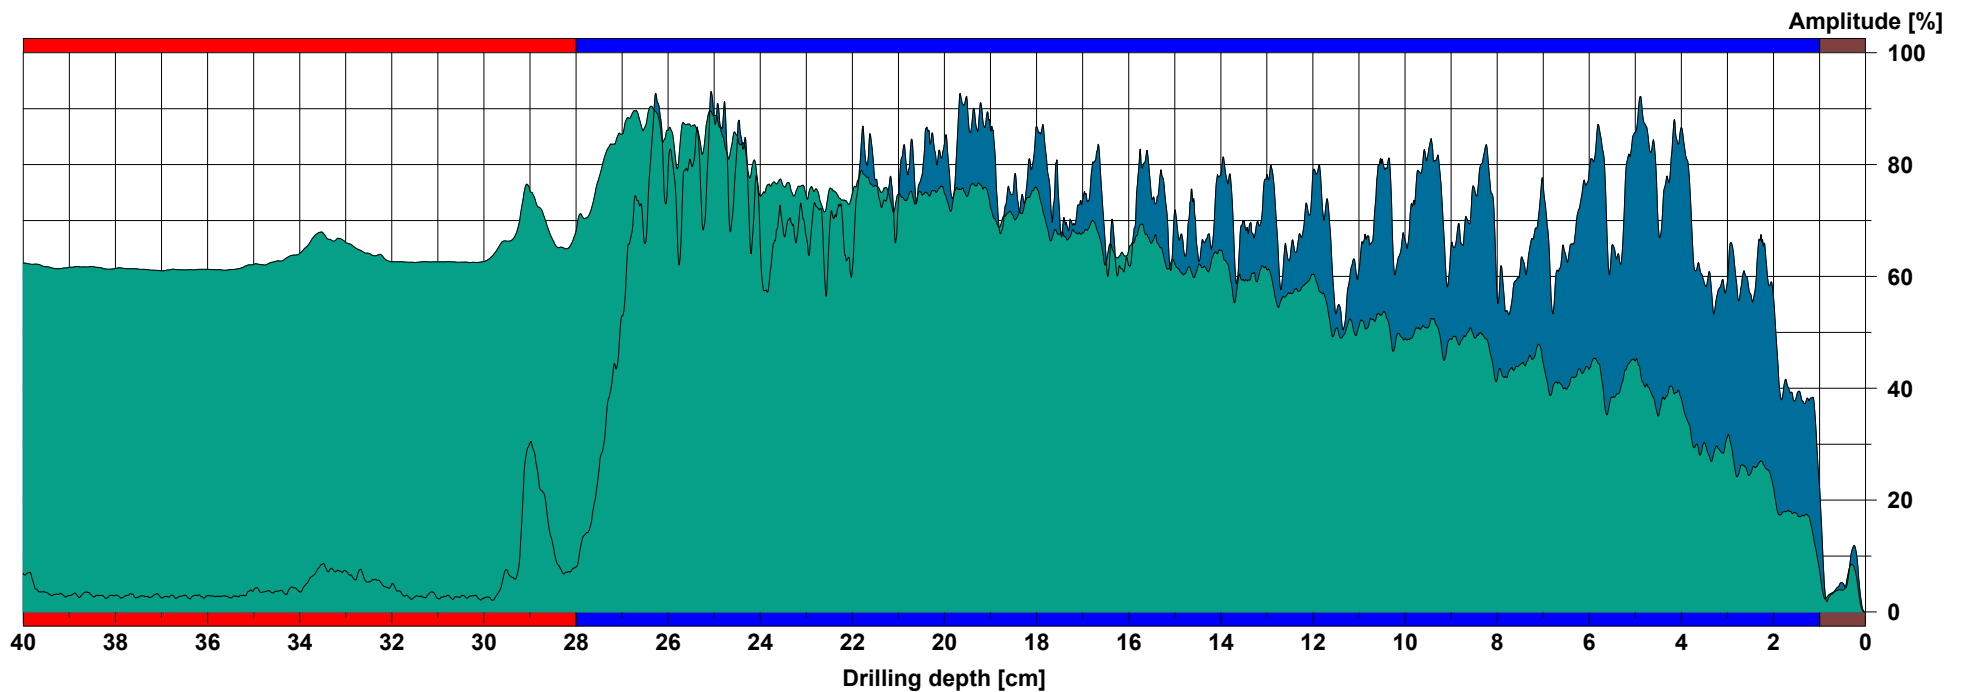
43 Elsworthy Road 0.5 N

- The first test was carried out at the base of the northern side of the main trunk. This test showed very high resistance as it passed through reactive growth in the buttresses to 280 mm. Thereafter, the resistance drops suddenly to full depth of 400mm indicating significant decay in the main trunk.

From	0,00 cm to	1,00 cm	: Bark
From	1,00 cm to	28,00 cm	: Reaction Wood
From	28,00 cm to	40,00 cm	: Decay

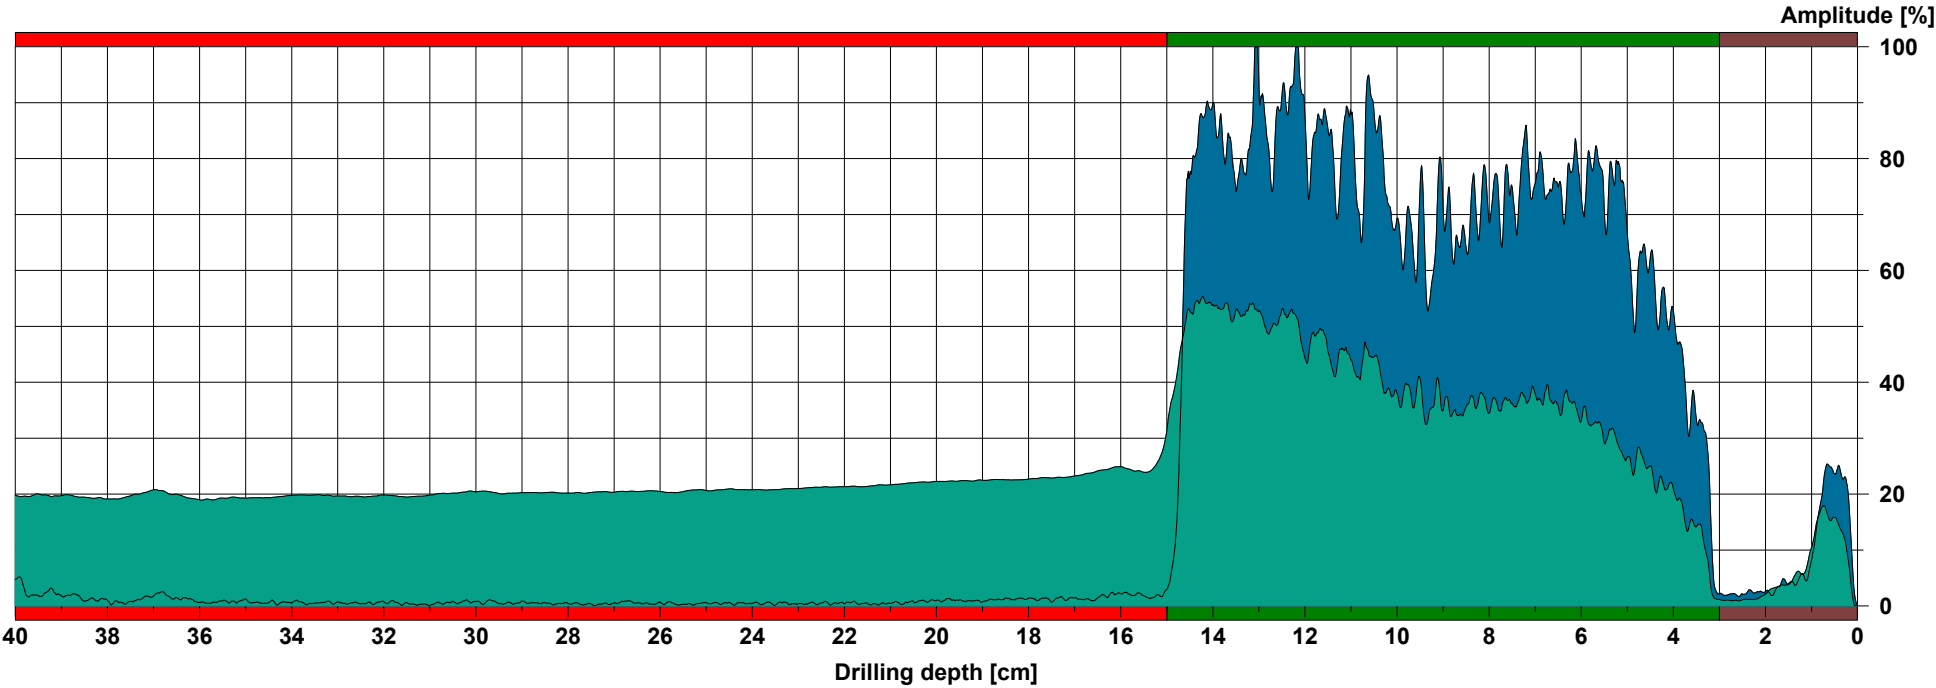
43 Elsworthy Road 0.5 E

- The second test on the eastern side of the tree was drilled and showed a high resistance through a buttress up to 150 mm after dropping rapidly to very low resistance up to the full depth of 400 mm.

From	0,00 cm	to	3,00 cm	:	Bark
From	3,00 cm	to	15,00 cm	:	Sound wood
From	15,00 cm	to	40,00 cm	:	Decay

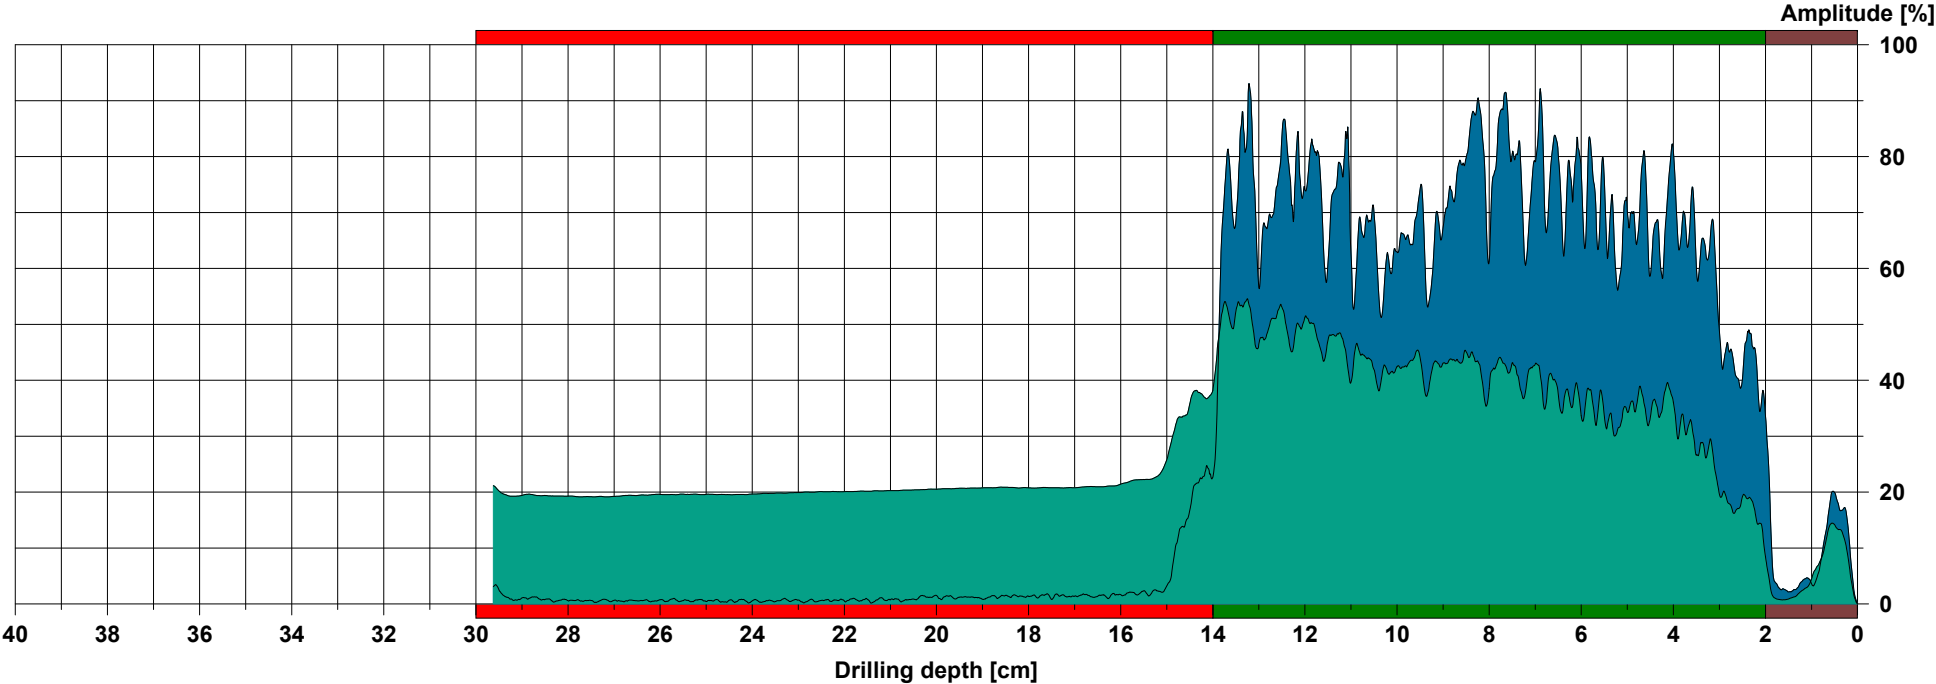
43 Elsworthy Road 0.5 S

- The third drill test carried out on the southern side of the trunk indicated high resistance up to a depth of 140mm before dropping substantially to a depth 300mm. At 300mm depth automatic drill retraction occurred, this is where the drill passes through decayed wood or internal hollowing and starts to drill back into wood of high resistance. It is likely that the drill passed through a small area of reactive wood or a knot within the trunk.

From	0,00 cm	to	2,00 cm	:	Bark
From	2,00 cm	to	14,00 cm	:	Sound wood
From	14,00 cm	to	30,00 cm	:	Decay

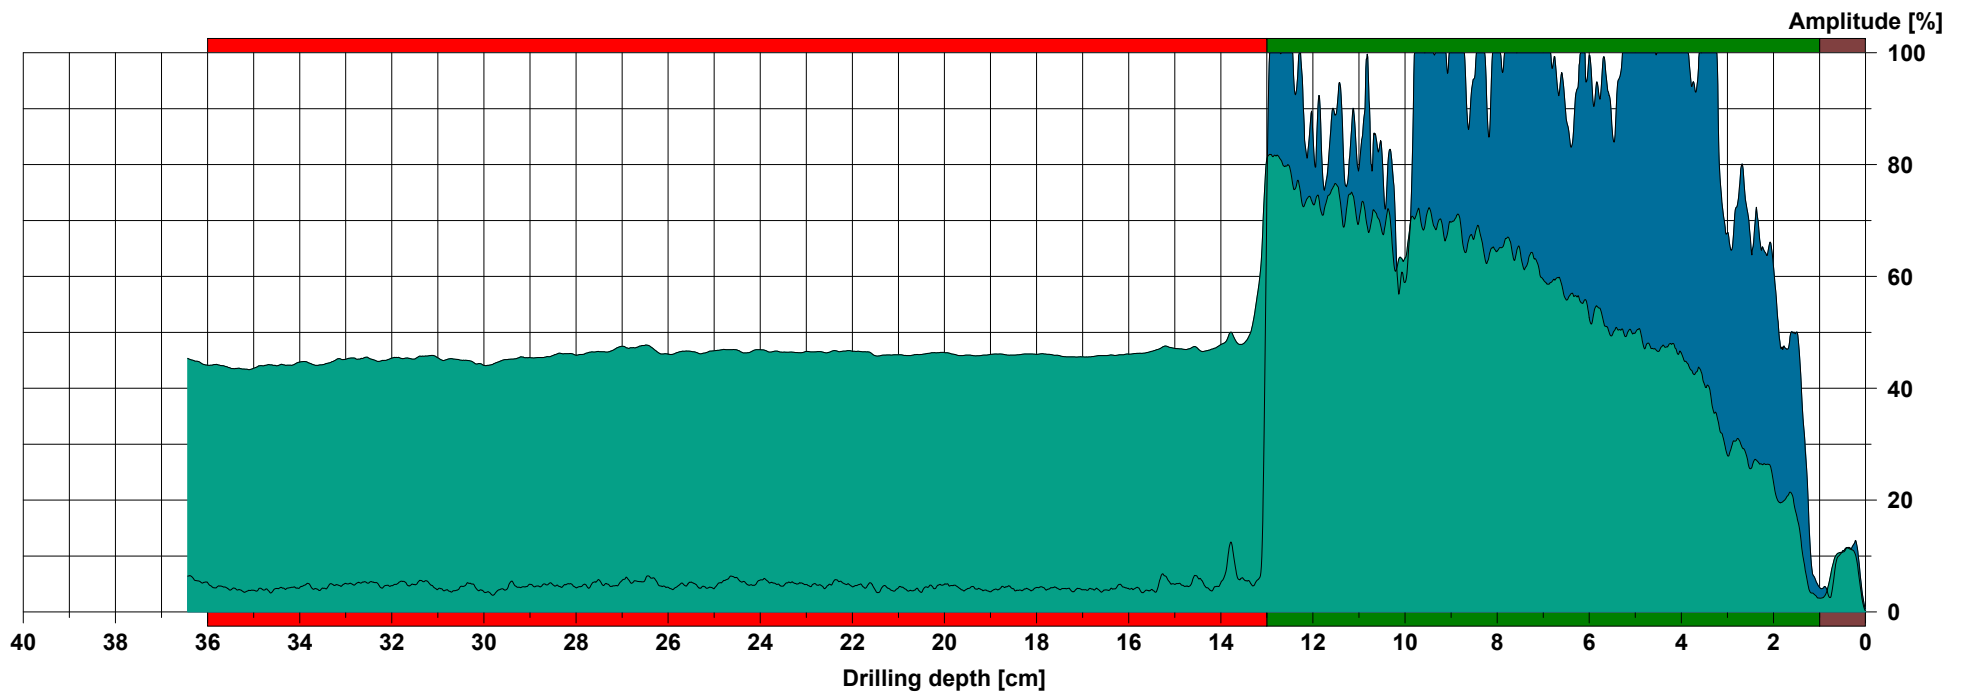
43 Elsworthy Road 0.5 W

- The fourth test was carried out on the western side of the main trunk and showed very high resistance drilling through reactive growth wood to a depth of 130mm. The resistance dropped low beyond this point to a depth of 360 mm where automatic needle retraction occurred.

From	0,00 cm to	1,00 cm	: Bark
From	1,00 cm to	13,00 cm	: Sound wood
From	13,00 cm to	36,00 cm	: Decay
