Royal College of General Practitioners

External Survey of Windows, Roof Leadwork & Rain Water Goods

REPORT OF FINDINGS

SPLIT REPORT 2 of 4

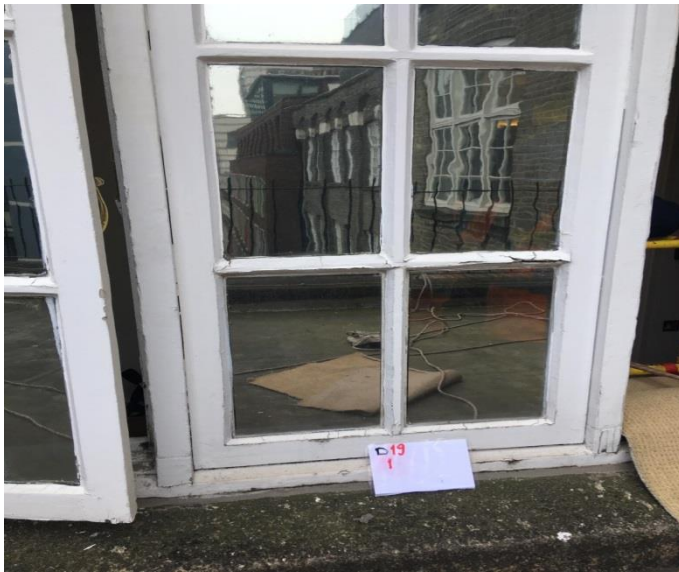
Drop 19 Picture 1

PICTURE	DAMAGE DESCRIPTION
1	Flaking paint, weathered/rotten timber, missing putty
2	Missing pointing, movement of bricks
3	Weathered paint, metal window overall condition
4	Weathered/flaking paint, cracks in putty

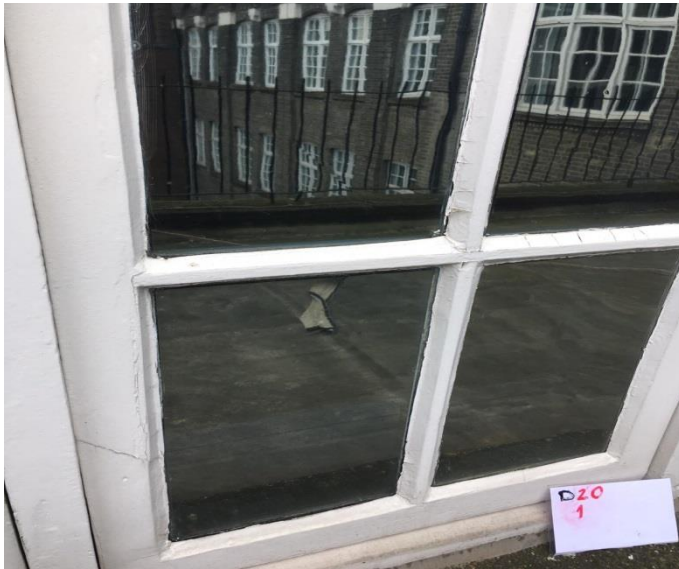
Drop 20 Picture 1

PICTURE	DAMAGE DESCRIPTION
1	Weathered paint, cracked putty
2	Weathered/flaking paint, cracked putty
3	Weathered/flaking paint, cracked putty
4	Damaged/weathered paint
5	Damaged timber

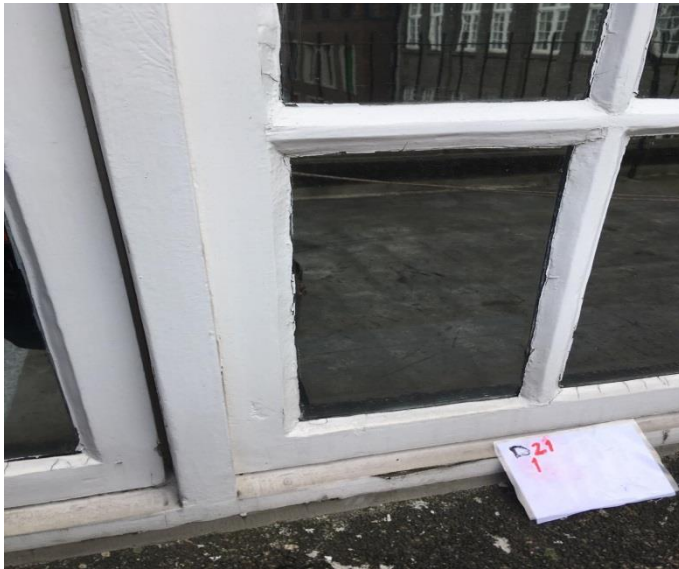
Drop 21 Picture 1

PICTURE	DAMAGE DESCRIPTION
1	Flaking/weathered paint, cracked putty
2	Loose brickwork above window
3	Weathered/flaking paint
4	Weathered/flaking paint, cracked putty
5	Weathered/flaking paint, cracked putty

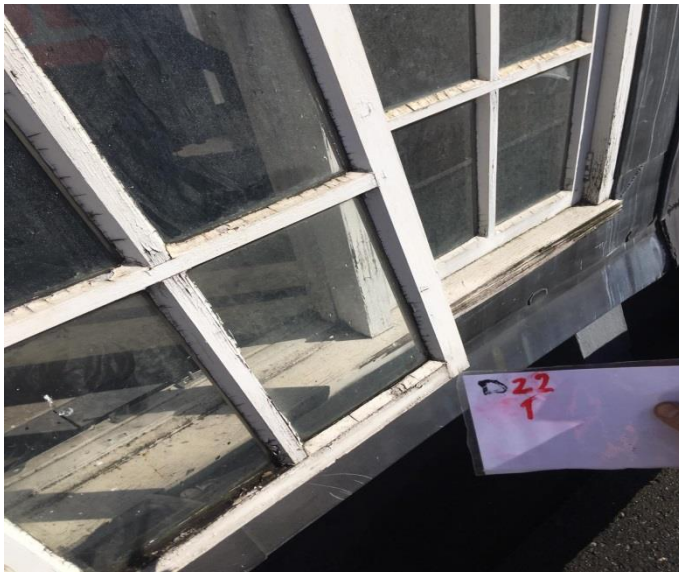
Drop 22 Picture 1

PICTURE	DAMAGE DESCRIPTION
1	Flaking paint, missing putty, damaged sill
2	Weathered/flaking paint
3	Weathered/flaking paint, minor damage
4	Flaking paint on pipe
5	Flaking paint, minor damage
6	Weathered paint
7	Minor damage, missing putty, flaking paint
8	Weathered/flaking paint

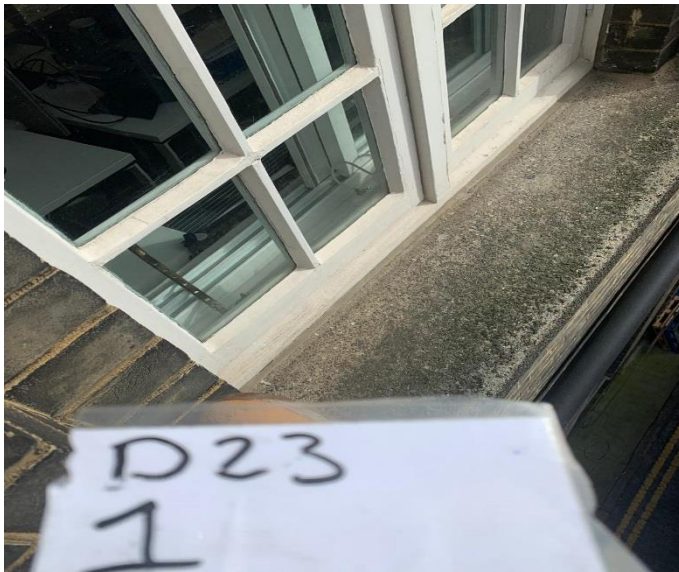
Drop 23 Picture 1

PICTURE	DAMAGE DESCRIPTION
1	Flaking paint
2	Cracked glass
3	Flaking paint
4	Flaking paint
5	Flaking paint
6	Cracked putty, flaking paint
	Hopper missing wire balloon

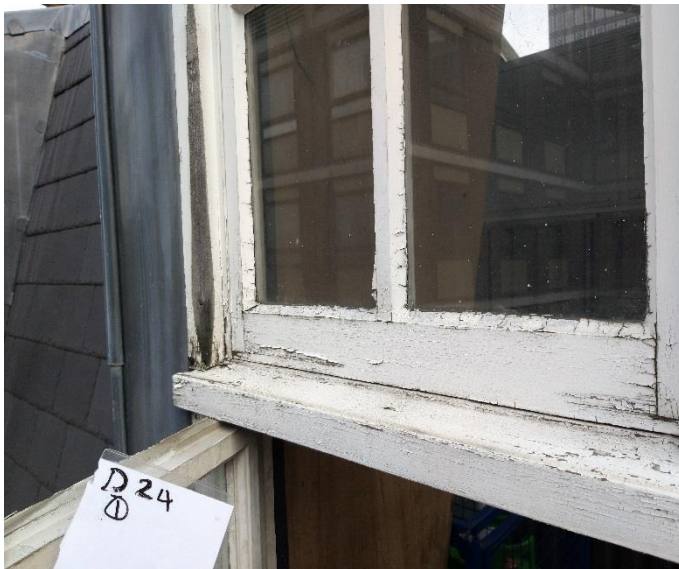
Drop 24 Picture 1

PICTURE	DAMAGE DESCRIPTION
1	Flaking paint, damaged frame/sill, rotten timber, cracked putty
2	Overall condition
3	Cracked sill, flaking paint, cracked putty
4	Flaking paint
5	Cracked putty
6	Flaking paint, cracked putty
7	Badly damaged brick
8	Flaking paint
9	Flaking paint, cracked mastic
10	Cracked mastic
11	Flaking paint, cracked putty
12	Flaking paint, cracked putty

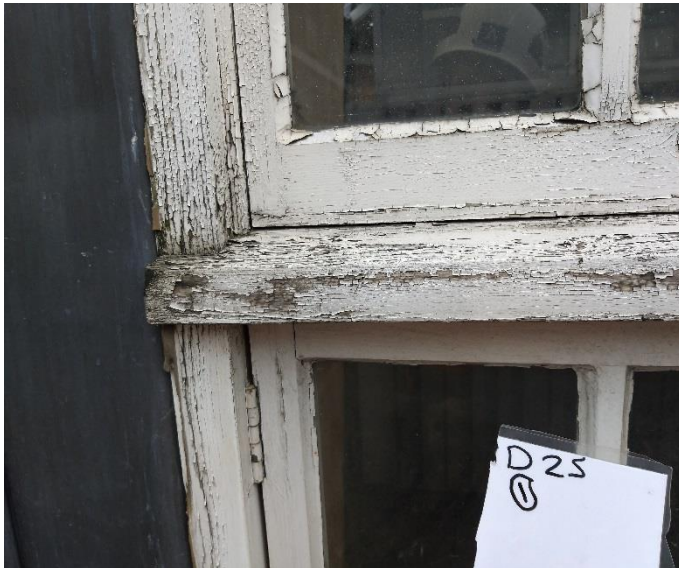
Drop 25 Picture 1

PICTURE	DAMAGE DESCRIPTION
1	Flaking paint, weathered timber, missing mastic, cracked putty, rotten timber
2	Overall condition
3	Putty cracked, flaking paint
4	Putty cracked
5	Flaking paint
6	Cracked putty, flaking paint
7	Cracked mastic, flaking paint
8	Cracked mastic, flaking paint
9	Cracked putty, flaking paint

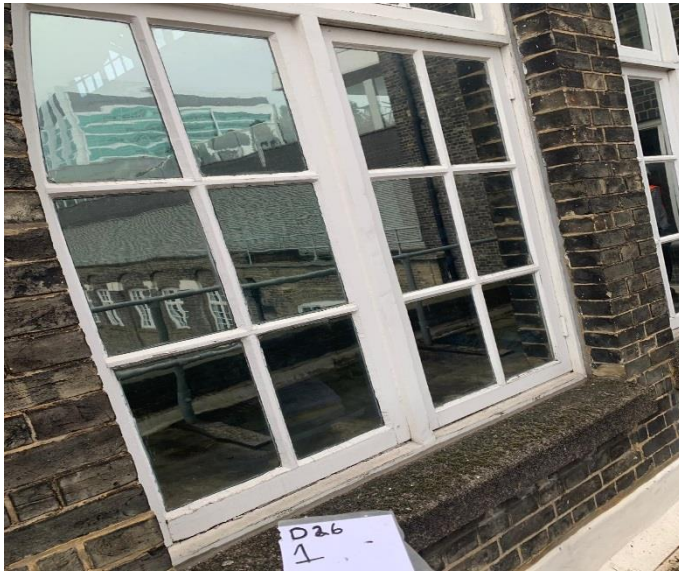
Drop 26 Picture 1

PICTURE	DAMAGE DESCRIPTION
1	Flaking paint, cracked putty
2	Flaking paint, cracked putty, minor damage
3	Flaking paint, cracked putty
4	Flaking paint, cracked putty
5	Minor damage, cracked putty, flaking paint, weathered sill
