# Royal College of General Practitioners

## External Survey of Windows, Roof Leadwork & Rain Water Goods

### REPORT OF FINDINGS

# REAR ELEVATION 4<sup>TH</sup> OF MARCH

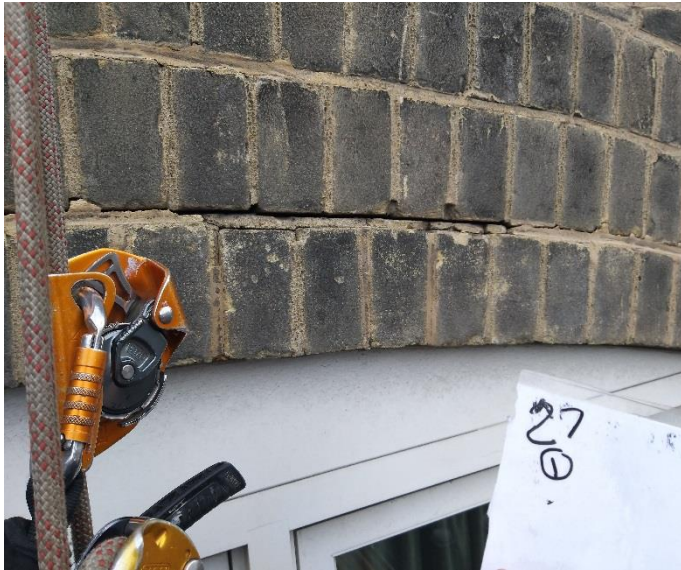
Drop 27 Picture 1

PICTURE	DAMAGE DESCRIPTION
1	Missing pointing, vibration in lintel when struck
2	Overall condition- good
3	Overall condition-good
4	Metal frame, flaking paint, damaged mastic, damaged brick
5	Metal window, flaking paint
6	Debris in hopper

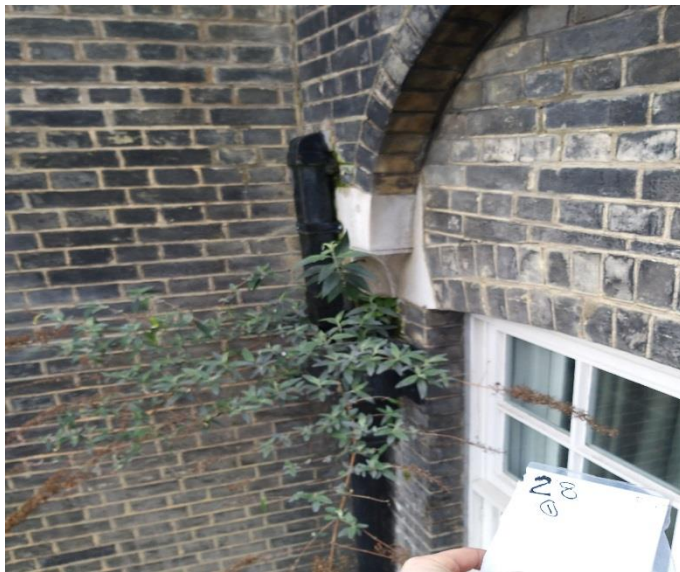
Drop 28 Picture 1

PICTURE	DAMAGE DESCRIPTION
1	Hopper blocked, outlet pipe leaking, moss algae growing
2	Cracked putty
3	Cracked putty
4	Flaking paint
5	Flaking paint
6	Poorly applied putty
7	Flaking paint
8	Cracked putty
9	Cracked paint
10	Flaking paint
11	Cracked paint
12	Cracked/missing putty, missing mastic
13	Flaking paint, cracked/not painted putty
14	Cracked putty, weathered sill, missing mastic, flaking paint
15	Weathered/dirty paint
16	Weathered/dirty paint, flaking paint, broken glass

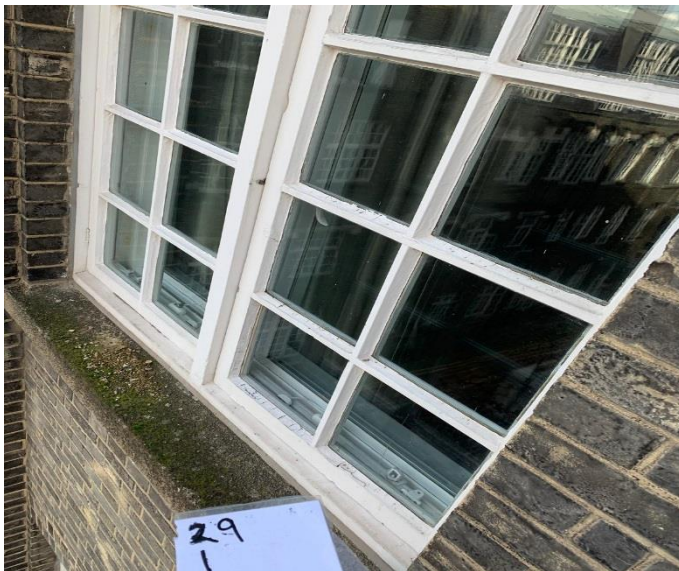
Drop 29 Picture 1

PICTURE	DAMAGE DESCRIPTION
1	Cracked putty, flaking paint
2	Cracked putty, flaking paint
3	Damaged brick, brick sticking out, area vibrating when struck
4	Flaking paint, cracked putty
5	Flaking paint, cracked putty
6	Flaking paint
7	Flaking paint
8	Flaking paint, cracked putty
9	Flaking paint cracked putty

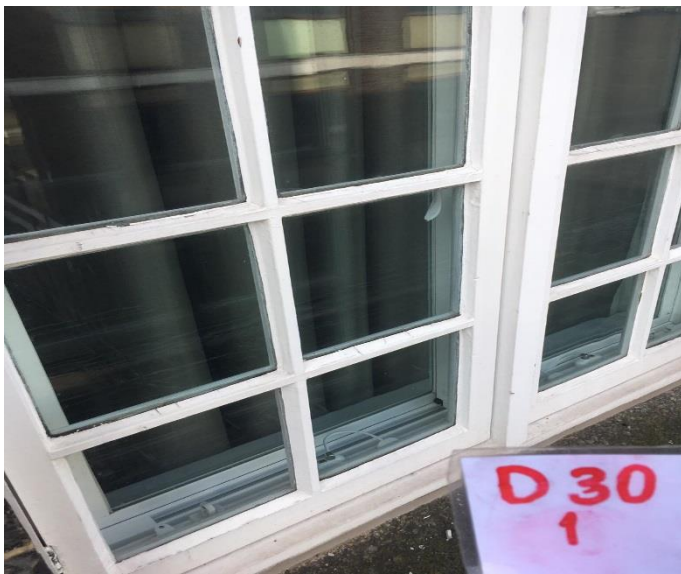
Drop 30 Picture 1

PICTURE	DAMAGE DESCRIPTION
1	Weathered/flaking paint
2	Weathered/flaking paint
3	Weathered paint
4	Weathered paint
5	Weathered/flaking paint
6	Weathered/flaking paint
7	Weathered paint, cracked putty
8	Weathered paint, cracked putty
9	Weathered/dirty/flaking paint

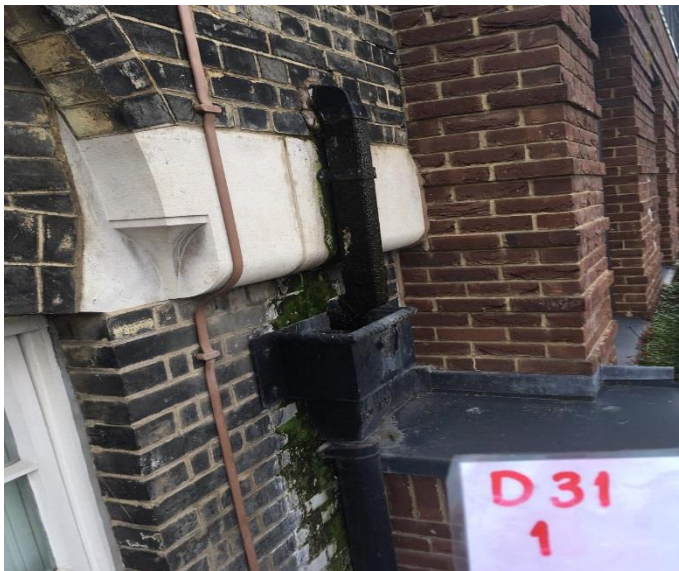
Drop 31 Picture 1

PICTURE	DAMAGE DESCRIPTION
1	Leaking gutter, flaking paint, moss/algae growing around pipe
2	Flaking paint, cracked putty
3	Weathered paint, cracked putty
4	Mortar on window, weathered paint, cracked putty
5	Weathered paint
6	Mortar on window, weathered paint, cracked mastic
7	Weathered/flaking paint
8	Mortar on window, minor frame damage, flaking paint, cracked putty
9	Minor damage, flaking paint, cracked putty
