1CP01

PROTECTION OF HERITAGE COLUMNS AT ROYAL COLLEGE OF GENERAL PRACTITIONERS (RCGP) (EXTRACT FROM PAYE REPAIR STRATEGY)

Document no: 1CP01-MDS-EN-REP-SS08_SL20-000010

Work Package Ref: Tranche 8

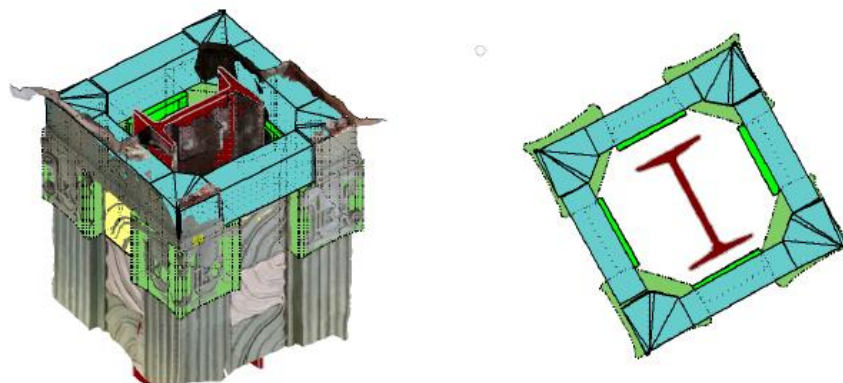
Figure 1 Photogrammetric Survey of a Typical Column

- 2.1.1 The interior clad columns are typical load-bearing terracotta block construction restrained back to the structural steel column with steel restraining ties. A common cracking pattern is observed to the top terracotta unit in the same plane as the down stand beam. This suggests that load transfer / movement from the steel frame has induced cracking to the top unit. One unit on the second floor has sustained significantly more damage than the others and has been historically wrapped (summarised from Byrne Looby Report 1CP01-MDS_BLY-EN-REP-SS08_SL20-000004)

- 2.1.2 The predicted settlement of the beams could cause further damage to the terracotta at the down stand beam. Therefore, mitigation measures should be implemented to the 12no. columns where the down stand beam bears onto the top of the terracotta units.
- 2.1.3 The 12no. columns should be temporarily restrained and encapsulated due to the potential risk of displaced units fracturing and falling to floor. The restraint method will involve Cambuckle straps and an encapsulation hoarding from the cushion course up.
- 2.1.4 The top two courses to the column should be strapped and secured in place with Cambuckle strap as detailed in the image shown below. This method also allows periodic inspection as it can be removed and reinstated by the surveyor. It has the

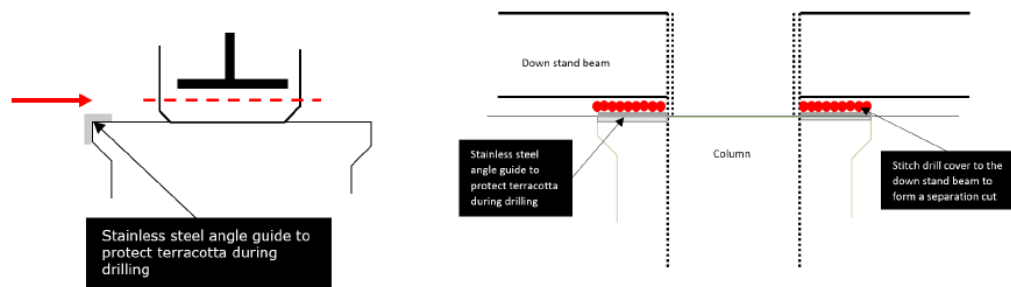
Figure 5 indicative sketch showing the down-stand beam divorce from the terracotta column

- 2.1.14 During visual inspections if the cracking to the top two courses worsens an additional mitigation measure will be implemented. The down stand beam will be divorced from the terracotta block by stitch drilling out the concrete cover to the down stand beam.

- 2.1.15 Drilling perpendicular to the beam the down stand beam will be separated from the terracotta column. A 500mm long diamond tipped drill bit will be used to “stitch” drill a series of holes to divorce the down stand beam from the terracotta block (shown in fig. 5 below). Diameter of the drill holes will be 12-24mm (maximum 24mm will not be exceeded)

- 2.1.18 At no point should the terracotta block be drilled into. A stainless-steel jig bracket will be used as a drill guide to prevent the drill damaging the terracotta block. The jig can be adapted on site with the introduction of shims to raise the stitch drill line offset from the terracotta block. A stitch drill trial will be undertaken to one column to confirm the methodology and controls are suitable before stitch drilling the remaining columns.
