# Arboricultural Impact Assessment BS5837:2012

16 Lyndhurst Gardens, London, NW3 5NR

Apex Environmental Ltd

Ref: AEL-18129-AIA

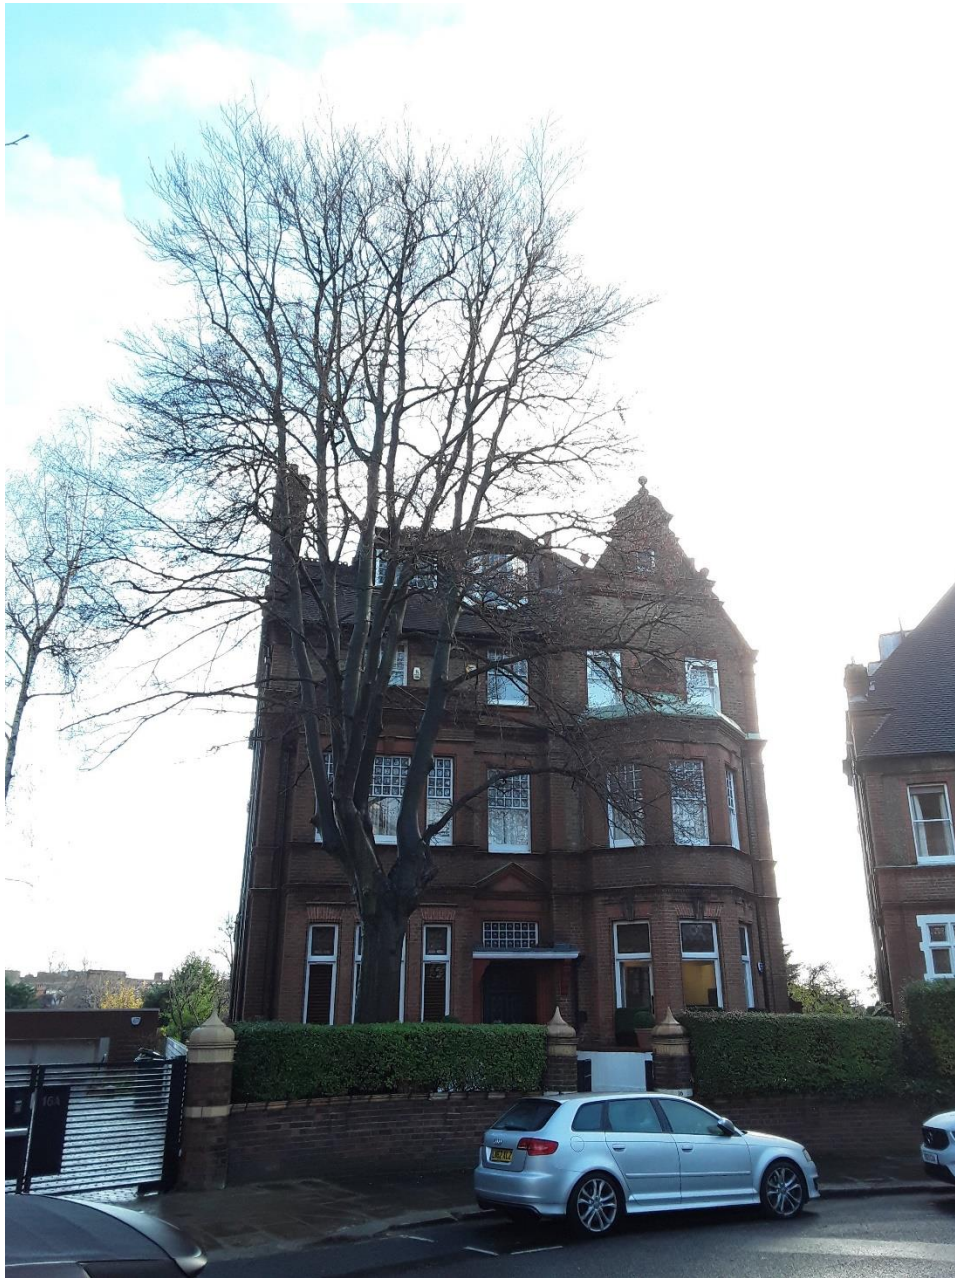
8.8 T.1 – Beech – This is a large mature tree in the front garden of 16. The tree is in good overall condition. The tree is growing within a raised planter which is showing signs of cracking. There are also some cracks to the front boundary wall in the same area. It is possible that this is due to pressure from tree roots. The nearby land is of hardstanding and there are some signs of cracking to the steps, which again could be from tree root damage (although no paving was lifted), and the hardstanding looked to established and it was seen that the tree had limited sources to moisture. The tree was free from fungus or defects in the lower stem. The tree looks to have been historically pollard at 4m. This has then been allowed to continue to grow to full height maturity. The has created a large dense canopy and there are signs of historical works to prune back the canopy (a separate search with London Borough of Camden, confirmed approval for the pruning back, thinning and crown lifting of this tree). This operation should be carried out again as the canopy is significantly shading the property (although this is not part of this application). This tree has been assessed as [Category B1](#)

AEL-18129-PIC1 – Showing T.1 in front garden

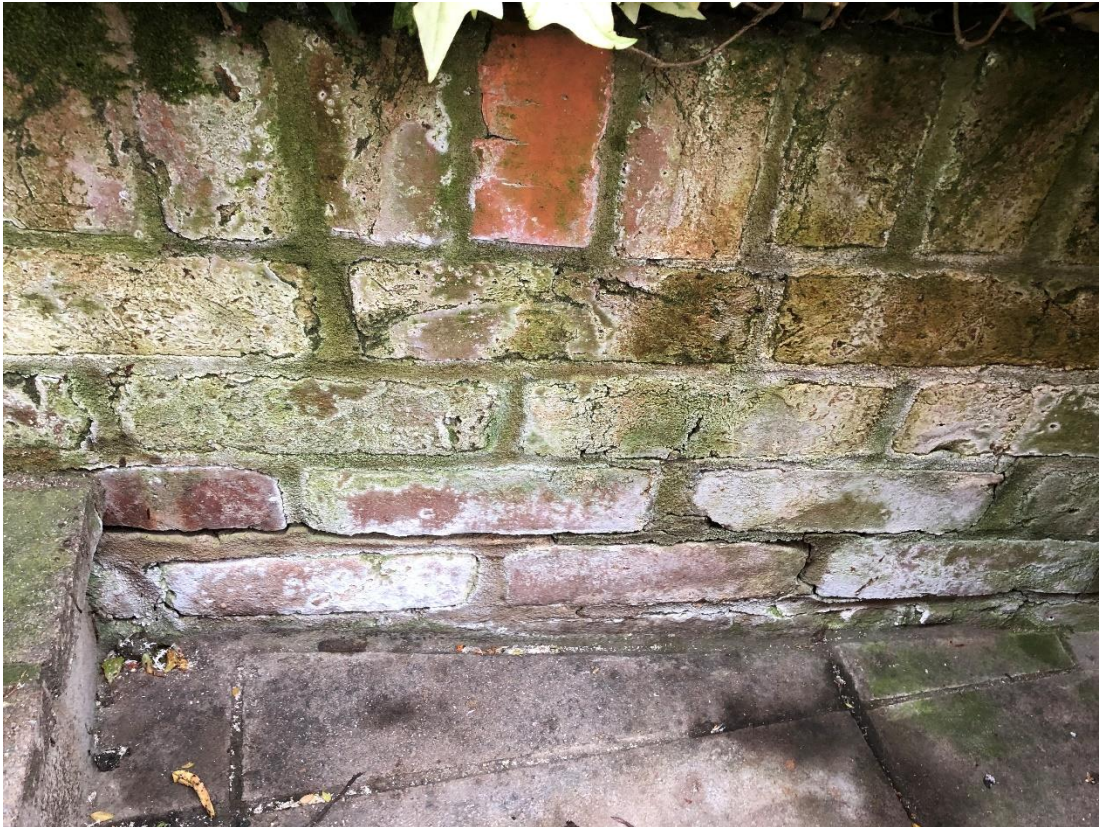
AEL-18129-PIC2 – Showing small crack in wall close to T.1

The brickwork is to be removed and replaced to remove any cracks to the concrete. The area will also include the removal of the existing storage building and the installation of a new bike storage area. The wall of the storage will be pulled back slightly from the current damaged wall. This will allow for a new reinforced wall to be installed outside of the current damaged wall. This will also allow for a new more substantial foundation and wall to be included to stop future damage from occurring.

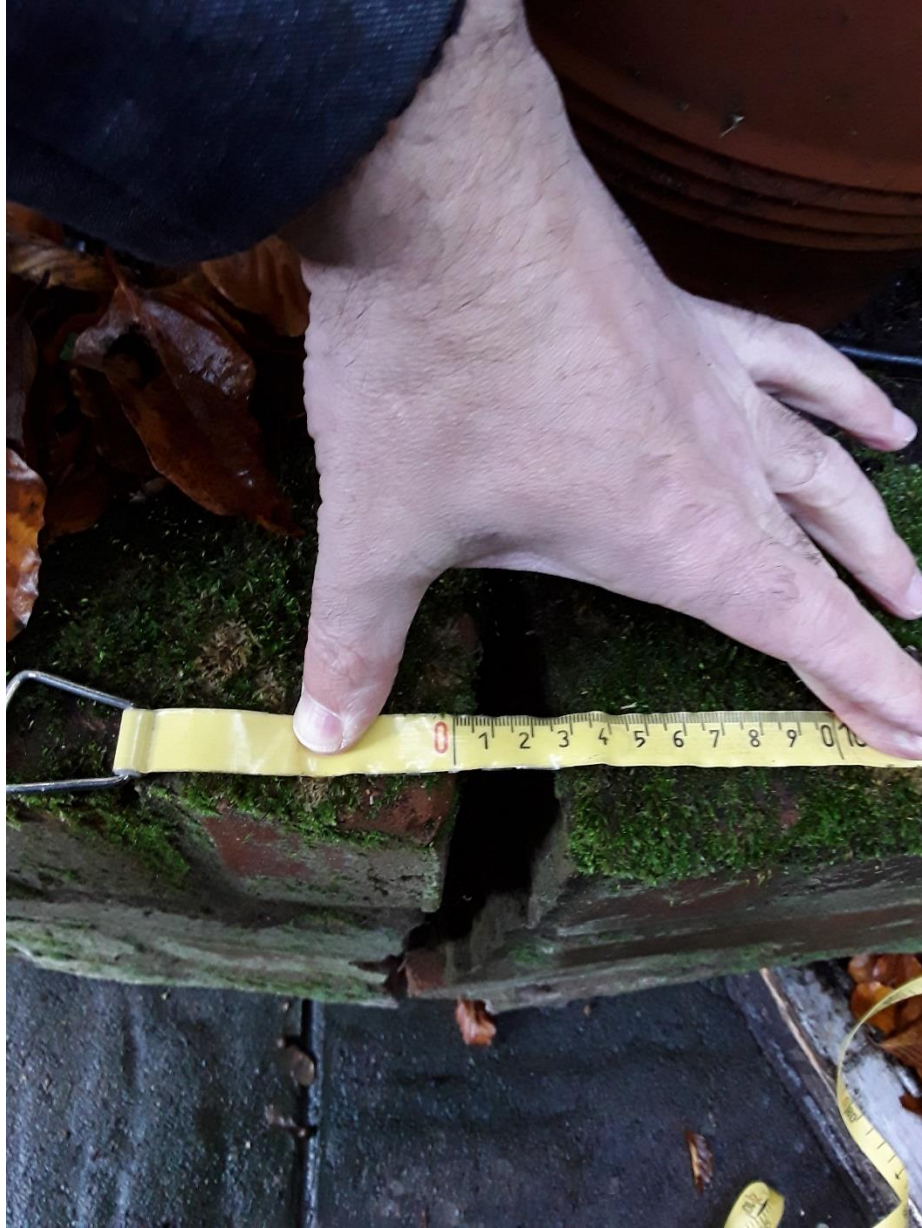
AEL-18129-PIC3 – Showing more significant crack in wall that will require repairing.

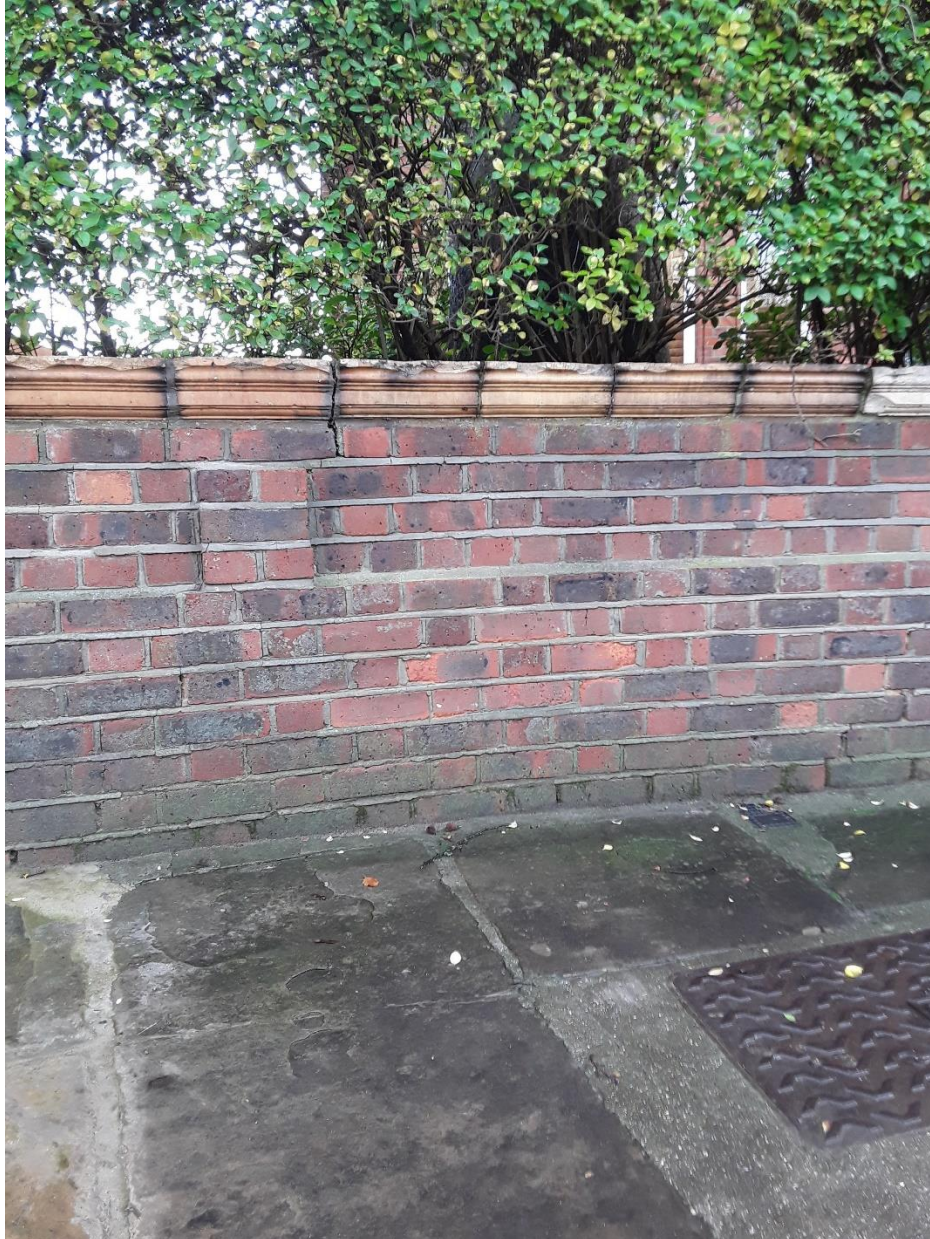
AEL-18129-PIC4 – Showing front boundary wall with crack that will require repair.
