**COMPARTMENTATION AND FIRE DOOR SURVEY**

**CENTRE POINT HOUSE,  
St Giles High Street,  
London WC2H 8LW**

**Project Number**  
I045302

**Date**  
04.01.21 and 31.03.21

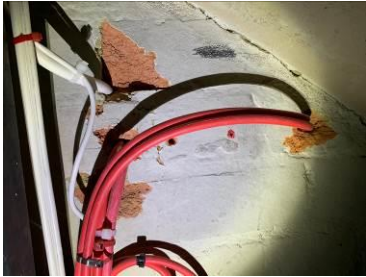
MISC LOCATION FAULTS – NOT IDENTIFIED ON THE ABOVE DRAWINGS				
Survey Report ID#	Survey Report Description and Recommendation	Status	Photograph	Comment
1	<b>Ground Floor</b> Cupboard under the stairs has unsealed cable penetrations

<p>This area has a high risk from the electrical installation that leads onto the main escape route from the premises.</p> <p><i>Recommendation - It is recommended that these areas are fire-stopped and sealed providing a minimum of 90mins fire resistance.</i></p>
2	<b>Second Floor</b> Podium roof to main building is believed to have been converted into plant area. This has Georgian wired glazing providing separation

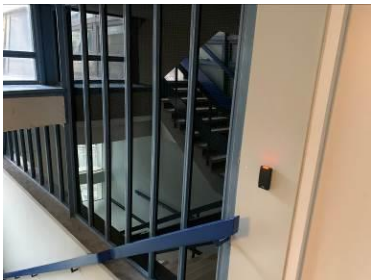
<p>The Georgian wired glazing is likely to only have a notional 30 minutes of fire resistance, which is inadequate compartmentation from the stairwell.</p> <p><i>Recommendation – It is recommended that consideration is given to upgrading the Georgian wired glass to achieve a minimum of 90mins fire resistance.</i></p>

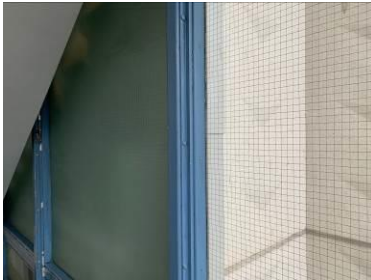
3	<b>South stairs to White Lion House</b> Georgian wired glazing providing separation into void between buildings

<p>No access could be provided to this area to identify separation behind and if any cavity barriers are present. Georgian wired glazing will only provide a notional 30 minutes of fire resistance, which is inadequate compartmentation from the stairwell.</p> <p><i>Recommendation – It is recommended that further investigations are undertaken to determine the sub-strata and fire resistance. It is understood</i></p>

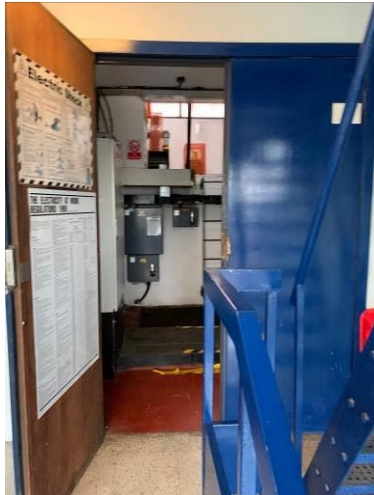
that this is being considered by the landlord/ building surveyor with its contractors.
4	<b>Eighth Floor</b> Lift motor room fire door has multiple faults that will unlikely provide adequate fire resistance

<p>The door set itself is of an unknown fire resistance, has only two hinges, hinges are not fire rated and is showing areas of damage.</p> <p><i>Recommendation – It is recommended that either the door is upgraded or repaired (including adding further fire resisting hinges) etc. or the door set is replaced with a FD60S rated door set.</i></p>

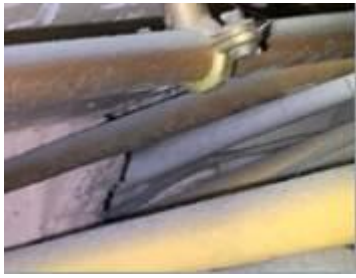
3	<b>South stairs lift lobby.</b> Unsealed cable penetration

<p>Unsealed cable penetrations require suitable mastic seal, with correct width to depth ratio.</p> <p><i>Recommendation - It is recommended that these areas are fire-stopped and sealed providing a minimum of 60mins fire resistance.</i></p>
4	<b>Lift lobby to corridor (Fire door)</b>

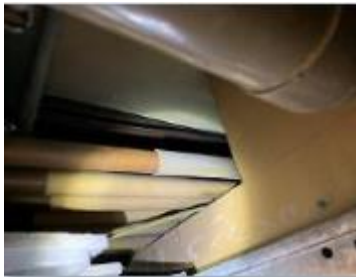
<p>Plasterboard partitions inadequately fitted and unsealed. No intumescent material around combustible pipework.</p> <p><i>Recommendation - It is recommended that these areas are fire-stopped and sealed providing a minimum of 60mins fire resistance.</i></p>

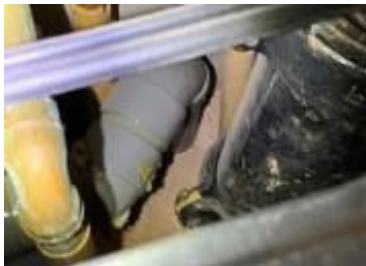
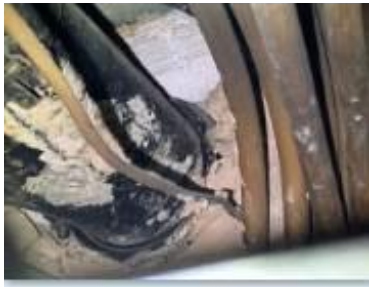
7	<b>Corridor leading into flats 2/3</b>  Unsealed services and combustible pipework leading into flat without intumescent device fitted

Unsealed penetrations through compartment wall with combustible pipework fitted without intumescent material added to close opening in fire situation.  <i>Recommendation - It is</i>

recommended that these areas are fire-stopped and sealed providing a minimum of 90mins fire resistance.
8	<b>Vertical openings by cross corridor</b>  Non-compliant foam used to seal vertical openings through floor slab

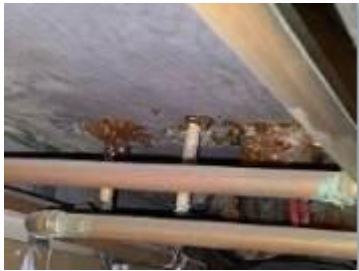
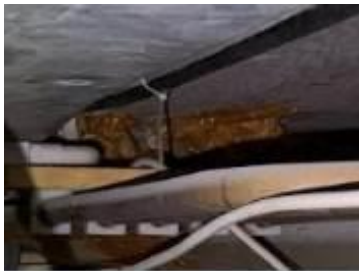
PU foam provides inadequate fire resistance and should be replaced by suitable fire resisting materials.  <i>Recommendation - It is recommended that the PU foam in these areas is removed and subsequently fire-stopped and sealed providing a minimum of 90mins fire resistance.</i>
9	<b>Above cross corridor</b>  Wall header unsealed with incomplete plasterboard separation

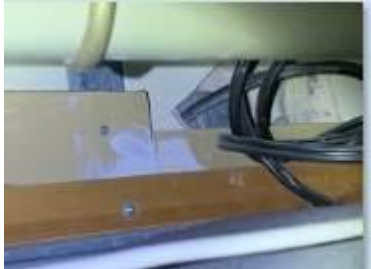
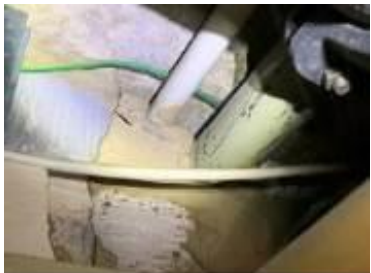
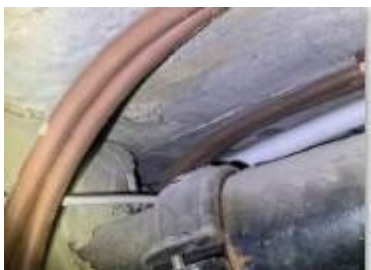
Combustible pipes unsealed and missing intumescent mastic seals to allow closing during a fire situation.  <i>Recommendation - It is recommended that these areas are fire-stopped and sealed providing a minimum of 90mins fire resistance.</i>
12	<b>Vertical openings between flats 4/5</b>  Non-compliant foam used to seal vertical openings through floor slab

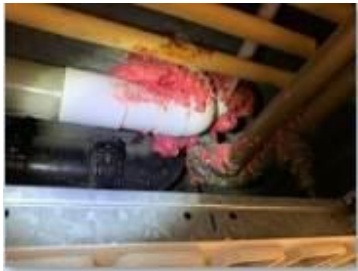
<p>PU foam provides inadequate fire resistance and should be replaced by suitable fire resisting materials.</p> <p><i>Recommendation - It is recommended that the PU foam in these areas is removed and subsequently fire-stopped and sealed providing a minimum of 90mins fire resistance.</i></p>
14	<p><b>Corridor leading into flats 6/7</b></p> <p>Unsealed services and combustible pipework leading into flat without intumescent device fitted</p>

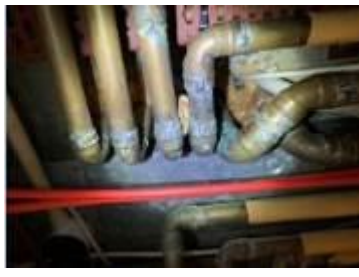
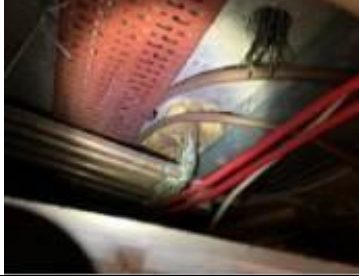
15	<b>Vertical openings between flats 6/7</b> Non-compliant foam used to seal vertical openings through floor slab

<p>PU foam provides inadequate fire resistance and should be replaced by suitable fire resisting materials.</p> <p><i>Recommendation - It is recommended that the PU foam in these areas is removed and subsequently fire-stopped and sealed providing a minimum of 90mins fire resistance.</i></p>
16	<b>Vertical openings by cross corridor</b> Non-compliant foam used to seal vertical openings through floor slab

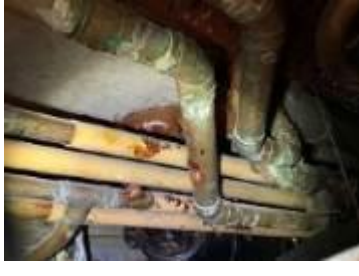
<p>PU foam provides inadequate fire resistance and should be replaced by suitable fire resisting materials.</p> <p><i>Recommendation - It is recommended that the PU foam in these areas is removed and subsequently fire-stopped and sealed providing a minimum of 90mins fire resistance.</i></p>

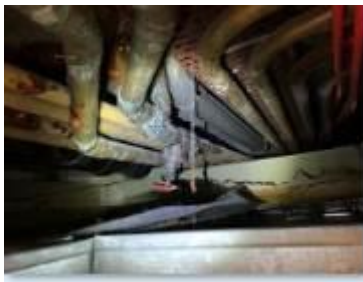
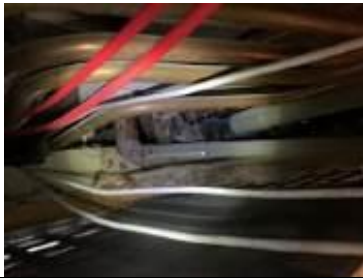
<p>Plasterboard partitions inadequately fitted and unsealed. No intumescent material around combustible pipework.</p> <p><i>Recommendation - It is recommended that these areas are fire-stopped and sealed providing a minimum of 60mins fire resistance.</i></p>
18	<b>Cross corridor (Fire door)</b>		n/a	<p>Doors warped and do not close flush together. Unknown beading used (not believed to be fire rated).</p> <p><i>Recommendation – Due to the nature of the issues noted it is recommended that this door is replaced with an FD60S rated door set.</i></p>

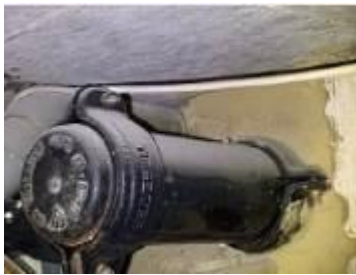
<p>Combustible pipes unsealed and missing intumescent mastic seals to allow closing during a fire situation.</p> <p><i>Recommendation - It is recommended that these areas are fire-stopped and sealed providing a minimum of 90mins fire resistance.</i></p>
20	<p><b>Vertical openings between flats 8/9</b></p> <p>Non-compliant foam used to seal vertical openings through floor slab</p>

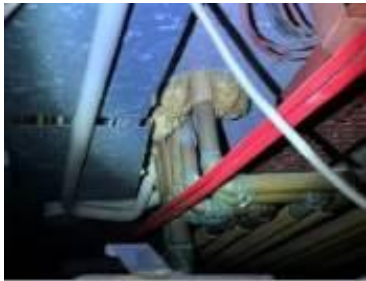
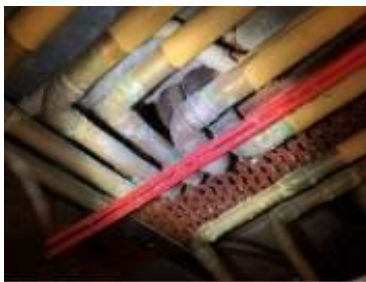
<p>PU foam provides inadequate fire resistance and should be replaced by suitable fire resisting materials.</p> <p><i>Recommendation - It is recommended that the PU foam in these areas is removed and subsequently fire-stopped and sealed providing a minimum of 90mins fire resistance.</i></p>
21	<p><b>Vertical openings between flats 9/10</b></p> <p>Non-compliant foam used to seal vertical openings through floor slab</p>

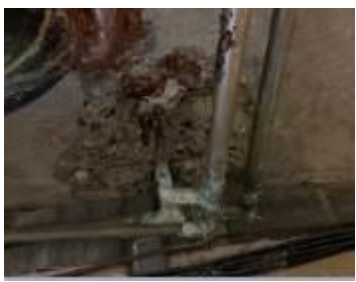
<p>PU foam provides inadequate fire resistance and should be replaced by suitable fire resisting materials.</p> <p><i>Recommendation - It is recommended that the PU foam in these areas is removed and subsequently</i></p>

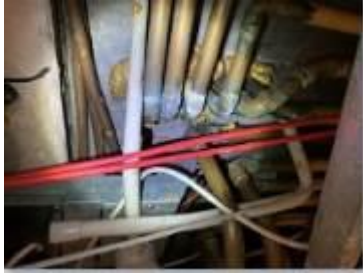
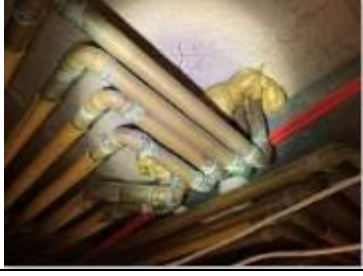
<p>PU foam provides inadequate fire resistance and should be replaced by suitable fire resisting materials.</p> <p><i>Recommendation - It is recommended that the PU foam in these areas is removed and subsequently fire-stopped and sealed providing a minimum of 90mins fire resistance.</i></p>
24	<b>Meter cupboard example</b>  Non-fire rated meter cupboards located outside each flat on this floor

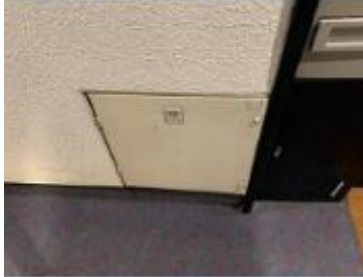
<p><i>Recommendation – It is recommended that the meter cupboard is replaced with a fire rated cupboard providing a minimum of 90mins fire resistance.</i></p>

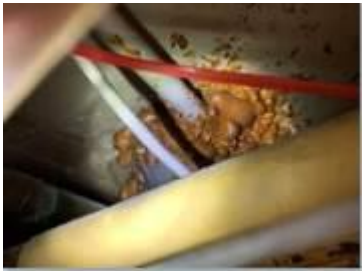
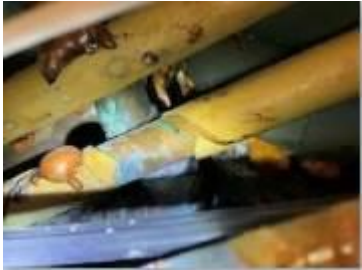
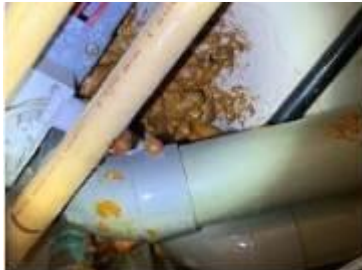
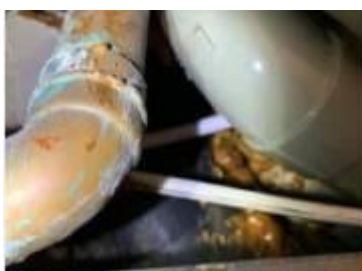
<p>PU foam provides inadequate fire resistance and should be replaced by suitable fire resisting materials.</p> <p>Recommendation - It is recommended that the PU foam in these areas is removed and subsequently fire-stopped and sealed providing a minimum of 90mins fire resistance.</p>
26	<p><b>Corridor leading into flat 12.</b></p> <p>Unsealed services and combustible pipework leading into flat without intumescent device fitted</p>

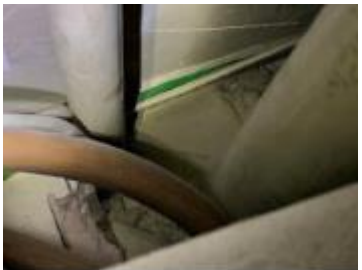
<p>Combustible pipes unsealed and missing intumescent mastic seals to allow closing during a fire situation.</p> <p>Recommendation - It is recommended that these areas are fire-stopped and sealed providing a minimum of 90mins fire resistance.</p>

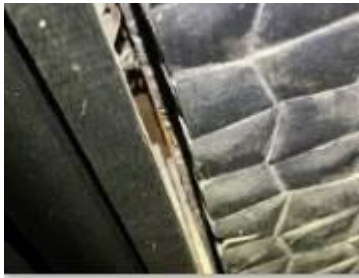
Unsealed wall edge requires suitable mastic seal, with correct width to depth ratio.  <i>Recommendation - It is recommended that this area is fire-stopped and sealed providing a minimum of 90mins fire resistance.</i>
28	<b>North stairs (Fire door)</b>		n/a	Doors do not close flush together in frame.  <i>Recommendation – It is recommended that either the doors are repaired to enable them to close fully flush to the stops or that the doors are replaced with an FD60S door set.</i>

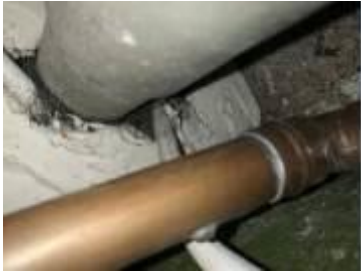
Unsealed services leading through floor slab. Fire stopping required to provide adequate compartmentation.  <i>Recommendation - It is recommended that these areas are fire-stopped and sealed providing a minimum</i>

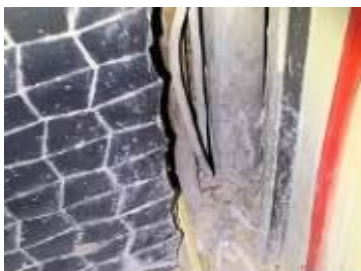
Services left unsealed with opening through the concrete floor slab.  <i>Recommendation – It is recommended that this area is either repaired or is fire-stopped and sealed providing a minimum of 90mins fire resistance.</i>
3	<b>Above entrance to flat 25</b>  Unsealed cable penetrations and combustible pipe penetration without closer

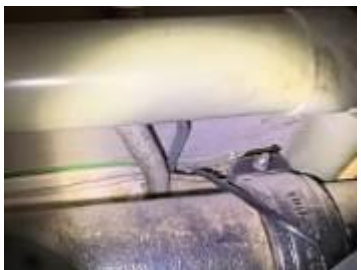
Combustible pipes unsealed and missing intumescent mastic seals to allow closing during a fire situation.  <i>Recommendation - It is recommended that these areas are fire-stopped and sealed providing a minimum of 90mins fire resistance.</i>

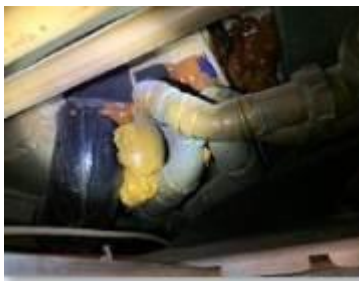
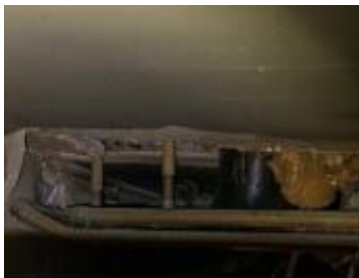
<p>PU foam provides inadequate fire resistance and should be replaced by suitable fire resisting materials.</p> <p><i>Recommendation - It is recommended that the PU foam in these areas is removed and subsequently fire-stopped and sealed providing a minimum of 90mins fire resistance.</i></p>

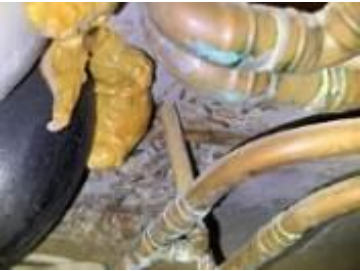
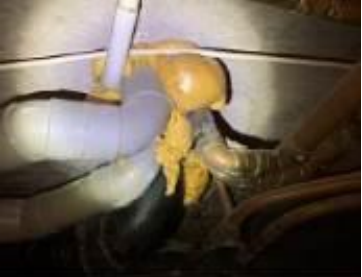
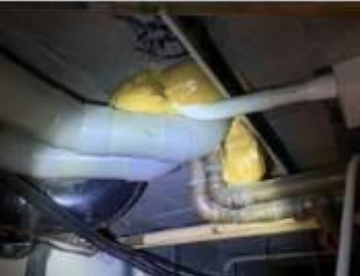
<p>PU foam provides inadequate fire resistance and should be replaced by suitable fire resisting materials.</p> <p><i>Recommendation - It is recommended that the PU foam in these areas is removed and subsequently fire-stopped and sealed providing a minimum of 90mins fire resistance.</i></p>

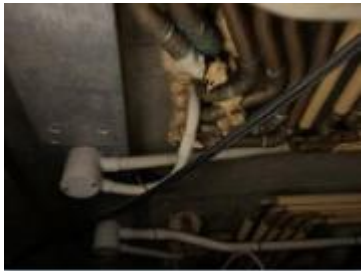
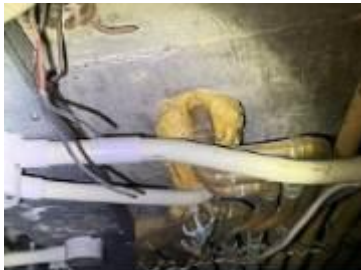
<p>PU foam provides inadequate fire resistance and should be replaced by suitable fire resisting materials.</p> <p><i>Recommendation - It is recommended that the PU foam in these areas is removed and subsequently fire-stopped and sealed providing a minimum of 90mins fire resistance.</i></p>
8	<b>Corridor leading into flat 22/21</b>  Unsealed services and combustible pipework leading into flat without intumescent device fitted

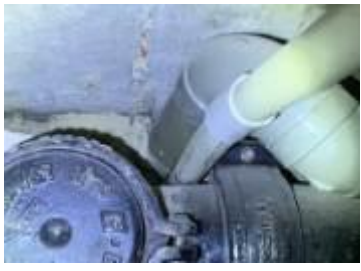
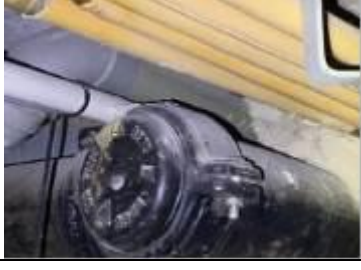
<p>Combustible pipes unsealed and missing intumescent mastic seals to allow closing during a fire situation.</p> <p><i>Recommendation - It is recommended that these areas are fire-stopped and sealed providing a minimum of 90mins fire resistance.</i></p>
9	<b>Above cross corridor door</b>  Wall header unsealed with incomplete plasterboard separation

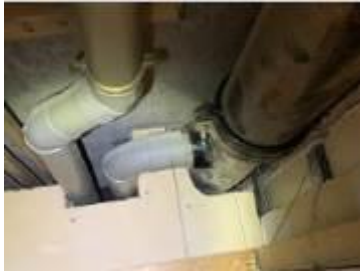
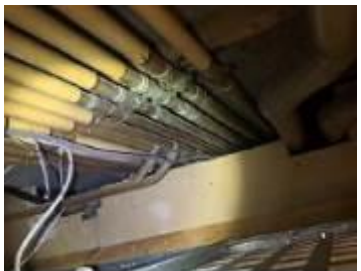
<p>Plasterboard partitions inadequately fitted and unsealed. No intumescent material around combustible pipework.</p> <p><i>Recommendation - It is recommended that these areas are fire-stopped and sealed providing a minimum of 90mins fire resistance.</i></p>

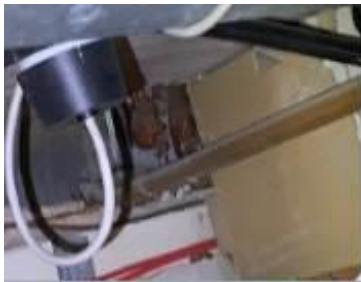
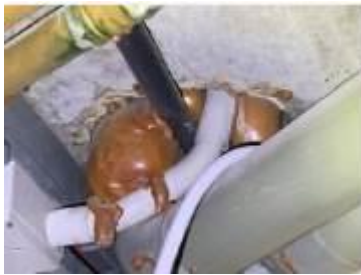
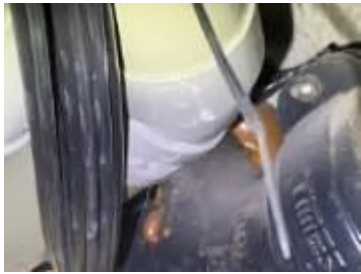
<p>PU foam provides inadequate fire resistance and should be replaced by suitable fire resisting materials.</p> <p><i>Recommendation - It is recommended that the PU foam in these areas is removed and subsequently fire-stopped and sealed providing a minimum of 60mins fire resistance.</i></p>

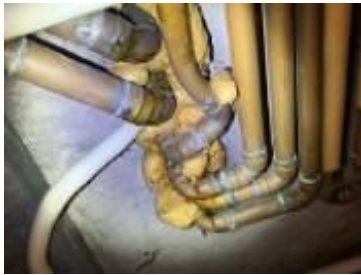
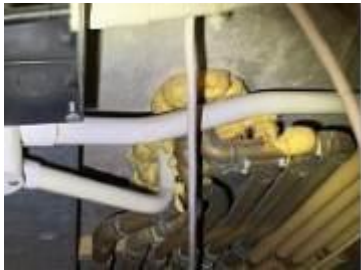
<p>PU foam provides inadequate fire resistance and should be replaced by suitable fire resisting materials.</p> <p><i>Recommendation - It is recommended that the PU foam in these areas is removed and subsequently fire-stopped and sealed providing a minimum of 90mins fire resistance.</i></p>
17	<p><b>Above cross corridor door</b></p> <p>Wall header unsealed with incomplete plasterboard separation</p>

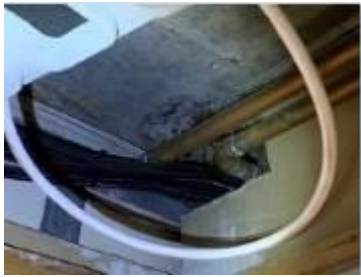
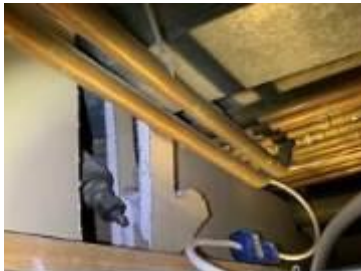
<p>Plasterboard partitions inadequately fitted and unsealed. No intumescent material around combustible pipework.</p> <p><i>Recommendation - It is recommended that these areas are fire-stopped and sealed providing a minimum of 90mins fire resistance.</i></p>
18	<p><b>Cross corridor (Fire door)</b></p>		n/a	<p>Door damaged with unknown beading (not believed to be fire rated) and doors do not close flush together.</p> <p><i>Recommendation – It is recommended that the doors are either repaired to ensure that they fit flush or replaced with a new FD60S rated door set</i></p>

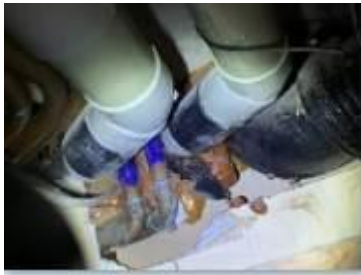
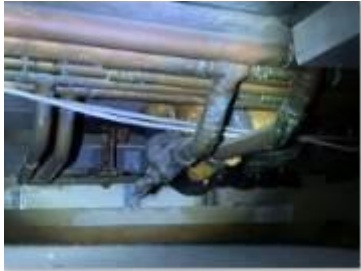
<p>PU foam provides inadequate fire resistance and should be replaced by suitable fire resisting materials.</p> <p><i>Recommendation - It is recommended that the PU foam in these areas is removed and subsequently fire-stopped and sealed providing a minimum of 60mins fire resistance.</i></p>
20	<b>Corridor vertically between flats 16/15</b>  Unsealed services and non-compliant foam used to seal vertical openings through floor slab

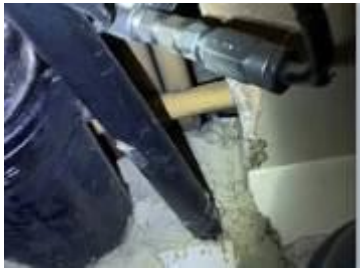
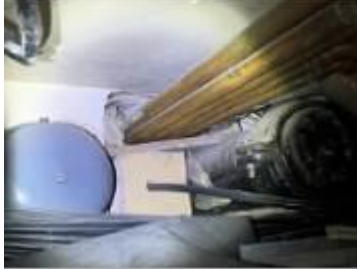
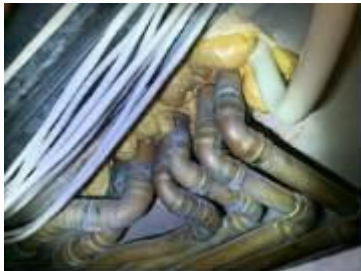
<p>PU foam provides inadequate fire resistance and should be replaced by suitable fire resisting materials.</p> <p><i>Recommendation - It is recommended that the PU foam in these areas is removed and subsequently fire-stopped and sealed providing a minimum of 90mins fire resistance.</i></p>
21	<b>Corridor vertically between flats 14/15</b>  Non-compliant foam used to seal vertical openings through floor slab

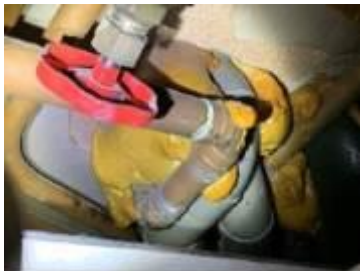
<p>PU foam provides inadequate fire resistance and should be replaced by suitable fire resisting materials.</p> <p><i>Recommendation - It is recommended that the PU foam in these areas is</i></p>

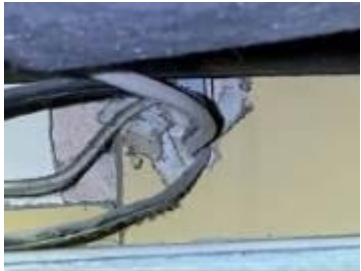
<p>Unsealed cable penetrations require suitable mastic seal, with correct width to depth ratio.</p> <p><i>Recommendation - It is recommended that these areas are fire-stopped and sealed providing a minimum of 90mins fire resistance.</i></p>
23	<b>Above lift lobby door</b>  Wall header unsealed with incomplete plasterboard separation

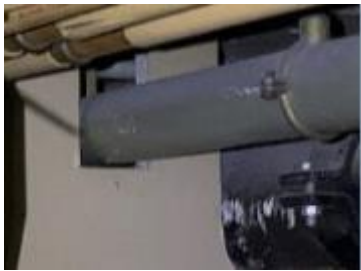
<p>Plasterboard partitions inadequately fitted and unsealed. No intumescent material around combustible pipework.</p> <p><i>Recommendation - It is recommended that these areas are fire-stopped and sealed providing a minimum of 90mins fire resistance.</i></p>

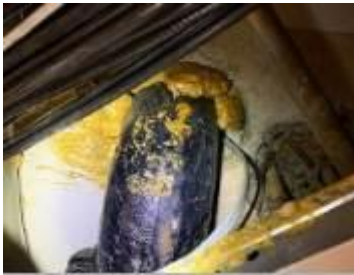
<p>PU foam provides inadequate fire resistance and should be replaced by suitable fire resisting materials.</p> <p><i>Recommendation - It is recommended that the PU foam in these areas is removed and subsequently fire-stopped and sealed providing a minimum of 90mins fire resistance.</i></p>

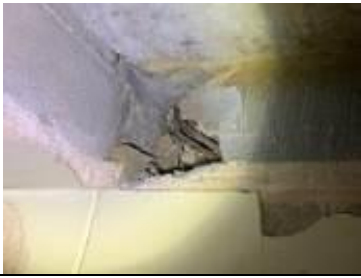
Unsealed openings through blockwork wall into flats.  <i>Recommendation - It is recommended that these areas are fire-stopped and sealed providing a minimum of 90mins fire resistance.</i>
14	<b>Communal corridor by cross corridor doorset</b>  Unsealed cable penetration and non-compliant foam used to seal vertical openings through floor slab

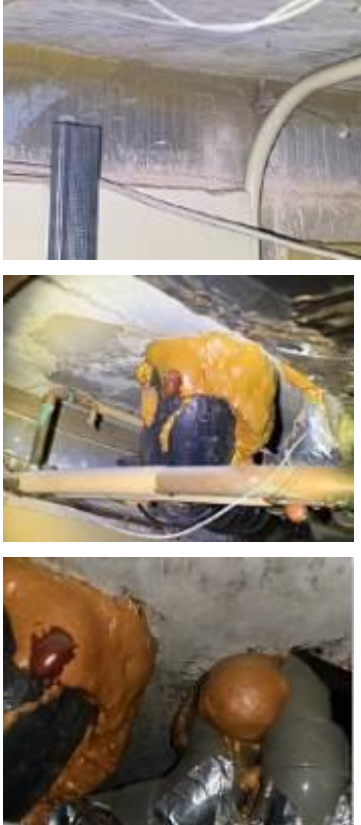
PU foam provides inadequate fire resistance and should be replaced by suitable fire resisting materials.  <i>Recommendation - It is recommended that the PU foam in these areas is removed and subsequently fire-stopped and sealed providing a minimum of 90mins fire resistance.</i>
15	<b>Cross corridor separation</b>  Header above door set providing inadequate seal.

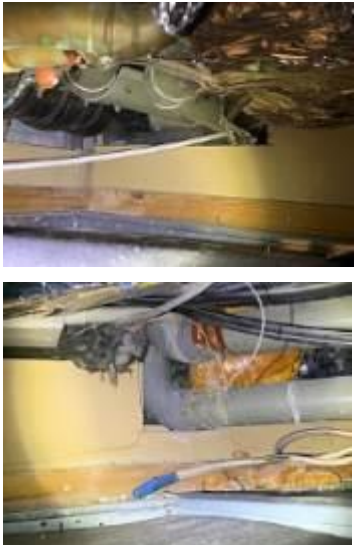
Plasterboard partition inadequately fitted and unsealed. Services leading through it do not have closers or intumescent seals and a loose fit mineral fiber material has been used to seal an opening.  <i>Recommendation – It is recommended that these areas are fire-stopped and sealed providing a minimum of 60mins fire resistance.</i>

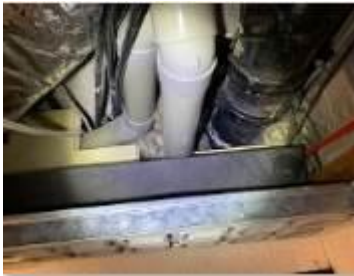
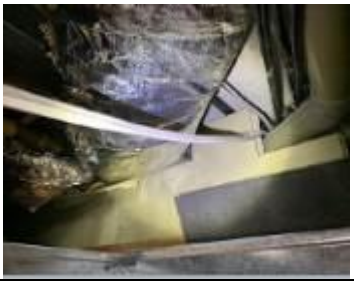
Plasterboard partition inadequately fitted and unsealed. Services leading through it do not have closers or intumescent seals.  <i>Recommendation - It is recommended that these areas are fire-stopped and sealed providing a minimum of 60mins fire resistance.</i>
25	<b>Vertical service openings by cross corridor separation</b>  Non-compliant foam used to seal openings vertical openings through floor slab

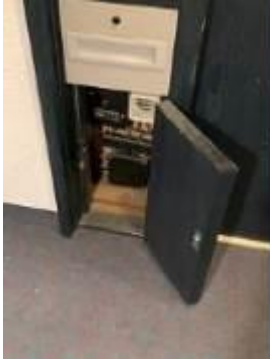
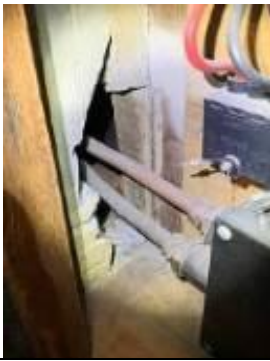
Timber non-fire rated door and missing seal / damaged openings from meter cupboard into flat.  <i>Recommendation - It is recommended that the meter cupboard be replaced with a FD90S rated cabinet and the gaps between the cabinet and the flat are sealed to provide a minimum of 90minutes fire resistance.</i>
31	<b>Services between flats 37/36</b>  Services leading into flats 37/36 sealing with non-compliant foam and combustable pipe without intumescent seal
