ARBORICULTURAL ASSESSMENT REPORT

102 Albert Street, London, NW1 7NE

Survey Date: 13/01/2022

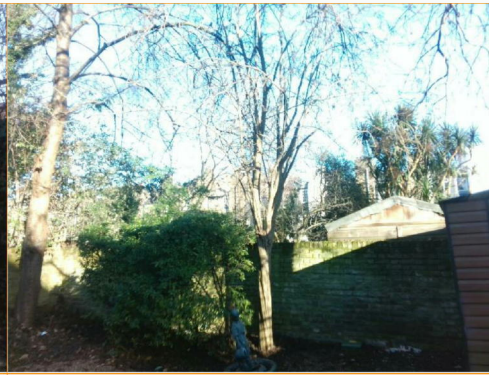
T3 - Hawthorn

Tree No	Common Name	Age Class	Condition	Height (m)	Crown Spread (m)	Stem diam. (mm)	Dist to bldg. (m)	Roots implicated	Pruning history	Recommendation	Tree work constraints	Notes	Owner address	Owner
T3	Hawthorn	Mature	Fair	8.1	4	110	14.9	N	No significant past tree works.	No work required.	Restricted access.		102 Albert Street London NW1 7NE	PH
T4	Cherry	Mature	Fair	12.7	5.0	260	14.8	N	No significant past tree works.	No work required.	Restricted access.		102 Albert Street London NW1 7NE	PH
T5	Cherry	Mature	Fair	6.3	5.0	230	9.4	N	Subject to past management.	No work required.	Restricted access.		100 Albert Street London NW1 7NE	P3P
T6	Sycamore	Mature	Fair	16.4	9.0	510	23.1	N	No significant past tree works.	No work required.	Restricted access.		115 Arlington Road London NW1 7ET	P3P

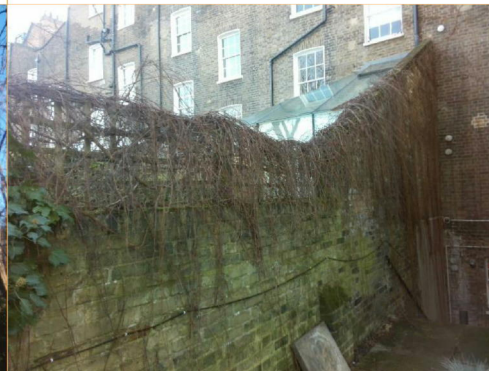
C1 - Vine

Tree No	Common Name	Age Class	Condition	Height (m)	Crown Spread (m)	Stem diam. (mm)	Dist to bldg. (m)	Roots Implicated	Pruning history	Recommendation	Tree work constraints	Notes	Owner address	Owner
C1	Vine	Mature	Fair	1.6	1.0	10*	2.6	N	Managed as a climber.	No work required.	Restricted access.		100 Albert Street London NW1 7NE	P3P
H1	Laurel (Cherry)	Mature	Fair	2.2	1.0	50	0.1	N	Managed as a hedge.	Fell and treat stump with eco plugs (broadleaved).	Restricted access.		102 Albert Street London NW1 7NE	PH
H2	Pyracantha	Mature	Fair	2.6	3.0	40	3.1	N	Managed as a hedge.	No work required.	Restricted access.		102 Albert Street London NW1 7NE	PH
T1	Sycamore	Mature	Fair	15.3	8	580	7.7	Y	Subject to past management.	Fell and treat stump with eco plugs (broadleaved).	Restricted access.		104 Albert Street London NW1 7NE	P3P
T2	Ash (Common)	Mature	Fair	16.2	9.0	520	14.3	Y	No significant past tree works.	Fell and treat stump with eco plugs (broadleaved).	Access through building. Restricted access. Parking restrictions.		102 Albert Street London NW1 7NE	PH
