## SITE INVESTIGATION FACTUAL REPORT

Report No: [REDACTED]  
Client: Sedgwick International UK - Maidstone  
Site: 102-104, Albert Street  
Camden  
Client Ref: [REDACTED]  
Date of Visit: 22/11/2021

Home Emergency Response - Subsidence Investigation - Drainage Services – Crack & Level Monitoring – Property Video Surveys

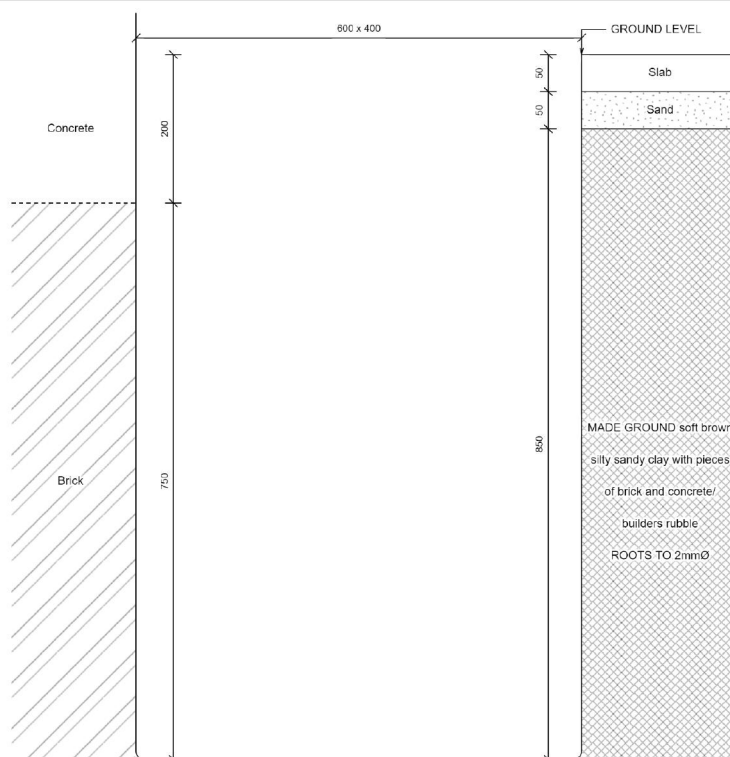
TRIAL PIT REF: TP1

For Strata below 950mm see Bore Hole log

U/S not found No samples taken tp abandoned at 950mm due to collapsing made ground. BH done to rear of tp to avoid made ground.
