—The British Museum

King Edward Building Basement Ventilation Tunnels Waterproofing Refurbishment Design & Access Statement R01

Revision	Date	Comments
0	23.03.2022	Draft Issue for Comment
01	25.03.2022	Issue for LBC Application

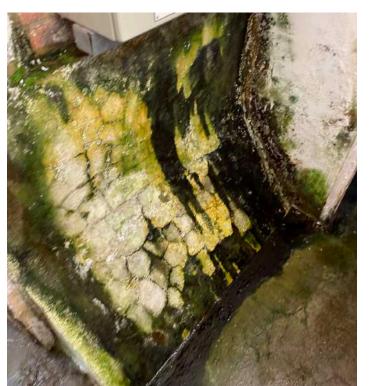
During a building inspection in December 2019, water ingress was identified within the KEB tunnels, resulting in mould and bacterial growth, and it appears that the area has been subject to historic water issues. The water ingress has also resulted in damage to electrical control systems responsible for ventilation in the tunnels and air supply to Galleries and the other KEB spaces noted above.

Photo of mould growth on floor and walls

The tunnels will be decontaminated and de-moulded using a spray application called 'Spore Clean'. This is a highly effective and environmentally safe chemical treatment which disinfects, removes stains, and restores surfaces from damage caused by mould and its chemical metabolites.

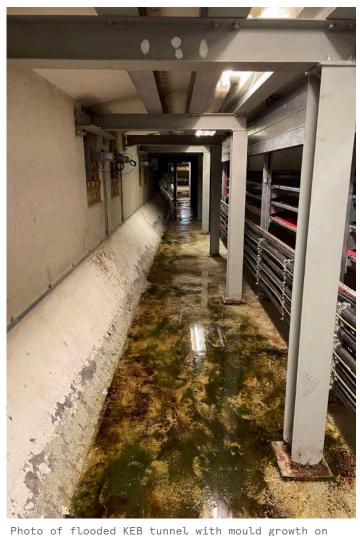
floor and walls

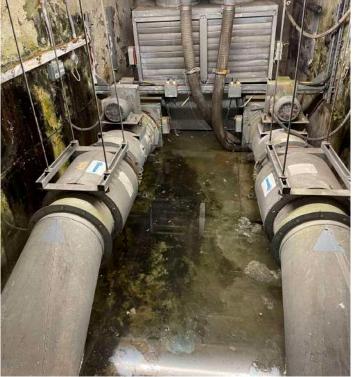
Flooded KEB tunnel with damaged air handling unit

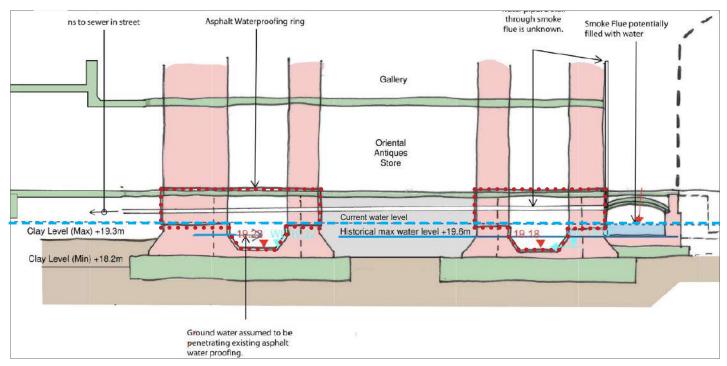
Originally the groundwater level would have been below where the waterproofing turns horizontally through the wall however, since the construction of the KEB, groundwater levels have risen in London. It has been noted that the current groundwater level varies with rainfall.

Based on information from archives of site investigations elsewhere on the museum site, the groundwater is now roughly between 0.7m-1.4m above the top of the foundations and therefore above the potential weak point in the waterproofing layers where it turns horizontally through the wall.

Sketch by Civic Engineers showing structural waterproofing and current level of ground water

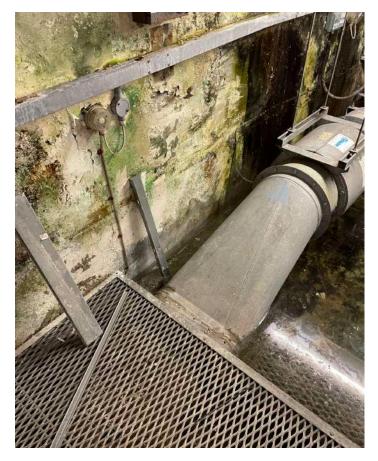
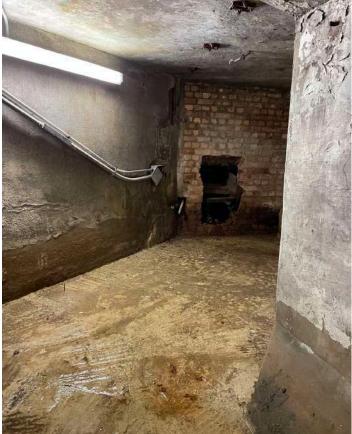
- This Type A render has also failed and much of it has become loose and friable.

Site surveys completed have noted that some of the existing Type 'A' tanking that is in place is defective or friable, and is likely to fall away during preparation of the surfaces for waterproofing. It is difficult at this stage to give an accurate assessment of the extent of this, and it will be investigated further when a contractor is appointed. Some local remedial repairs and plugging of the walls will be required where mortar in brick joints has decayed. This will be completed using appropriate lime-based mortars with approval of the heritage consultant.

Examples of areas of friable material and damaged brickwork that will require local repair

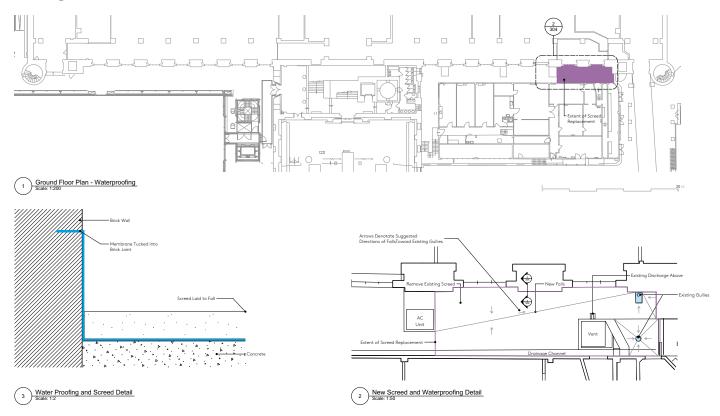
Extract from Nex drawing 304 showing the extent of screed replacement

Our proposal is to take up the existing screed and apply a new bonded waterproofing to the structural slab. A new screed will then be laid to the correct falls to direct water to the gullies.

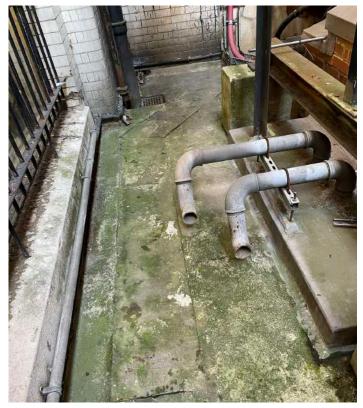
There is water penetration into the tunnels via the roof of the tunnel over the AHU units. Our inspections have lead us to conclude that this is due to the failure of the waterproofing and drainage in a small section of slab on the southeast corner of the KEB.

The problem is compounded due to the water discharge pipes from the tunnels currently pointing west, while the drainage gullies are located to the east end. The fall of the screed does not direct the water to the gullies, resulting in frequent flooding.

Photo showing area the is regularly flooded resulting in water leakage into the basement. Image shows the misalignment of the drainage gullies and water discharge pipes.
