Our Ref: SV220310-746: Mr& Mrs Holmes, Garden Flat, 37 Redington Road, NW3 7QY

T1 Oak – Background history, pruning guidance and current pruning recommendations.

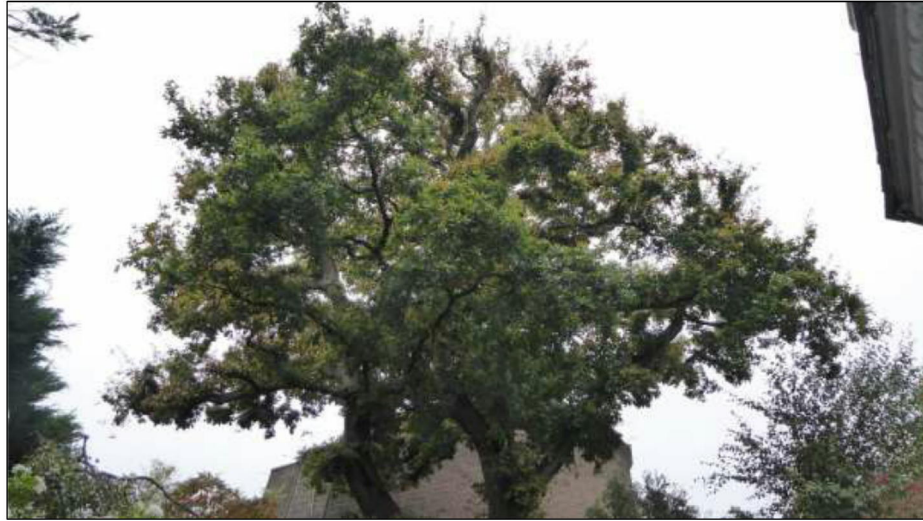
A review of the trees health and condition following the reduction works was carried out on the 06/10/2018, which showed that the tree appeared to have responded well to the extent of reduction works carried out. Whilst particular dense in some areas, the tree exhibited obvious extension growth from both the past cut points and as reactive new epicormic growth throughout the inner crown.

View from rear garden 37 Redington Road, NW3
[Image dated 08/10/2018]

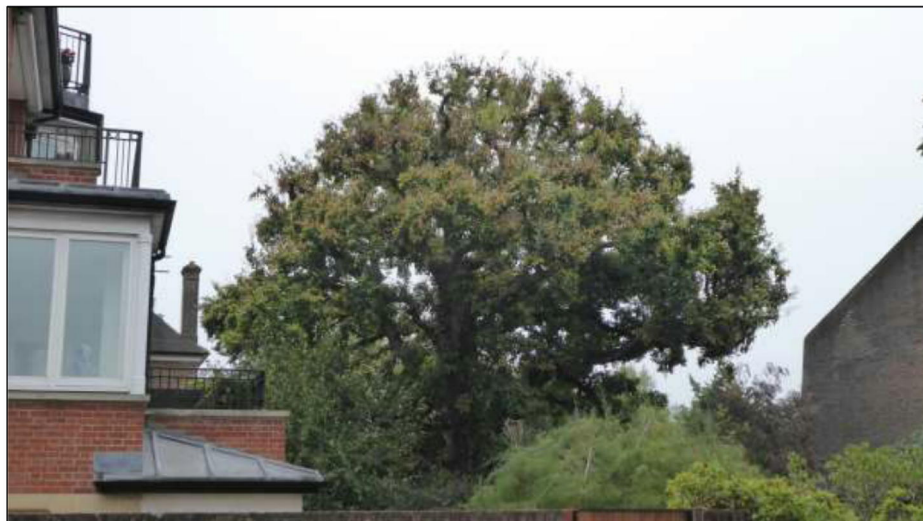
View from Oakhill Avenue, NW3
[Image dated 08/10/2018]

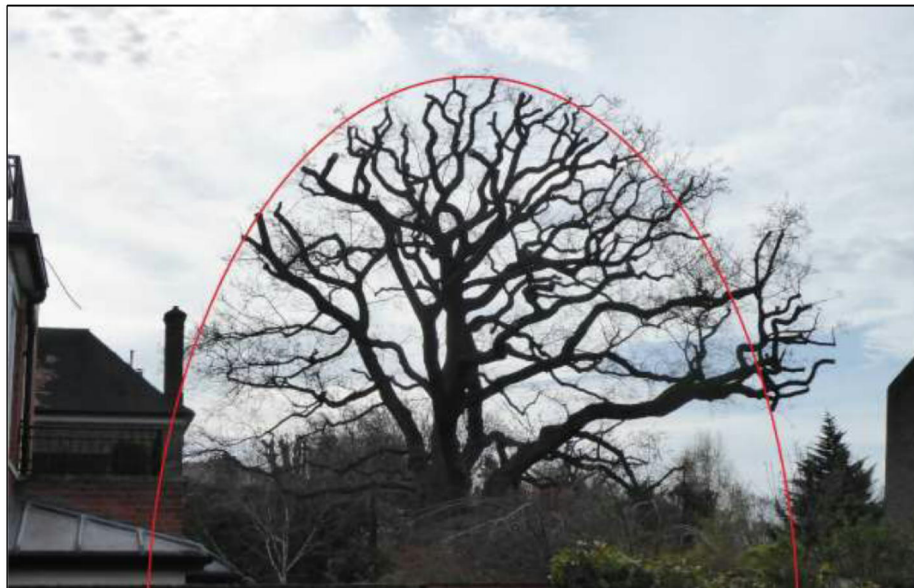
View south-eastwards from Oakhill Avenue – note: lowest south/south- westerly limb extends beyond [approx. 2.0m] the optimal crown shape.
[Image dated 17/04/2018]

Further selective crown reduction works can therefore be carried out, with a view to achieving an optimal crown outline. Targeting pruning of the above indicated portions of the crown of up to approx. 2.5m, when combined with the selective removal and thinning of emergent regrowth, will further reduce and effectively manage the crown/leaf volume – thereby managing the trees moisture uptake to be as low as reasonably possible whilst leaving the tree in full keeping with its preserved status.

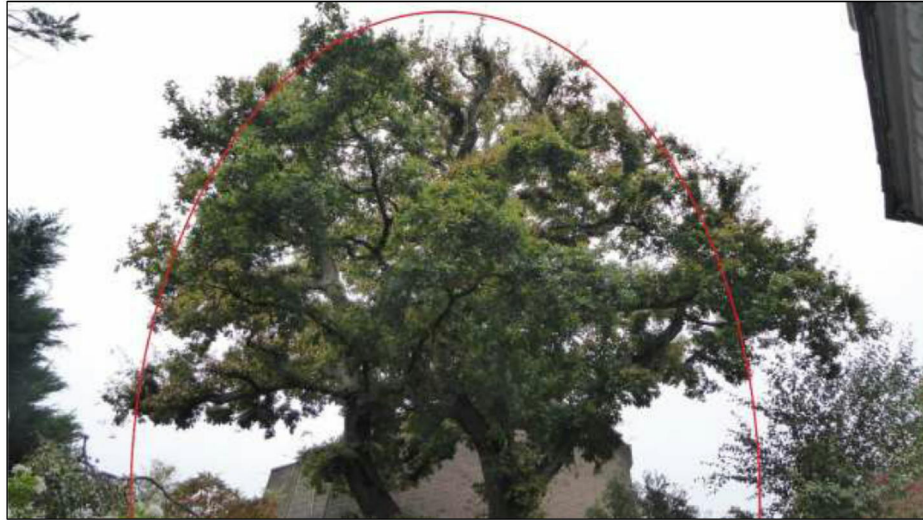
View south-westwards from rear garden 37 Redington Road – note: lowest north-westerly limb and upper easterly portions of the crown extend beyond the optimal crown shape.
 [Image dated 08/10/2018]

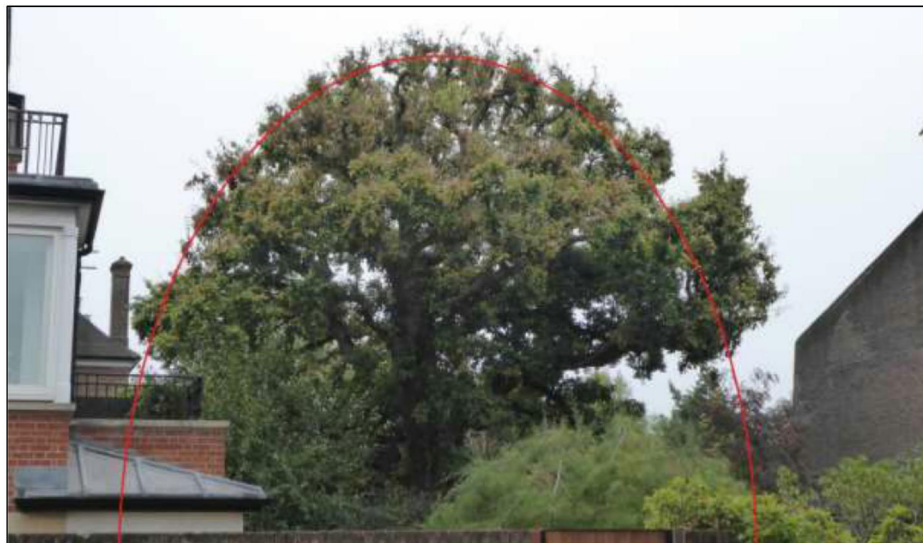
View south-eastwards from Oakhill Avenue – note: lowest south/south-westerly limb extends beyond the optimal crown shape.
 [Image dated 08/10/2018]

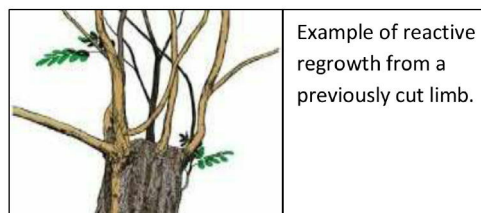
When large diameter stems and branches are cut, the effect is to prompt more vigorous [reactive] growth in order to re-grow the lost portions as quickly as possible. Often, in healthy trees, the re-growth emerges from latent buds below the bark and can, more often than not, increase the amount of branches than were previously present in a very short space of time. This effect can be seen when pollarding trees. What was once one limb with several branches, is cut and from the 'stump' grows several newly forming limbs. If these are left unchecked, they will go on to form new limbs and branches in place of the originally reduced limb -

This regrowth can be selectively removed in order to thin the density of emergent twig growth.

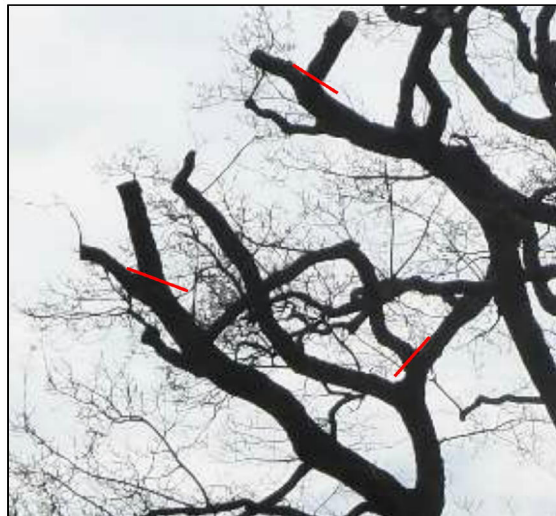
In some areas of the crown, this has led to a duplication of stumped limbs in close proximity with others. Example of this is as below -

As indicated and annotated with the red lines above, as the crown re-fills with the emergent regrowth over the coming years and in turn provides further options for where cuts can be made to suitable growth points, remaining stumps can begin to be selectively removed in their entirety.

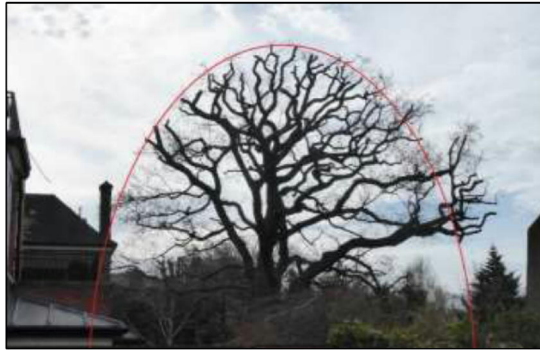
As mentioned within the opening sections of this guidance, there are portions of the crown outline which remain as extending in the region of 2.0m beyond the optimal crown outline shape. Example of this is as below -

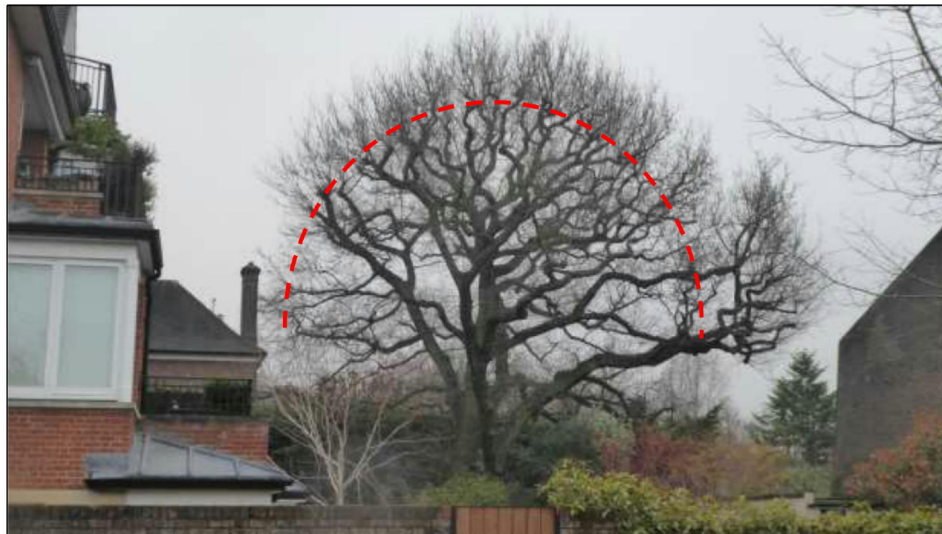
View south-eastwards from Oakhill Avenue
[Image dated 16/03/2022]

Recommendations	<p>General overall reduction of height and spread radius of up to 1.5m, focussing on selective thinning and/or reduction of regen. regrowth from previous pruning stumps,</p> <p>Combined with – Selective lateral reduction of up to 2.5m targeting misshapen crown portions to the south, south-west, and north-east [see images] to balance crown,</p> <p>Combined with – Selective removal of duplicated previous pruning-stumps in order to form idealised scaffold limb structure [see images],</p> <p>Combined with – Selective removal of inner crown reactive epicormic growth – whilst ensuring inner crown natural-growth is retained as far as possible.</p>
-----------------	---
