Arboricultural Appraisal Report

Subsidence Damage Investigation at:

Flats 1 - 9
8 Compayne Gardens
London
NW6 3DH

CLIENT: Crawford & Company
CLIENT REF: [REDACTED]
MWA REF: [REDACTED]
MWA CONSULTANT: Andy Clark
REPORT DATE: 15/09/2021

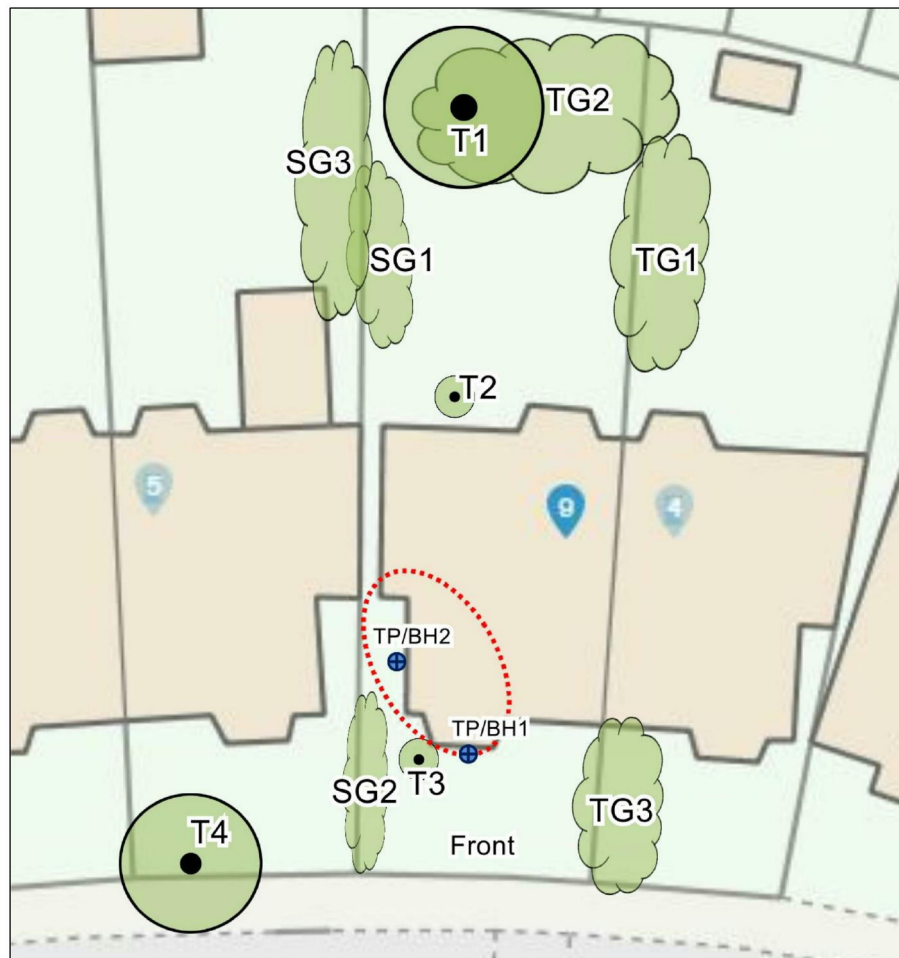
Site Plan

Approximate areas of damage

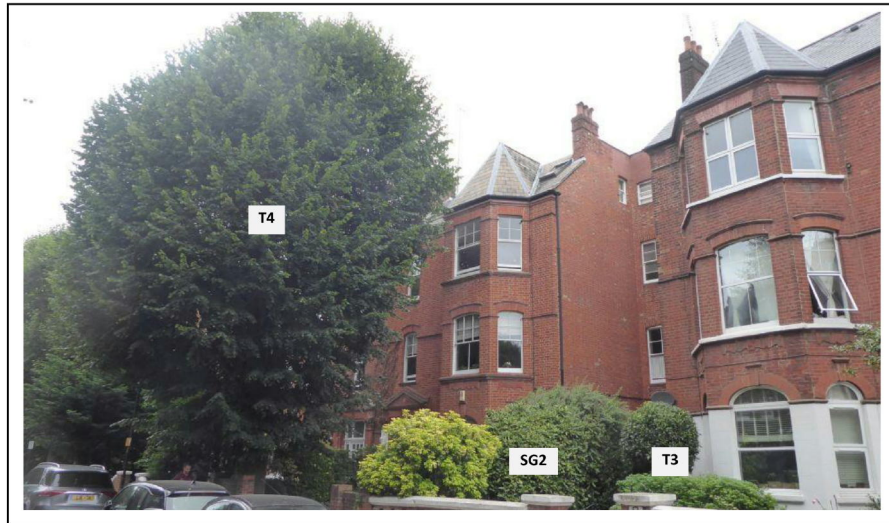
Based on the technical reports currently available, engineering opinion and our own site assessment we conclude the damage is consistent with shrinkage of the clay subsoil related to moisture abstraction by vegetation. Having considered the information currently available, it is our opinion that T4 Lime is the principal cause of the current subsidence damage, combined with a localised contributory influence from SG2 group and T3 Bay.

Overview of T4 Lime, SG2 group and T3 Bay

If an arboricultural solution is to be implemented to mitigate the influence of the implicated trees/vegetation we recommend that T4 and T3 are removed and that SG2 group is subject to significant crown reduction works in order to reduce the groups collective moisture uptake.

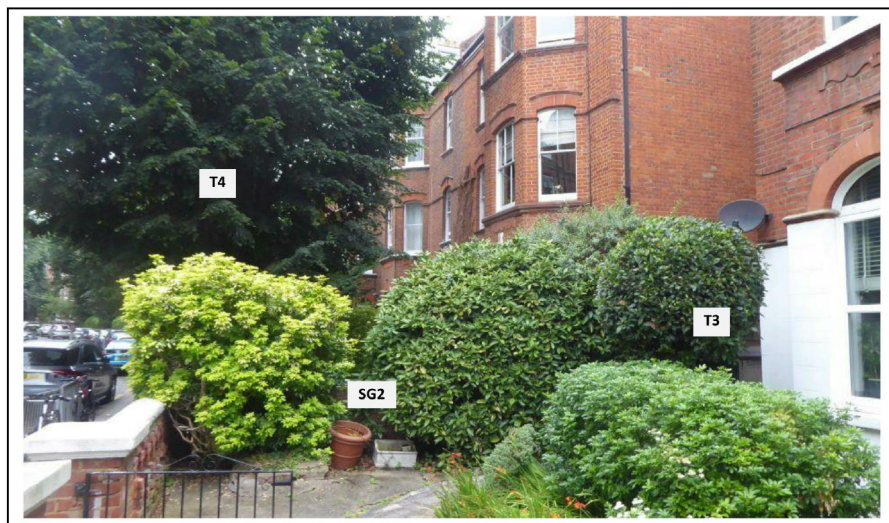
The origins of the *Tilia* spp. roots will be the Lime T4. The tentatively identified shrub. Spp. roots will be from the nearby shrubs of SG2 and T2 Bay.

View of T4 Lime, SG2 group and T3 Bay adjacent to front left corner of the building

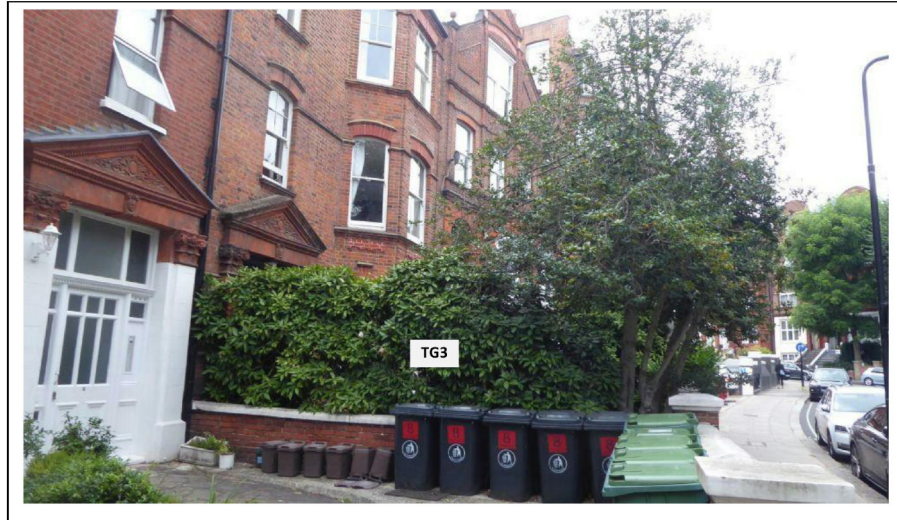
View of TG3 group

Management history		No significant past management noted.					
Recommendation		None at present.					
TG3	Aucuba, and Holly group	6.5	220	3.0	0.6	Younger than Property	Third Party 6 Compayne Gardens NW6 3DH
Management history		Subject to past management/pruning - appears regularly pruned.					
Recommendation		Reduce height of group to 2.0m and cut back sides to leave crown spread of no more than 1.0m. Trim thereafter on an annual cycle to maintain at broadly reduced dimensions.
