TECHNICAL REPORT ON A SUBSIDENCE CLAIM

Deltamist Limited
Flats 1 - 9
8 Compayne Gardens
NW6 3DH

4th May 2021

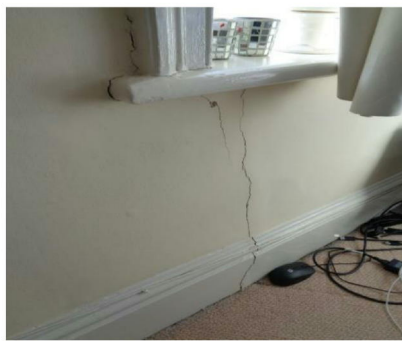
Cracking beneath the front window in flat 3

Crack to left hand side of bay window below cill extending through the skirting board approximately 3mm width and hairline crack over window.

Crack over right corner of bay window extending to right hand return wall at a width of 3/4mm.

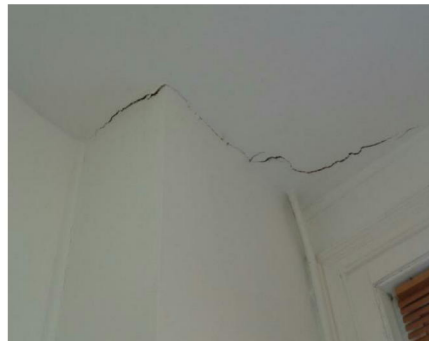
Cracking to the bathroom in flat 4

Vertical crack approximately 5mm wide from floor to ceiling and around wall ceiling junction to front corner (at front projection junction).

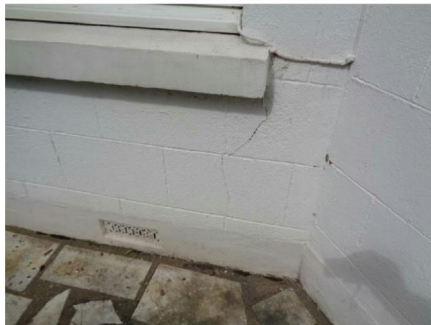
Cracking to the right side of the front bay

Crack below right corner of ground floor bay cill at a width of approximately 1mm.

Crack to right hand side of ground floor bay cill but were also noted to the first floor central bay cill.

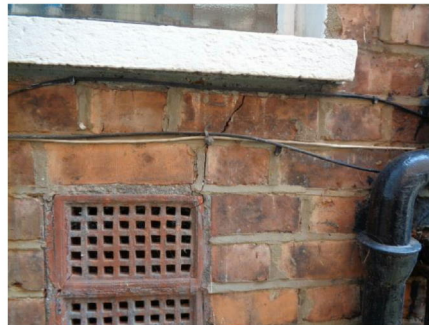
Cracking to the left elevation below the foremost window

Crack below ground floor bathroom window at a width of 3mm extending through an air brick.

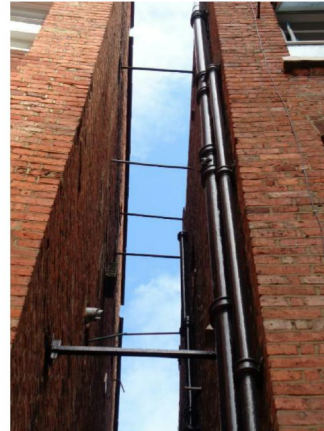
Significant historic bow in the flat wall at high level which has been historically retained by steel bars spanning between the subject property and No. 10 Compayne Gardens. This has been in place for well over 20 years.

We also noted some quite significant deflection of the flank wall at high level. This is clearly an historic problem due to lateral restraint issues with the masonry. Attempts have been made to support the deflection in the past by installing steel bracing between the subject property and the adjoining property at No. 10 Compayne Gardens.

Deflection of the flank wall showing
bracing bars in place

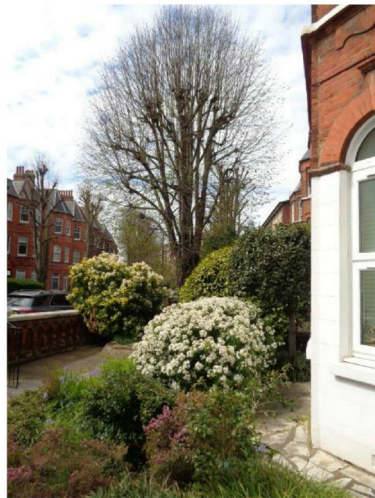
The timing of the event, the presence of shrinkable clay beneath the foundations and the proximity of vegetation where there is damage indicates the shrinkage to be root induced. This is a commonly encountered problem and probably accounts for around 70% of subsidence claims notified to insurers.

Vegetation close to the front left corner

We have instructed a contractor to undertake ground investigations to include trial pits and boreholes and a CCTV survey of underground drains. This will enable us to confirm the cause of the damage and recommend appropriate mitigation measures.

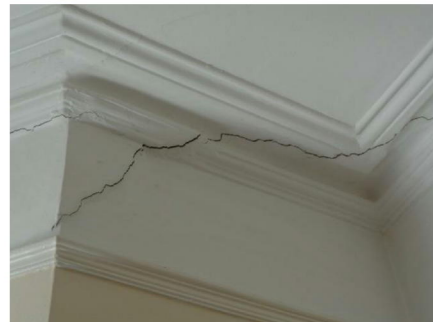
Typical internal damage
