## Subsidence Risk Assessment

Leverton & Sons Ltd  
212 Eversholt Street  
Camden  
London  
NW1 1BD

JPL/210310/Ra

Submitted on 18<sup>th</sup> November 2021

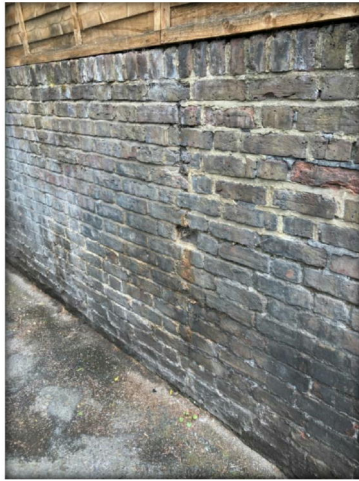
| Tree No. | Species | DBH (mm) | Height (m) | Crown Spread (m) | Age | Vitality | Condition |
|---|---|---|---|---|---|---|---|
| T01 | Common Lime<br>( <i>Tilia europaea</i> ) | 550 | 9.0 | N: 2.5<br>E: 1.0<br>S: 3.0<br>W: 3.0 | EM | Good | <ul style="list-style-type: none"> <li>Third party tree.</li> <li>Access prohibited, measurements estimated.</li> <li>Single stemmed specimen with crown break forming at 3m.</li> <li>Recently pollarded, adequate regrowth.</li> <li>No observable defects.</li> <li>Slight bowing of brick masonry wall, adjacent to tree, attributed to direct damage.</li> <li>Cracks present within mortar, attributed to lateral movement.</li> </ul> |

We identified during our site visit, various cracking and deformation to the eastern brick masonry boundary wall adjacent to trees; T01, T02 – Common Lime, T03 – Silver Birch and T05 – Common Lime, please view Figures 4 to 7 below for further information.

Figure 4: Photograph Of Damage Visible To Eastern Flank Wall, Adjacent to T01 – Common Lime.

Due to the damage caused to the eastern brick masonry boundary wall and ongoing issues related to direct damage, we consider that the wall will in time need to be replaced entirely.

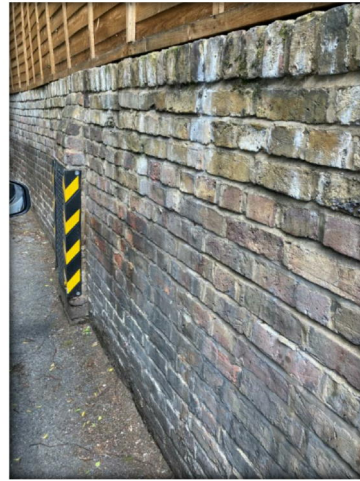
| Tree No. | Species | DBH (mm) | Height (m) | Crown Spread (m) | Age | Vitality | Condition |
|---|---|---|---|---|---|---|---|
| T02 | Common Lime<br>( <i>Tilia europaea</i> ) | 300 | 8.5 | N: 2.5<br>E: 2.0<br>S: 0.0<br>W: 1.0 | EM | Good | <ul style="list-style-type: none"> <li>Third party tree.</li> <li>Access prohibited, measurements estimated.</li> <li>Single stemmed specimen with crown break forming at 6m.</li> <li>Recently pollarded, adequate regrowth.</li> <li>No observable defects.</li> <li>Bowing of brick masonry wall.</li> <li>Vertical crack present within wall adjacent to tree.</li> </ul> |

Figure 5: Photograph Of Damage Expressed To Eastern Flank Wall, Adjacent to T02 – Common Lime.

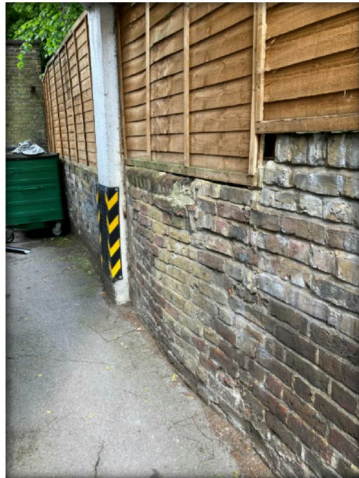
Figure 6: Photograph Of Damage Expressed To Eastern Flank Wall, Adjacent to T03 – Silver Birch.

We consider that T03 – Silver Birch, whilst is categorised as a low water demand tree is the greatest contributing factor associated with the subsidence expressed to 212 Eversholt Street, by virtue of its close proximity to the concrete supporting pillar, measured to be approximately 2.0 metres away. We do not consider a pruning specification compliant with BS: 3998 (2010) *Tree Work – Recommendations* would be effective in reducing the trees Zol, as such we prescribe the trees removal.

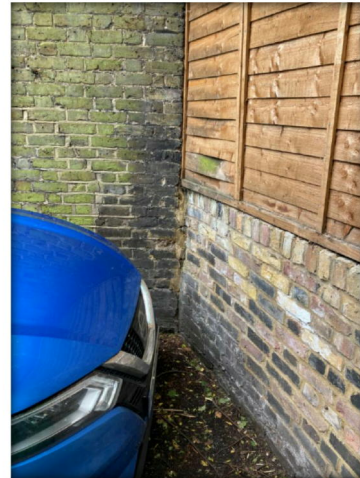
Figure 7: Photograph Of Damage Expressed To Eastern Flank Wall, Adjacent to T05 – Common Lime.

Trees T05 and T06 – Common Lime must now be pollarded, to reduce the trees Zol and thus reduce their potential to cause damage, ideally as soon as practically possible. Please note all these trees are subject to statutory protection, by virtue of them being located within a Conservation Area, as such a Section 211 Notice must be served upon the London Borough of Camden in the first instance.
