**BS5837:2012 ARBORICULTURAL REPORT AND TREE
SAFETY ISSUES, LAND AT 93 REDINGTON ROAD, NW3**

29 April 2022

Clients: Elena Dembovskaya and Lutfi Vala

Alan Engley

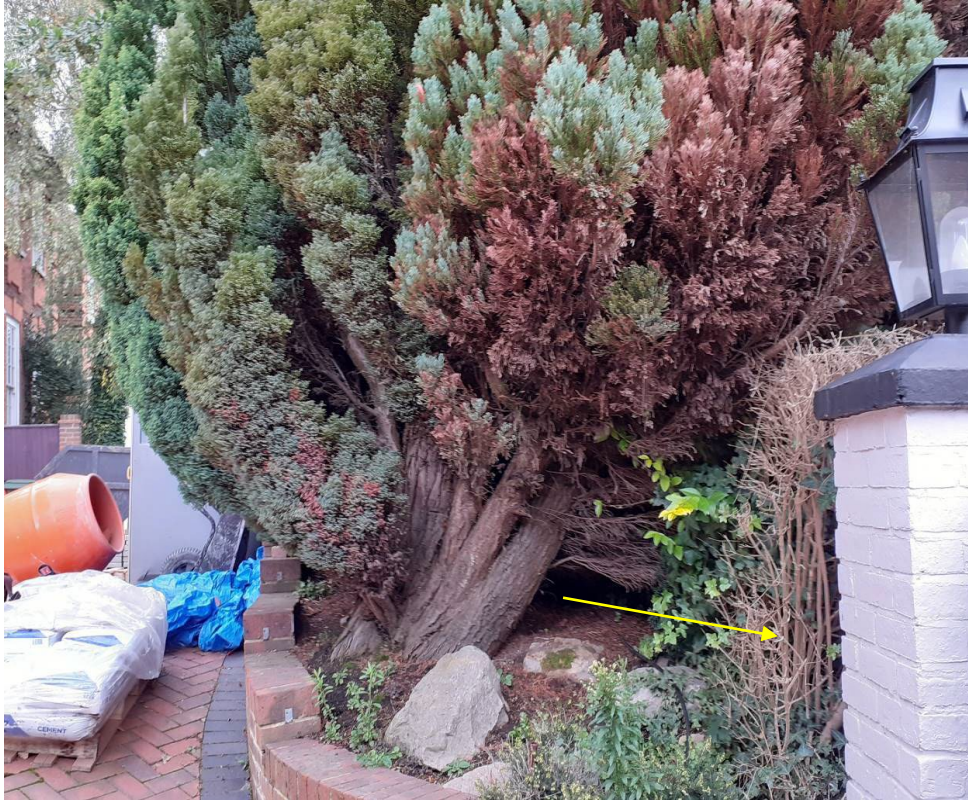
(Picture 1)

The front garden contains a rapidly deteriorating diseased Cypress G19, almost certainly due to root disease, in all probability Honey fungus.

Picture 1 viewed facing northeast from the driveway to no 93 with the front of the dwelling to the left of the camera; note the light and dark brown foliage of G19 indicates the progressive nature of a soil borne root disease, combined with the dead golden privet hedge (Yellow arrow) sometimes an indicator of root pathogens, suggest 'Honey Fungus' (*Armillaria mellea*). As the most likely culprit; I recommend tree felling, stump cutting and planting a replacement disease resistant specimen, such as a Yew tree.

- 4.10 T16 has a multi-stemmed upper canopy typically beginning to 'pull away' from the centre; I recommend modest crown reduction and re-shaping. G19 has the diseased tree; I have recommended its felling and retaining the nearby companions, followed by mitigation tree planting within the roadside border.
- 4.11 The modest pruning within the front garden will be barely noticeable; G19 has no attractive or positive amenity benefits; therefore its removal

6.2 Within the front garden, following tree felling, power stump cutting and backfilling using good quality topsoil, it is proposed to plant 3 disease resistant Yew cultivars within the same border. It should be expected that healthy young Yew trees will be very resistant to disease attack.
