25th April 2022

## **Health & Safety issues associated with access to 82 Fitzjohn's Avenue, Hampstead, London, NW3 6NP**

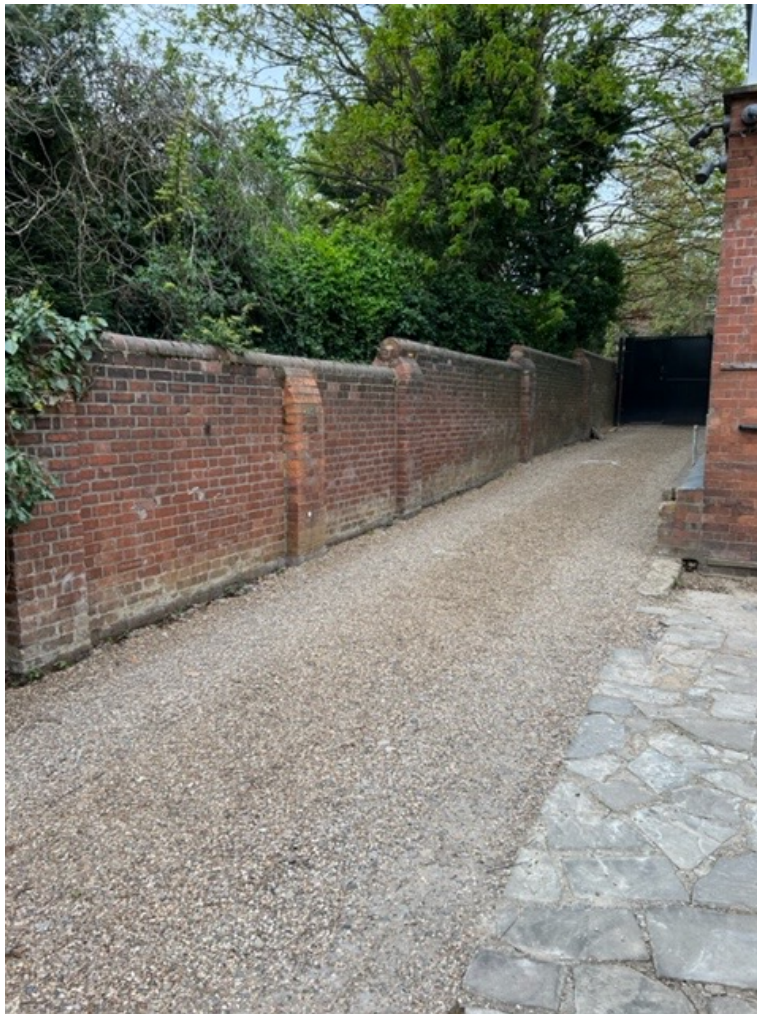
The red brick wall that creates a 'pinch' point for vehicles removing waste and delivering materials is shown in the photography below.

**View of the boundary wall across the access driveway**

The architect's and heritage consultant's proposal is to carefully dismantle this wall, salvaging bricks and carefully re-building it to match at the end of construction. This has been challenged by Camden Council's Conservation Officer on the grounds that the wall is within the Hampstead Conservation Area, is attractive, and over concerns regarding the quality of its reinstatement.

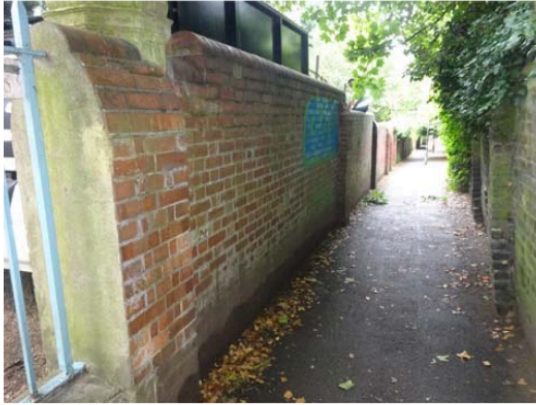
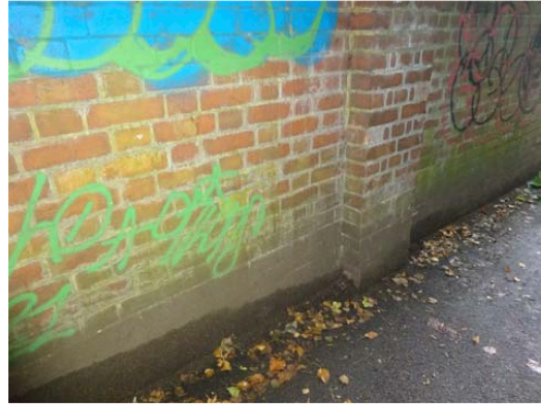
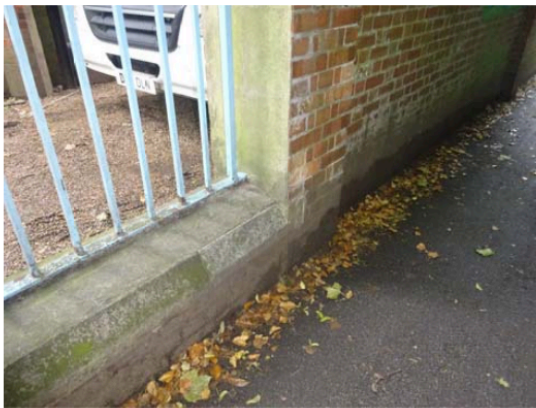
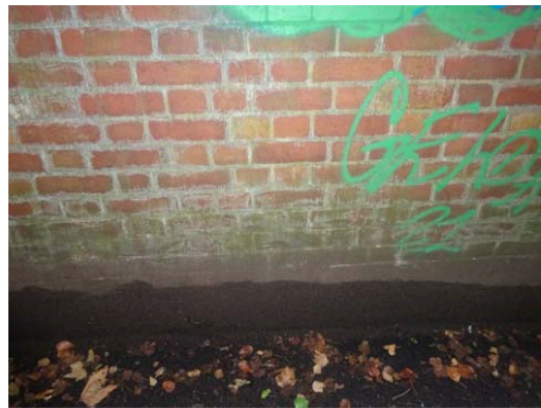
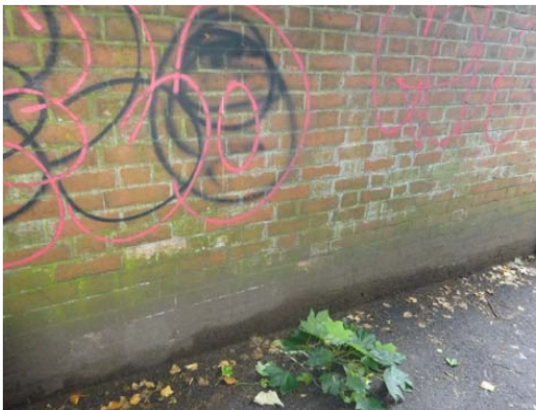
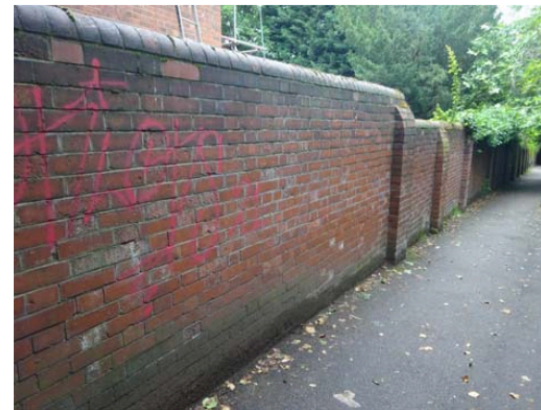
**View of boundary wall seen from Spring Walk**

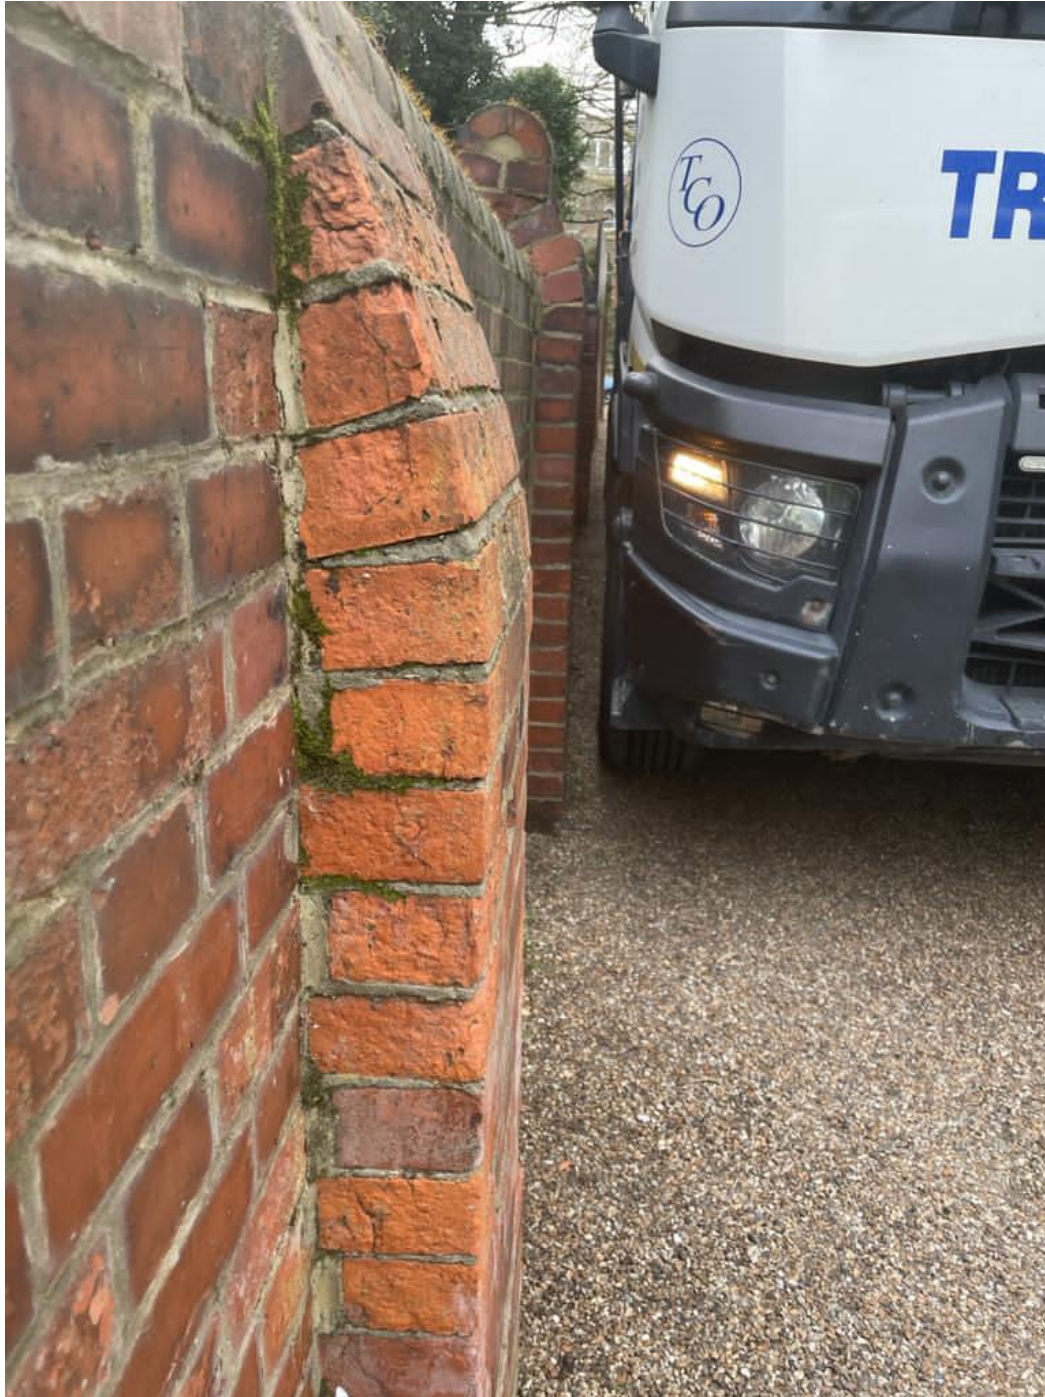
For efficient programming of the Phase 1 work Trenchco Ltd propose the use of a HIAB 'grab' lorry for the removal of waste and spoil: these vehicles are 2.49m wide giving 5cm clearance to either side of the driveway. Additionally, there is insufficient space on the site to turn vehicles meaning the it is necessary for the vehicles to be reversed into the site (under the supervision of a banksman).

**Proximity of a construction vehicle to the Spring Walk boundary wall**

The use of a banksman to supervise vehicles accessing the site cannot guarantee the wall will not be struck given the margin for error of only 5cm to each side of the vehicle. This is not a suitable safety margin – human factors and the lack of tolerance could lead to a vehicle impact to the wall – however this can be substantially improved by dismantling the wall.

To avoid the risk of the boundary wall collapsing and injury to pedestrians, the wall should be carefully dis-assembled, salvaging bricks where practicable, and the bricks stored on site. A timber hoarding can then be erected along the boundary wall providing greater width for access and providing a boundary treatment that is not subject to collapse.

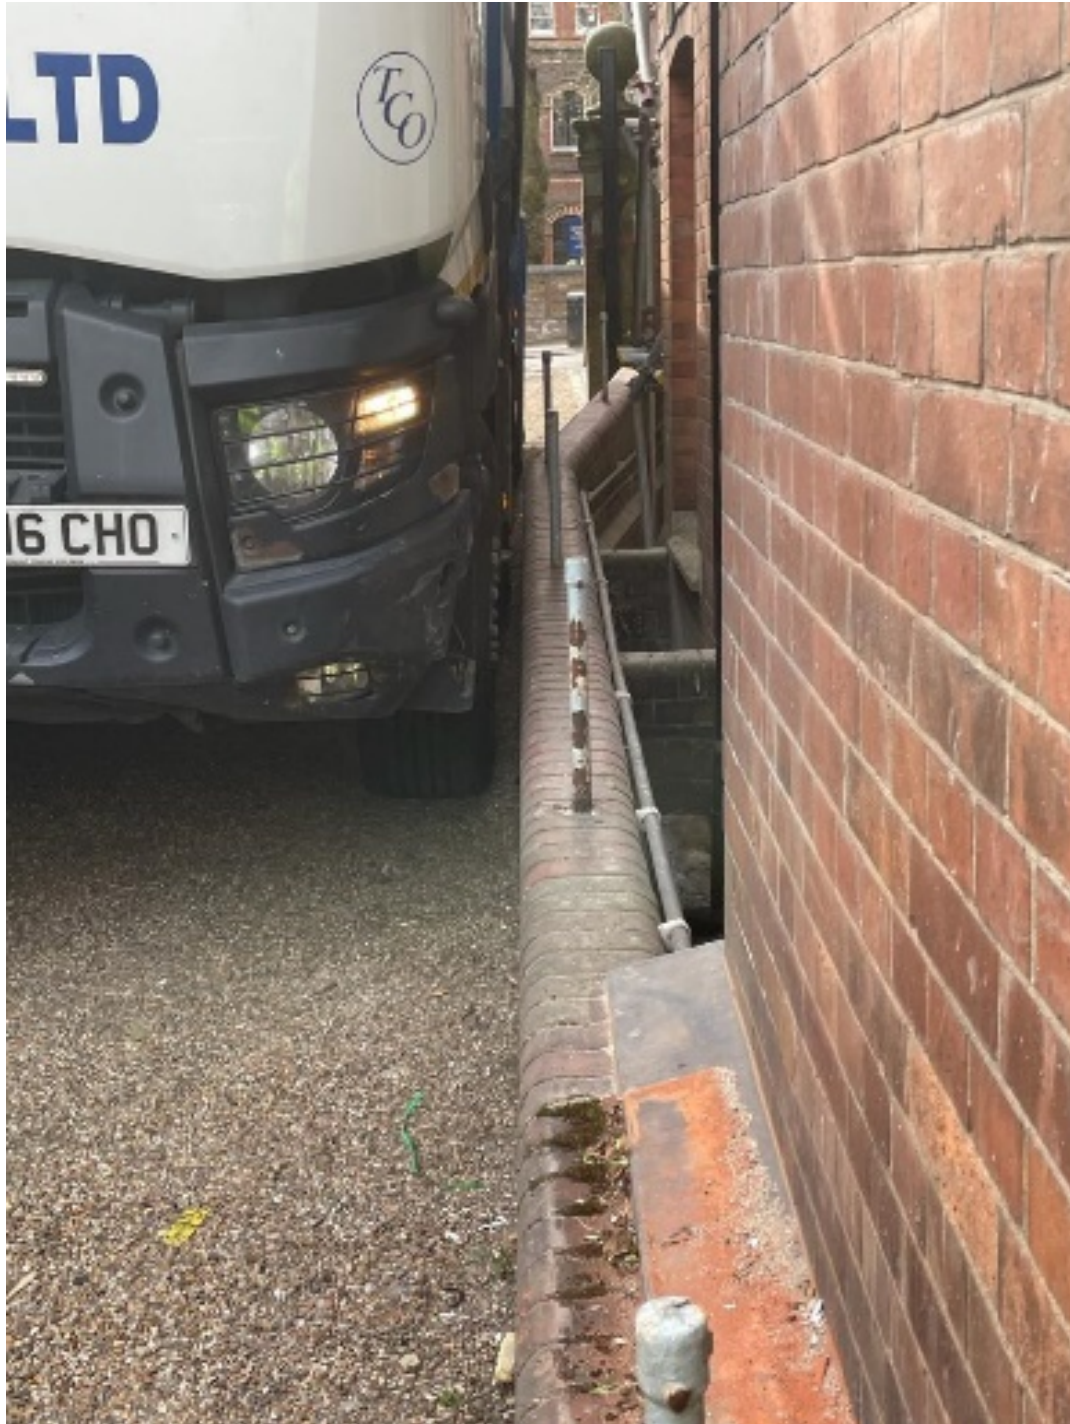
**Proximity of a construction vehicle to No 84 Fitzjohn's Avenue**

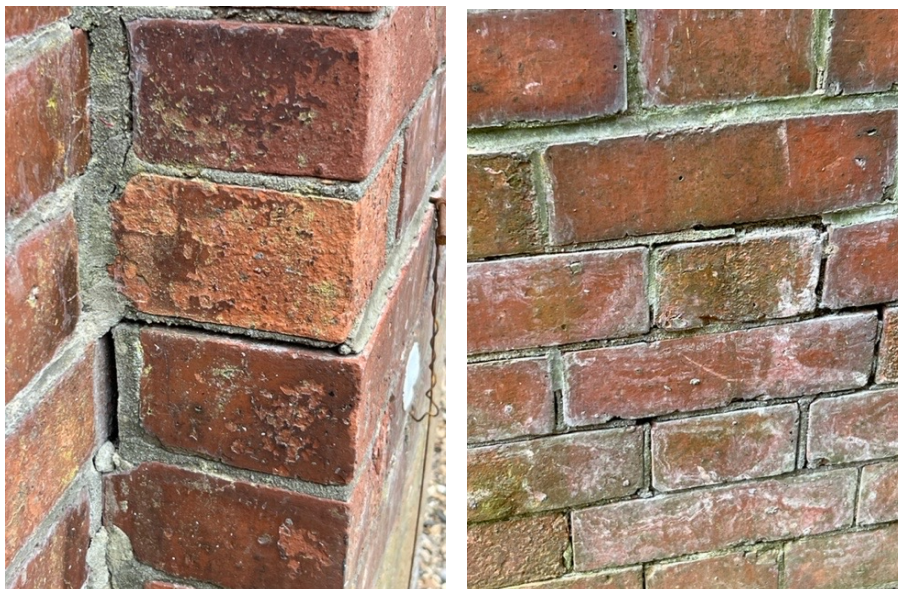
The wall has a number of cracks and defects that would indicate movement has taken place prior to works commencing on site. These weaken the structural stability of the wall.

### Existing cracks and open joints
