Design and Heritage Statement: Repairs to Cellar underneath front steps: 17 John Street, London WCIN 2DE

Client: Mr and Mrs Graham Date: 5th May 2022 Prepared by Paul Latham, AABC The Regeneration Practice Unit 190a New North Road Islington, London N1 7BJ

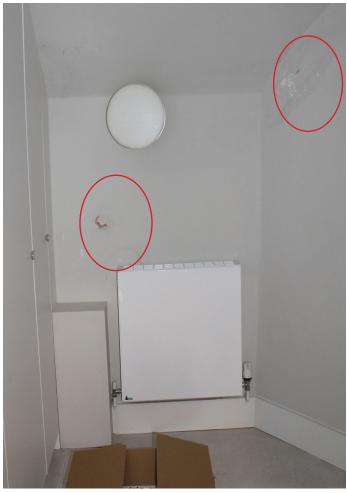
Damp has caused a breakdown of paint finishes to the front cellar under the steps (Figure 3). The cause is water ingress following shrinkage cracks which have appeared to the front, Bathstone-clad steps (Figure 4). This movement is probably related to shrinkage of the front wall following release of trapped moisture after successful replacement of inappropriate hard cement pointing with traditional non-hydraulic lime pointing last year (LB Consent 2021/3575/L dated 24-8-21).

Figure 3: Internal damp

It is believed the existing cellar is water-proofed in hard cement render skimmed in Gypsum plaster. Wholesale removal will damage historic brickwork. A local repair using compatable modern materials is therefore proposed;

- i) Cut out live pointing and repoint steps in Pre-mixed Fat Lime Mortar (London): https://www.lime. org.uk/products/lime/mortars/pre-mixed-non-hydraulic-lime-mortars/pre-mixed-fat-lime-mortarlondon.html
- ii) Open up modern render finishes internally from the affected cellar walls following careful removal of services and/or protection of joinery. Leave for a minimum of 6 months to dry out.
- iii) Repair existing tanking in Sika Nr.1 system in accordnce to manufacturers recommendations. Redecorate in a breathable paint for example Farrow & Ball Estate Emulsion.

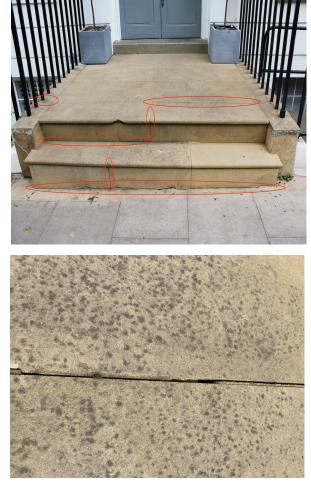
Figure 4: open joints in Bathstone steps
