**ARTEMIS
TREE
SERVICES**

Site
76 Lawn Road
London NW3 2XB

11th May 2022

Decay Detection DD-24430

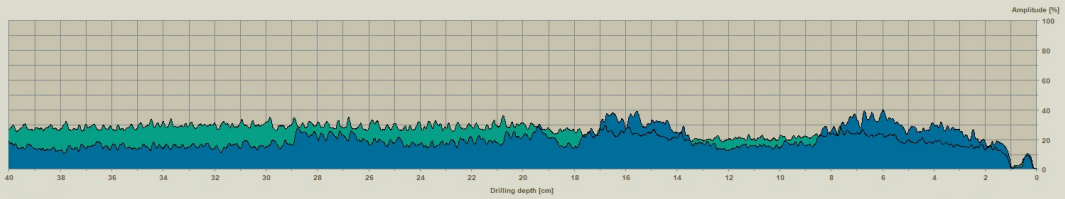
Measurement no.: 1 Speed : 2500 r/min Diameter: 58.00 cm
ID number : T1 W 3m Needle state: --- Level : 3m
Drilling depth : 40.10 cm Tilt : --- Direction: West
Date : 11.05.2022 Offset : 69 / 362 Species : Syammore
Time : 09:04:28 Avg. curve : off / off Location: 76 Lawn Road
Feed : 50 cm/min Name :

Tree ref.	Drill no.	Position	Interpretation
T1	1	3m West	Typical amplitude for sound wood. Peaks in amplitude indicating increase wood density and higher penetrating resistance in these areas.
T1	2	2.5m West	Typical amplitude for sound wood. Peaks in amplitude indicating increase wood density and higher penetrating resistance in these areas.
T1	3	2m West	Typical amplitude for sound wood. Peaks in amplitude indicating increase wood density and higher penetrating resistance in these areas.
T1	4	Ground level North	Typical amplitude for sound wood up to 27.5cm depth. Drop in amplitude between 27.5cm and 33cm depth, indicating area of localised decay.
T1	5	Ground level South	Typical amplitude for sound wood.
T1	6	Ground level West	Typical amplitude for sound wood.

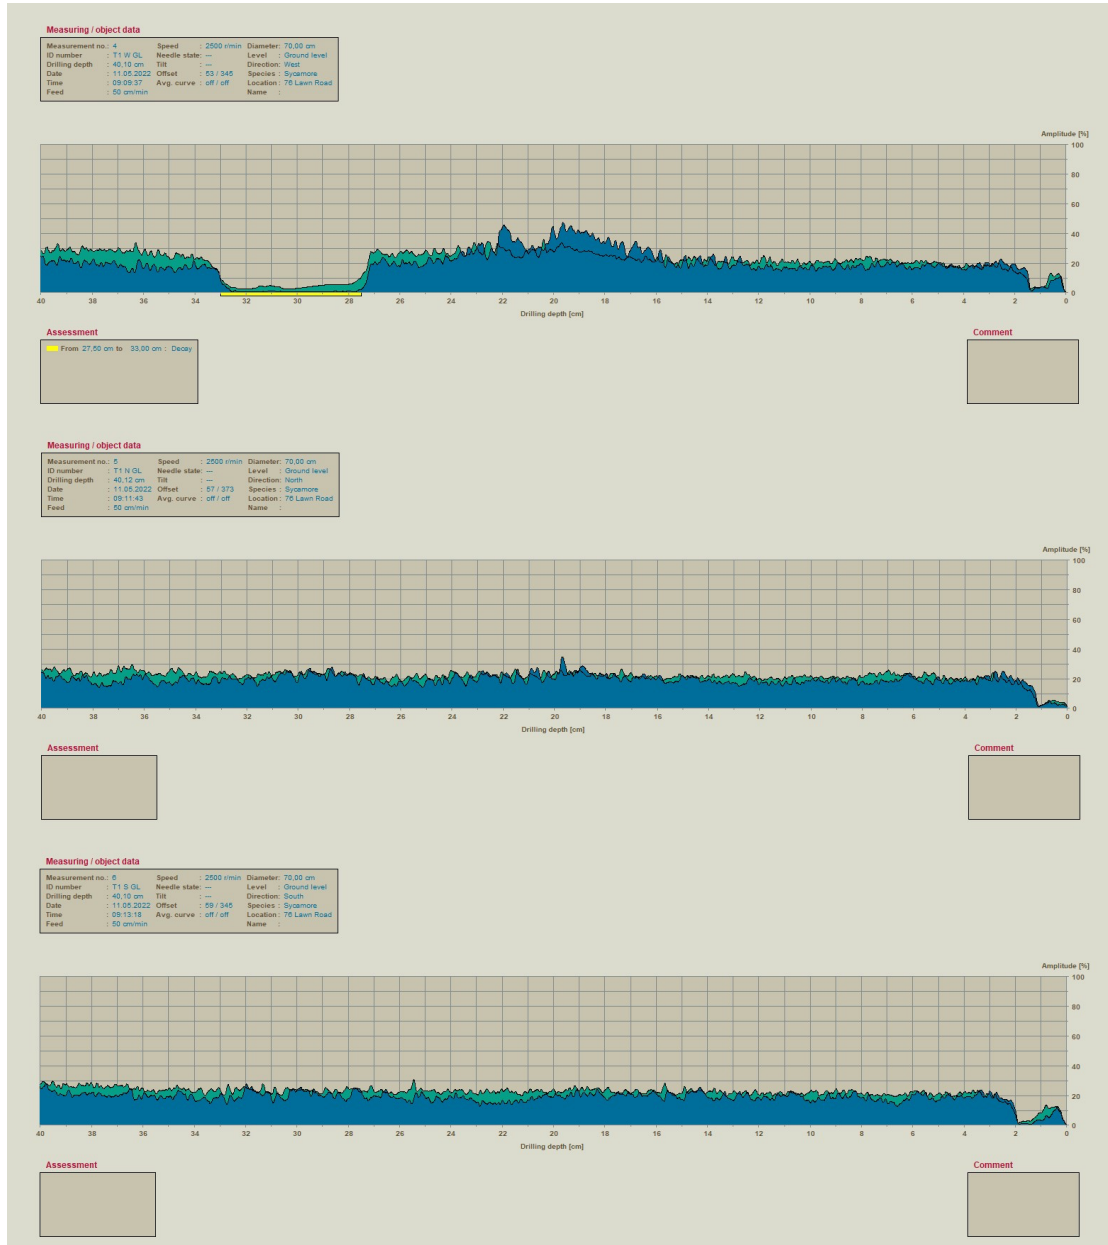
Appendix 2

A small area of localised decay has been identified in the centre of the trunk at ground level. The remaining sound wood around the localised decay is approximately 26cm thick.

7.1 No work required
