11 Doughty Street, London WC1N 2PL

DEVISE ENGINEERS

Structural engineer's report and feasibility

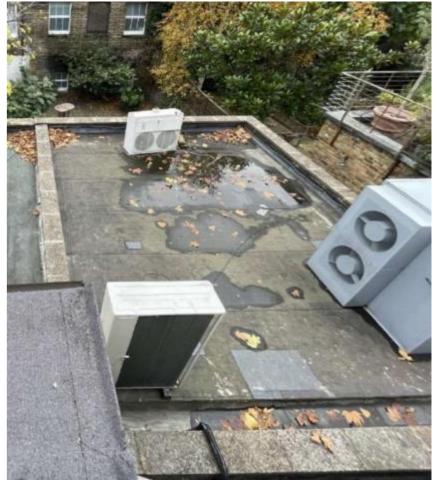
Figure 2: View of rear extension

Beyond the main volume of the property is a single storey extension with a flat roof which is of more recent construction.

No significant structural defects were observed to the single-storey rear extension.

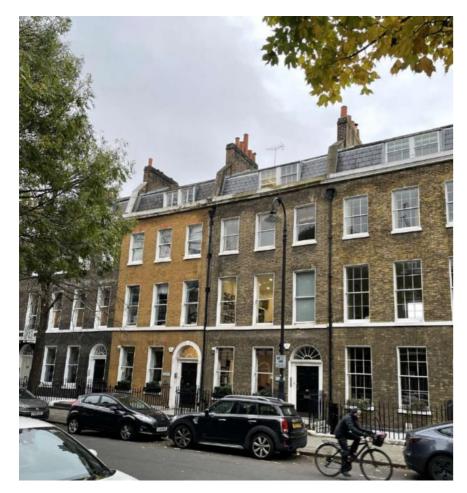
Figure 3: Front Elevation

The front elevation appears to be in reasonable condition and comprises of rendered up to ground floor with exposed brickwork above and a tiled mansard roof at fourth floor level.

Some slight staining to the brickwork below was observed and some spalling to the brickwork seen but no significant structural defects were observed.

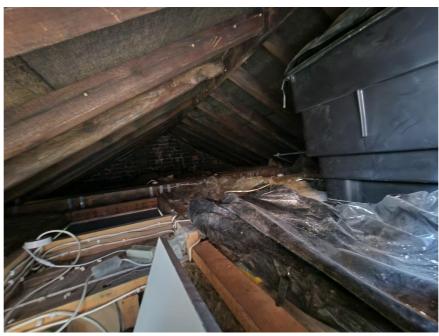
Figure 4: Existing Roof Construction

The main roof rafters are 95x65 timbers at c.440mm centres with central ridge board.

There are signs of historic water ingress, and some local areas of damp however no significant structural defects were observed in the areas that were accessible.

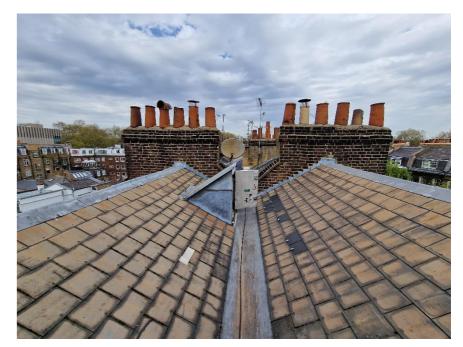
Figure 5: Existing Roof Construction

Strengthening works have been carried out to support the water tank within the roof space. These works include the addition doubled up timber joists positioned above the existing loft floor construction.

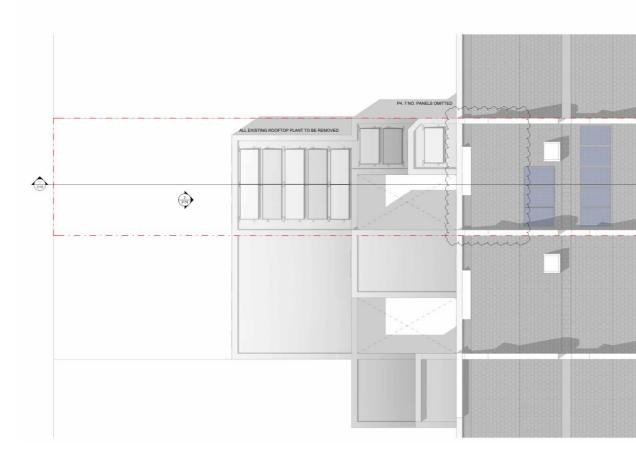
Figure 6: Proposed Roof Plan

Calculations carried out in the critical roof area (see Appendix II) confirm that the existing roof construction is capable of supporting the proposed panel layout without additional strengthening works.

The construction of the rear extension flat roof was not accessible though given the roof currently houses plant, which is to be removed, it will have adequate residual capacity for the proposed panels.

The photovoltaic panels proposed generally seem achievable as long as they are installed by a suitable contractor to the manufacturers specifications.
