The Frontage Building -

Feasibility appraisal for re-use/demolition

20/05/2022

GOSHCCC-BDP-ZZ-ZZ-RP-A-2000-0048

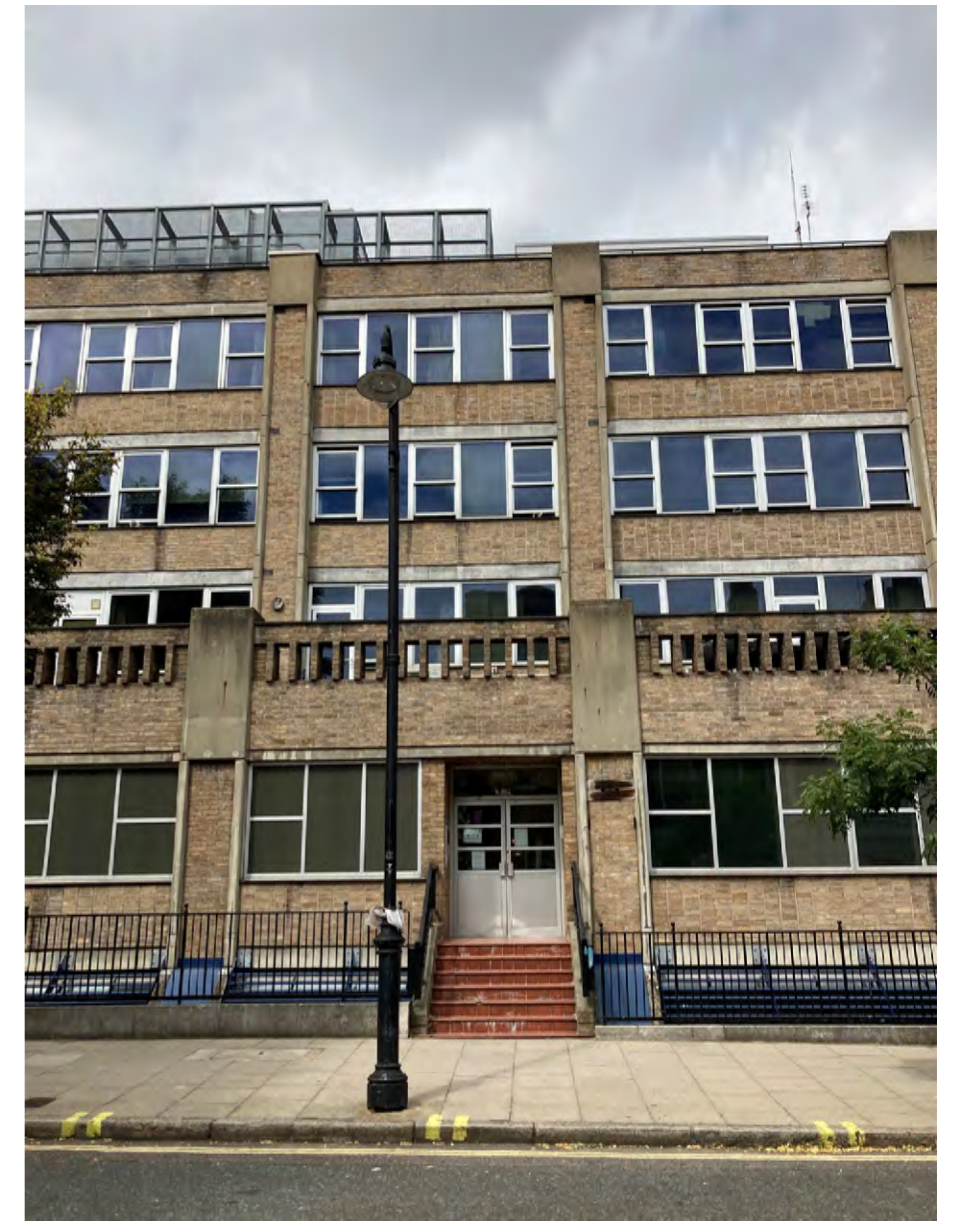
Stepped access and blanked windows to the existing Frontage Building

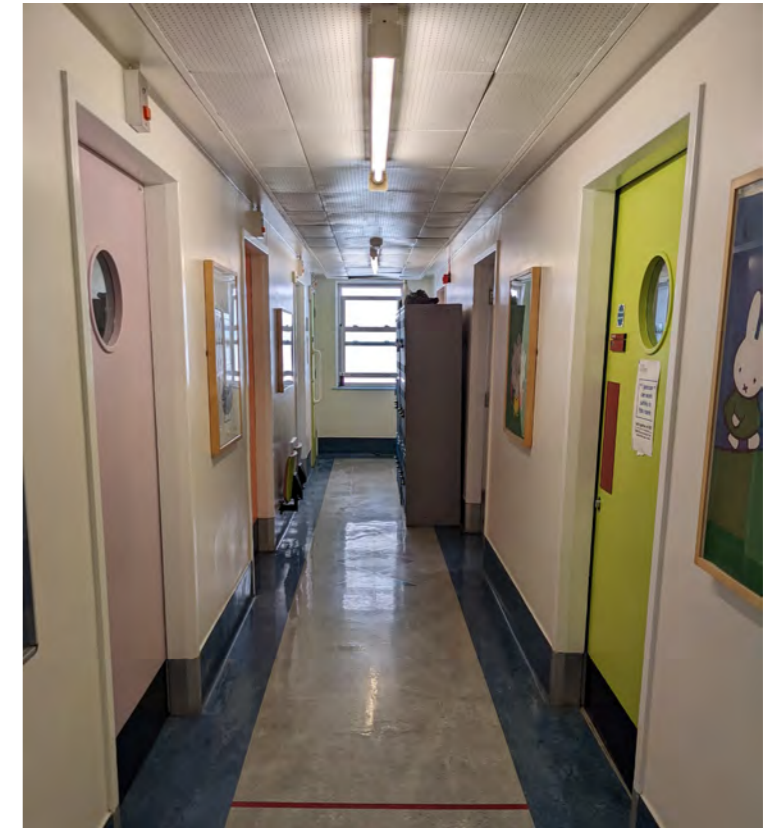
Dated and inefficient light fittings

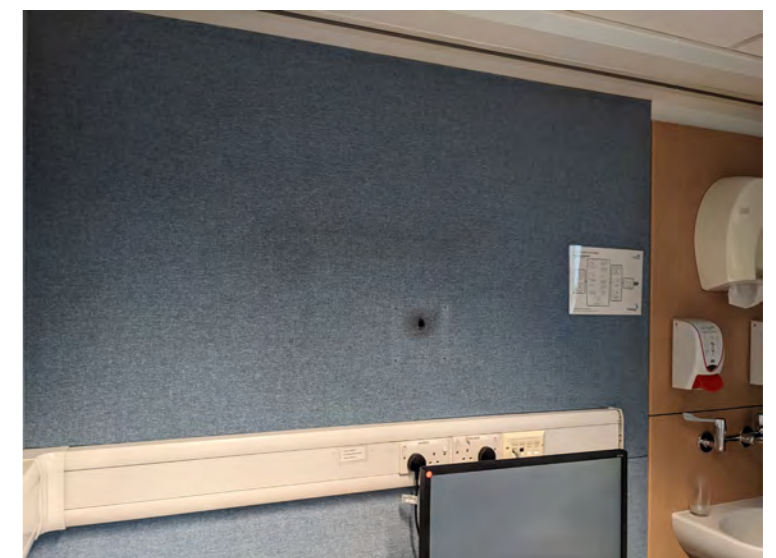
ad hoc electrical services - replacement of fuse boards required to comply with British Standards

- Replacement of the hot water system pumps within the next 5 years;
- Replacement of corroded pipe work throughout the building;
- Replacement of fuse boards in the low voltage switch room to ensure they comply with current British Standards;
- Replacement of the lighting system in the building with LEDs to create a more energy efficient solution;
- Other remedial repair work required in a building of this age including flooring, walls and ceiling repair and replacement.

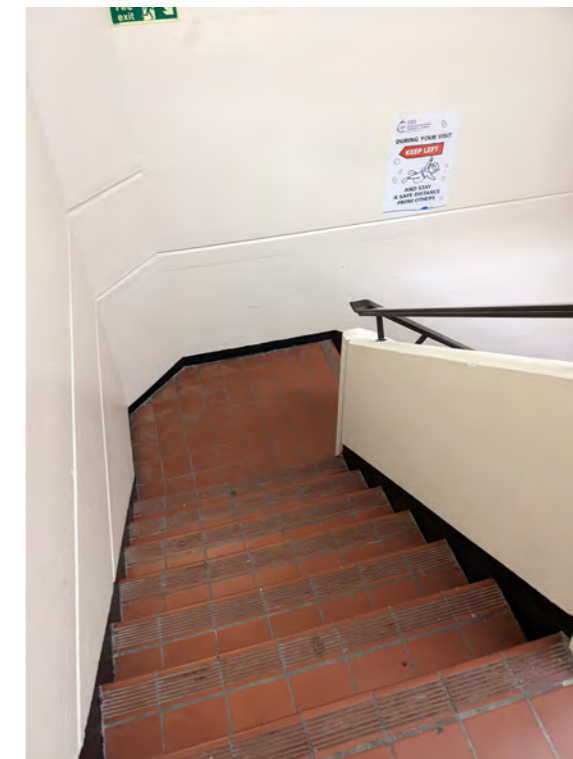
Image of narrow stairs unsuitable for bed movement

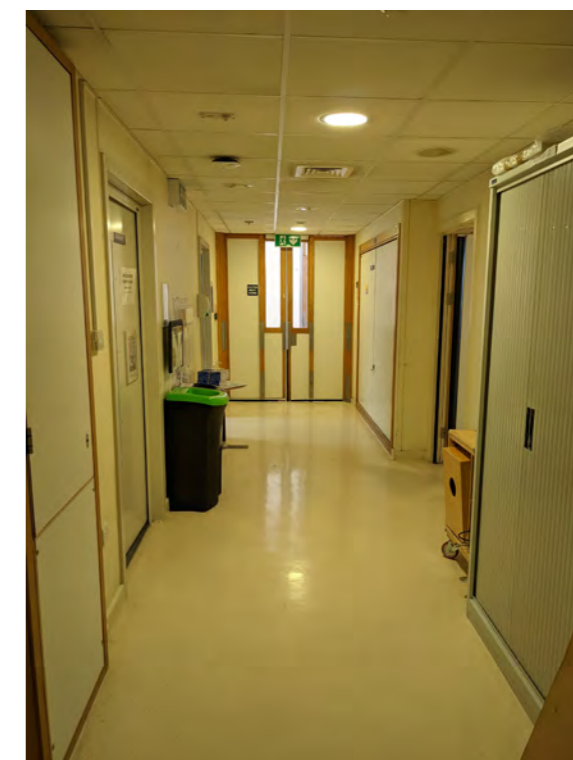
Central corridors without access to daylight

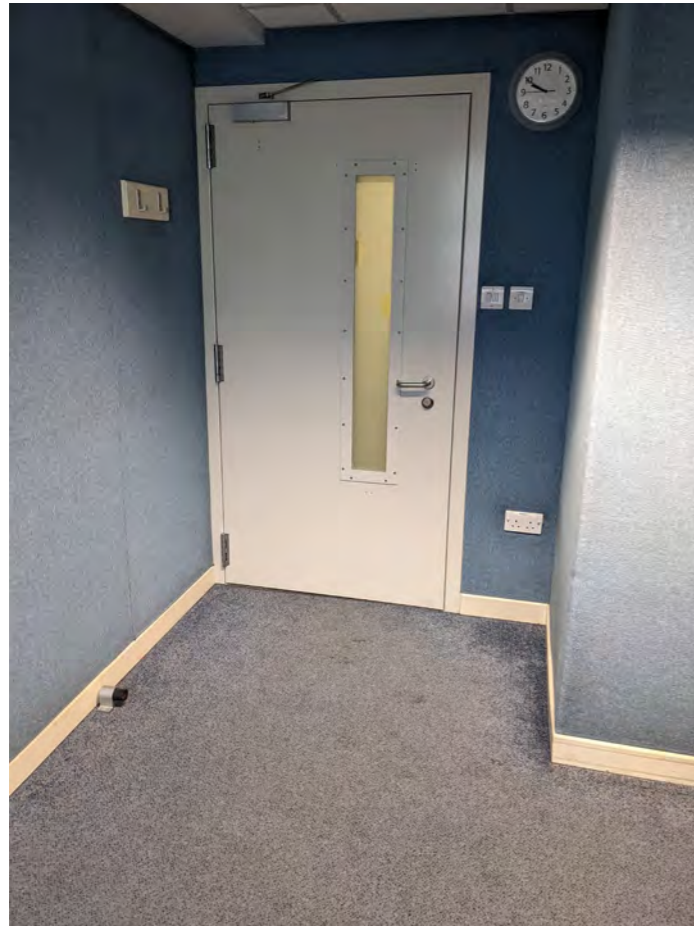
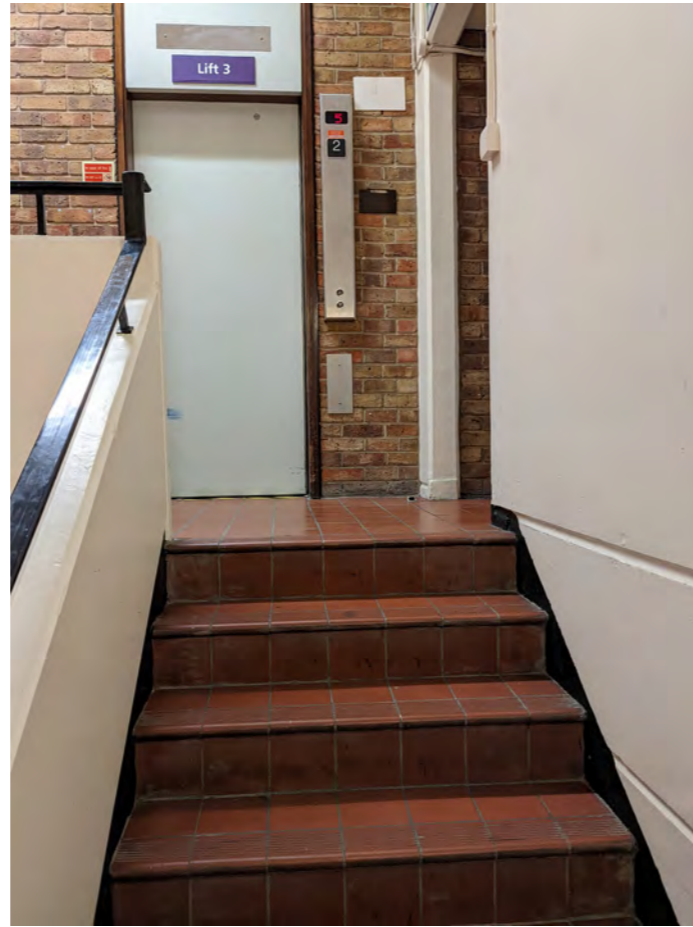
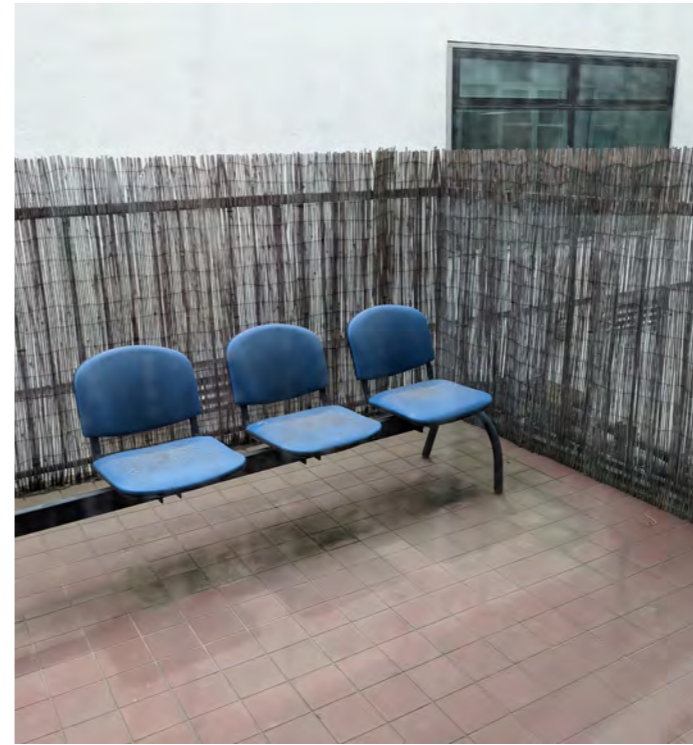
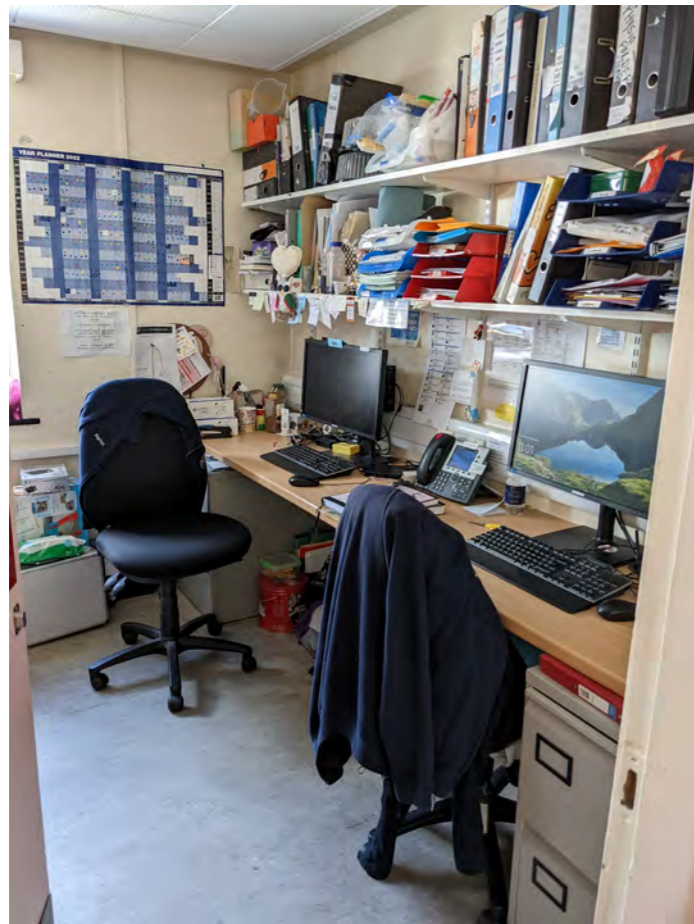
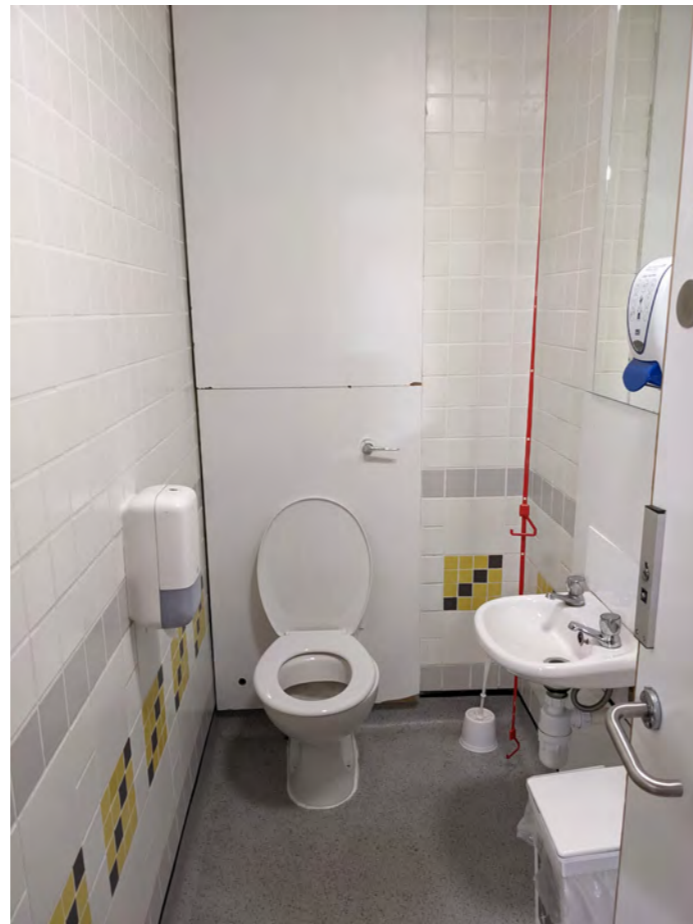
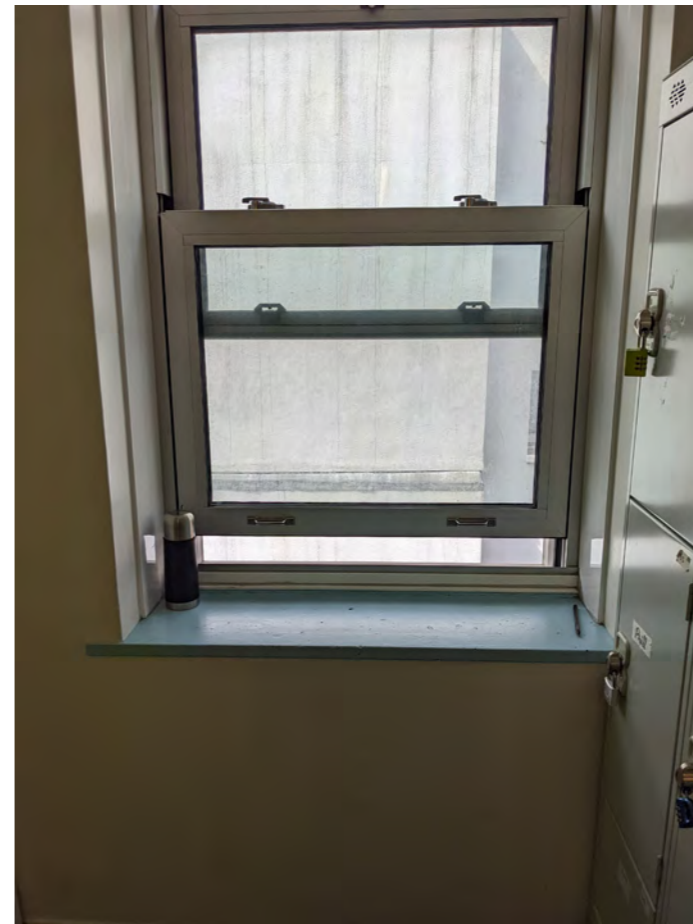
restricted headroom limits spaces to office based use

facilities not compliant with current regulations

poorly performing building fabric in need of repair

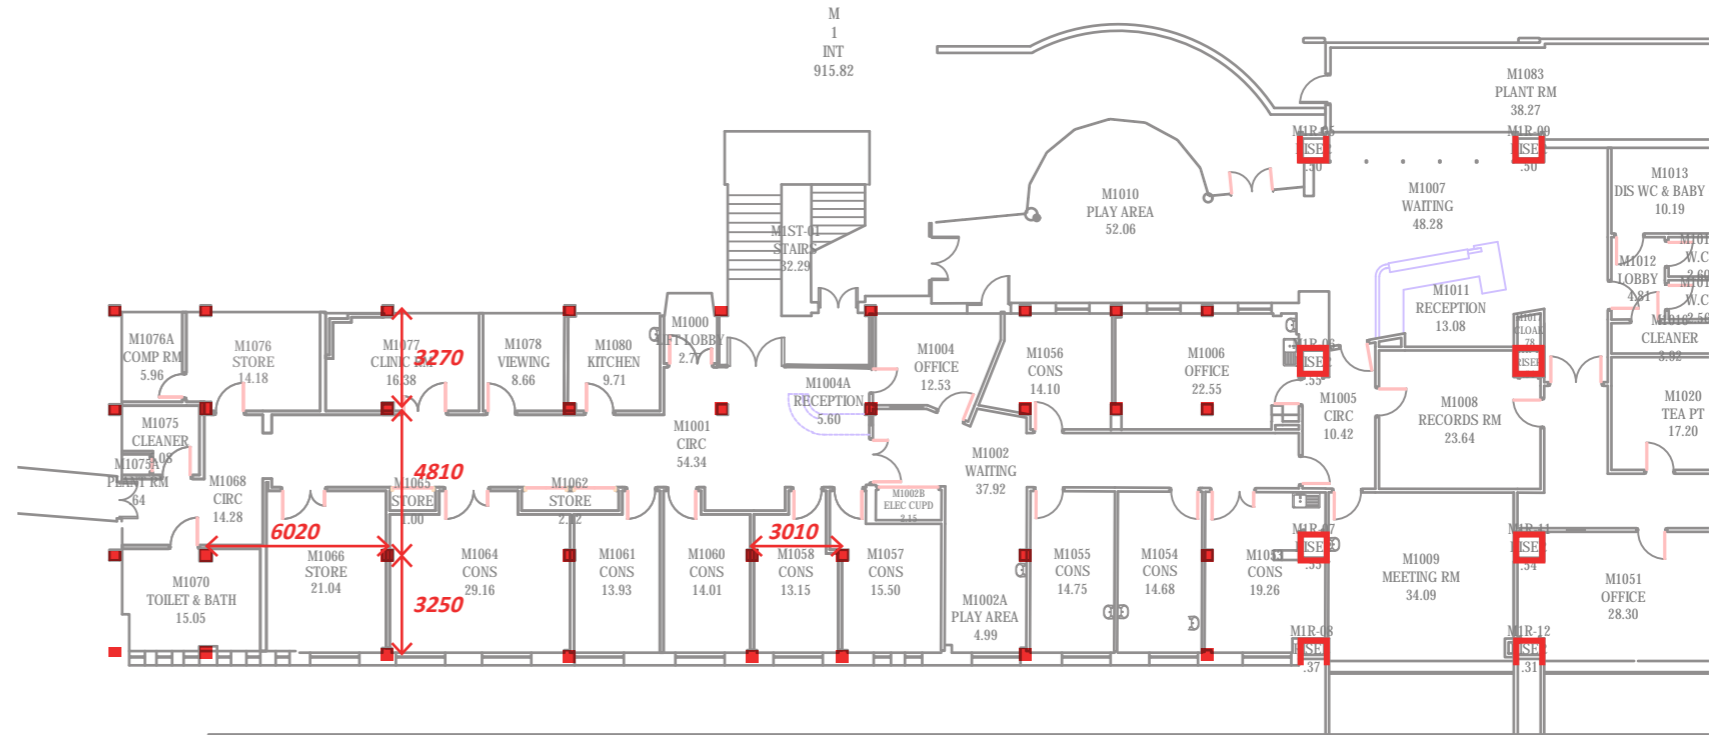
Phase 1 of the existing Frontage Building - columns highlighted in red

The existing structural frame has been designed for a building that is substantially smaller than the proposal. Its relatively tight grid of columns would become further constrained with strengthening to enable extension above. Extension into the ground to form an additional basement level is not feasible below the existing piled foundations without the removal of what is there, defeating the objective of retention or re-use.

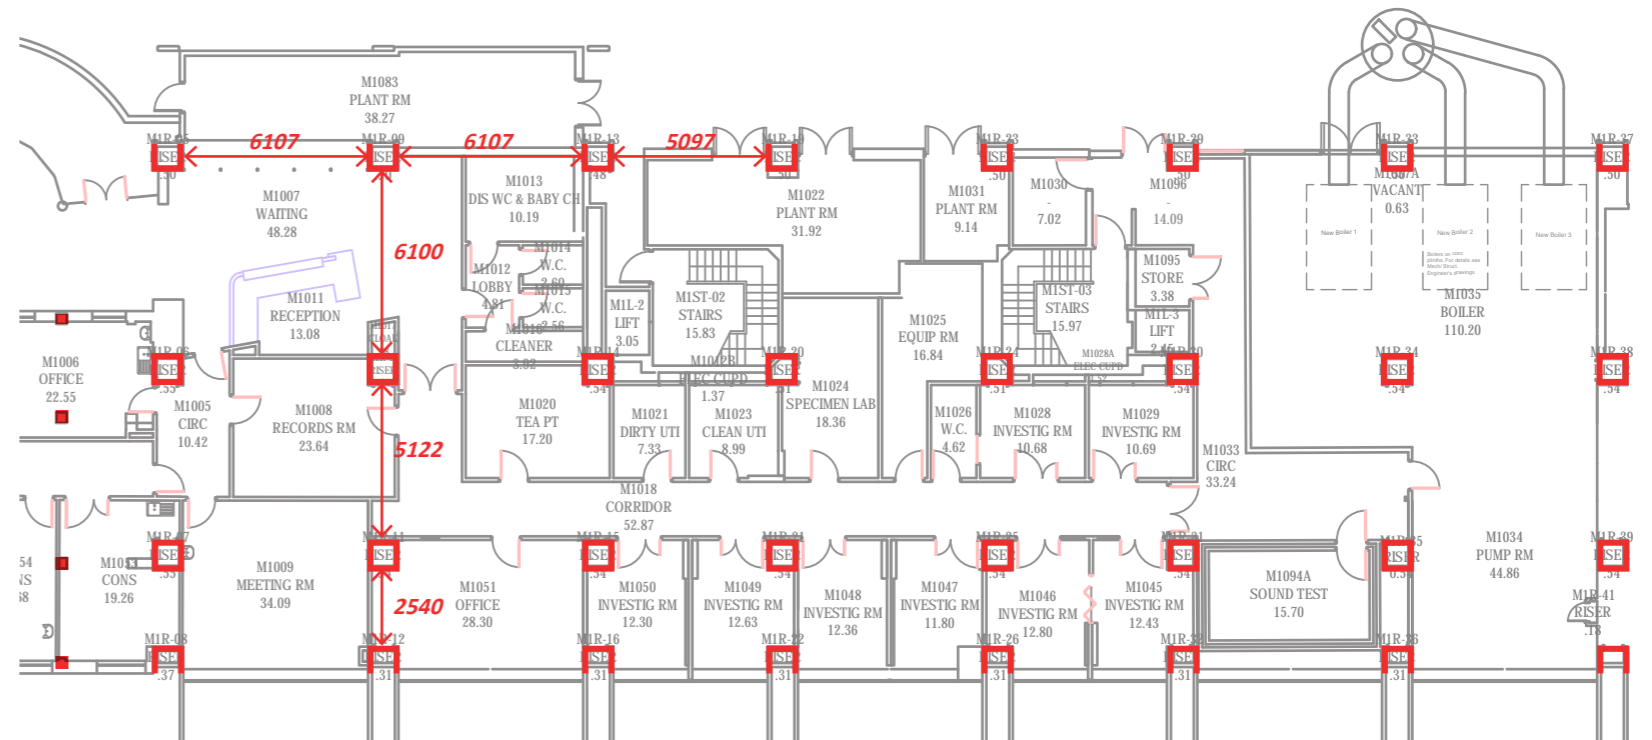
Phase 2 of the existing Frontage Building - structural fin walls highlighted in red

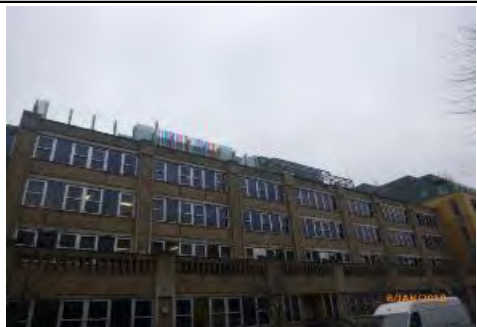
BUILDING									PHOTOGRAPH	
1. STRUCTURE

FOUNDATIONS	B	20	10					Low		Foundations were not visible during the inspection and no intrusive investigations were undertaken. Basement areas and external walls were however inspected and no evidence of structural movement to structure or foundations was apparent. Walls are of facing bricks common with the age of the building. There is some evidence of stepped cracking around window openings in localised areas and deterioration due to general weathering. The structure of the building comprises a reinforced concrete frame. The visible condition indicates cracking to concrete work due to oxidisation of steel rebars in localised areas. (Price included in section 2). Floors are suspended reinforced concrete with a mixture of plastered and suspended ceiling to these areas. The finish is generally in a satisfactory condition. The roof construction where visible is similar to the floor construction, with a concrete deck and a felt roof covering. One area of the roof has been converted into a roof garden. It is noted from the inspection that there is no evidential sign of movement or collapse. There was also no indication of roof leaks internally.

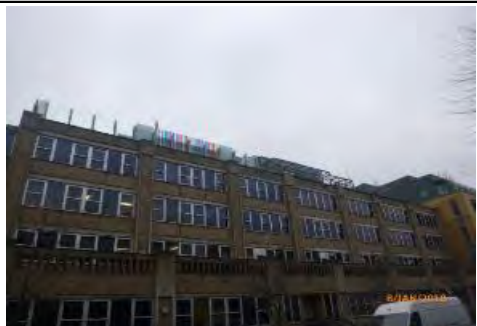
4. INTERNAL FABRIC & FIXTURES						Walls are a combination of solid masonry studwork and lightweight partitioning. A combination of finishes are present including studwork and plastered brickwork. The plastered finishes to solid walls are exhibiting impact damage to many areas due to suspected trolley use. A significant number of door frames are also suffering from impact damage. Generally these are minor defects and can be remedied as part of a future redecoration programme. The ceiling consists of painted plasterboard, inlet tiled and metal perforated suspended ceiling. Most areas can be painted over within the next five years however making good should be anticipated in the medium term as part of any future redecoration work. A budget cost has been provided for this, including tiled areas. Ceiling tiles vary in age and we have noted that around 60% are dated and are of poor appearance, however there is only limited damage to old tiles and as such only costing for localised replacement has been provided. Solid walls are those to the external and main structure core. The building structure is generally open plan and links a number of other buildings. Partitions, both studwork and system, are in fair condition but offer limited resistance to smoke and fire. It is noted to these areas that there is no evidence of smoke seals around doors and non compliance with BS476. Although glazing exhibited safety markings and seals, where noted to doors in most areas the partition systems are generally dated. In the long term, upgrading with modern partition should be considered and in the short term the building should be reviewed for fire spread and fire plan updated.
