Title:
200944 - Crown Estate Paving Commission (MASTER)

Project:
Cumberland Terrace

5 T266 LIME TREE CUMBERLAND TERRACE

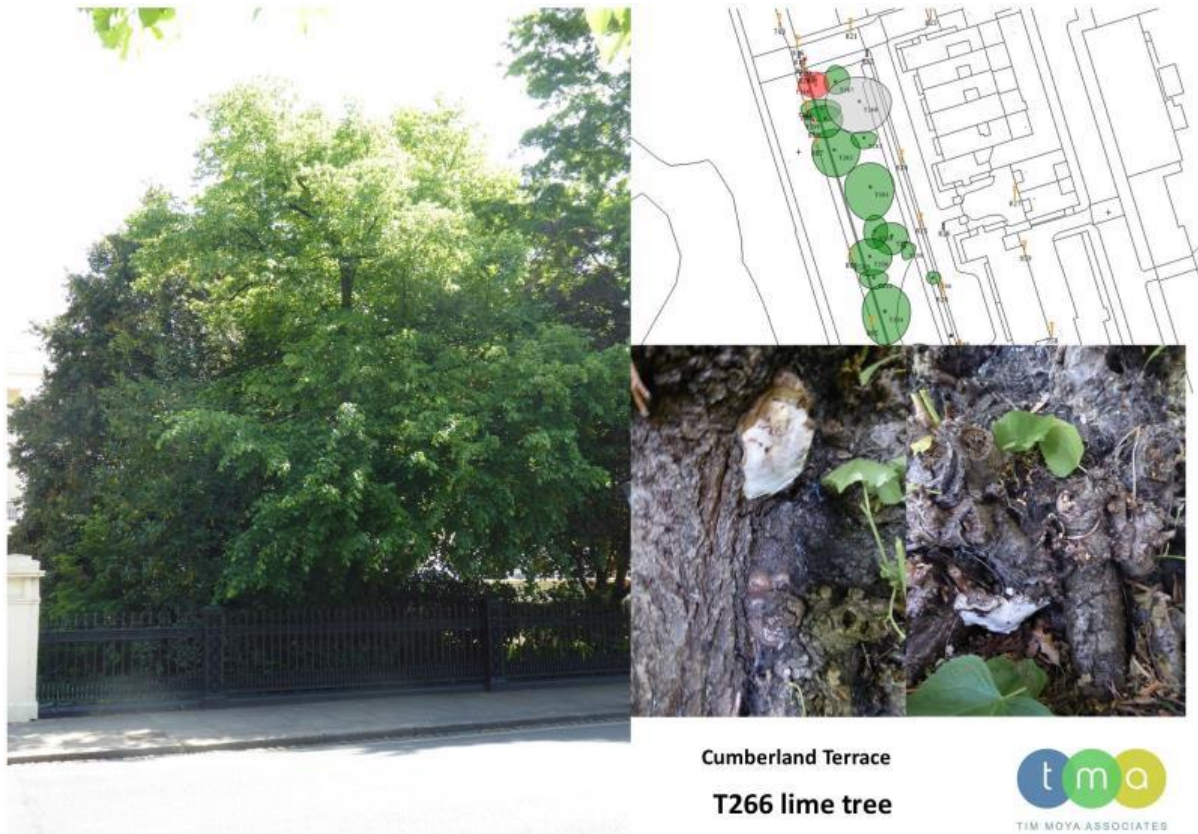
T266 lime tree - Cumberland Terrace: with map showing tree location (highlighted in red) and fungal fruit bodies on the base and lower stem.

- 5.1 A mature tree in good physiological condition with high vitality and well-developed buttressing, growing in a private garden within falling distance of a public footpath and highway.
- 5.2 The tree is sheltered to the east and south by other trees.
- 5.3 A previous inspection of the tree observed *Ganoderma australe* & *Kretzschmaria deusta*⁵ fungal fruiting bodies at the base and lower stem, prompting this investigation into the condition of wood at the base.
- 5.4 Due to the extent of epicormic growth around the base and lower stem it was not practical to use the PiCUS, so the investigation was carried out using the RESI PD.

- 5.9 Reducing the height of the tree to approximately 2m (fell, retaining high stump) is recommended to retain some amenity and ecosystem service value while managing the risk of harm to an acceptable level.

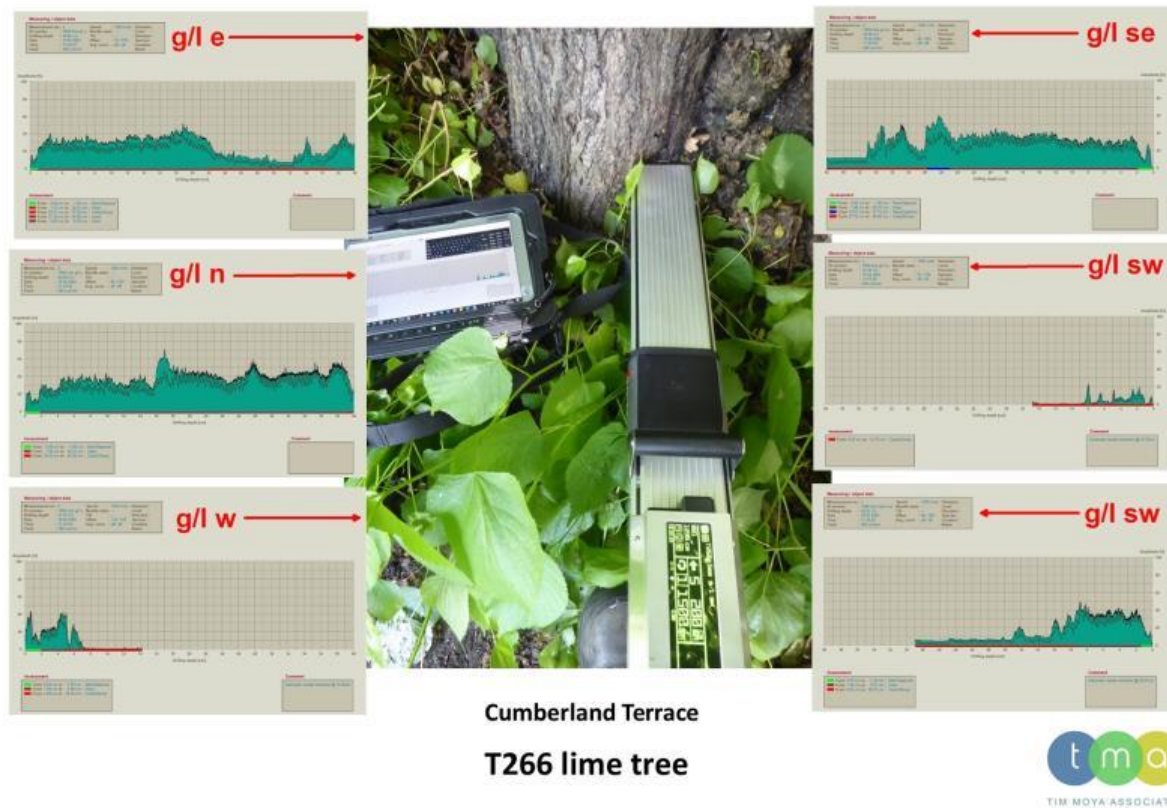
T266 lime tree RESI PD: graphs shown with direction indicated and an image of a test being undertaken.

- 5.5 The graphs confirm high resistance indicating intact wood to approximately 39cm to the north, and approximately 28cm to the south east. The graph to the east shows intact wood to approximately 22cm, from which point low resistance indicating decay is present.

- 5.6 The graphs to the south west and west confirm between 0cm & 10cm of intact wood remaining around the circumference with extensive decay throughout the remainder of the graphs.

- 5.7 It is important to note that lime trees are incapable of compartmentalising decay caused by *K.deusta*⁶.
- 5.8 The extent of decay identified in this investigation is considered to present an unacceptable risk of harm or damage through stem failure.

- 6.1 T88 plane tree - Park Crescent - *continue inspection regime*
- 6.2 T266 lime tree - Cumberland Terrace - *reduce height to 2m - necessary*
- 6.3 Please see updated tree records on the MyTrees server for details.
