## Revised Arboricultural Appraisal Report

### Subsidence Damage Investigation at:

180 Camden Road  
London  
NW1 9HG

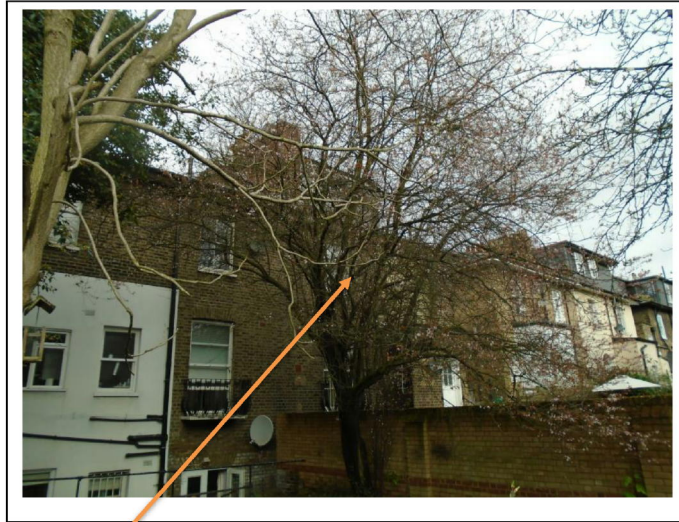
View of T1

| Tree No. | Species | Ht (m) | Dia (mm) | Crown Spread (m) | Dist. to building (m) | Age Classification | Ownership |
|---|---|---|---|---|---|---|---|
| T1 | Prunus | 9.5 | 300 * | 9 | 3.5 | Younger than Property | Third Party<br>Stella Wong-Lun-Sang of<br>180 Camden Road<br>NW1 9HG |
| Management history | | No recent management noted. Tree located approximately 2m above ground level of basement flat. | | | | | |

| Tree No. | Species | Ht (m) | Dia (mm) | Crown Spread (m) | Dist. to building (m) | Age Classification | Ownership |
|---|---|---|---|---|---|---|---|
| Recommendation | | Remove (fell) to near ground level and treat stump to inhibit regrowth. | | | | | |

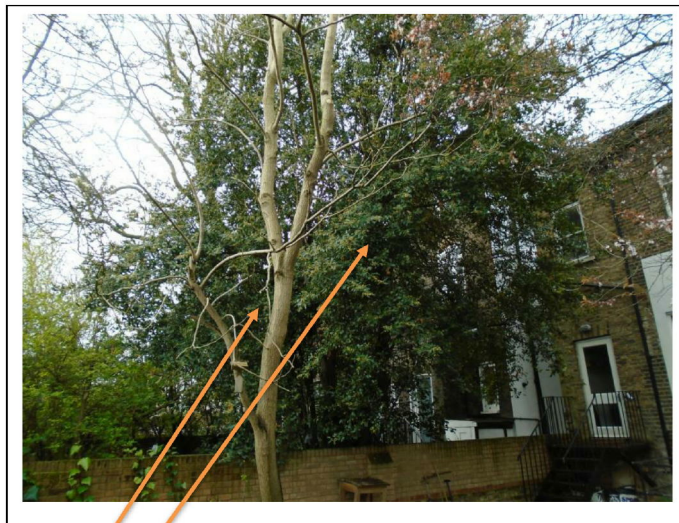
View of T2 & T3

| Tree No. | Species | Ht (m) | Dia (mm) | Crown Spread (m) | Dist. to building (m) | Age Classification | Ownership |
|---|---|---|---|---|---|---|---|
| T2 | Tree of Heaven | 12 | 240 | 8 | 7 | Younger than Property | Third Party<br>Stella Wong-Lun-Sang of<br>180 Camden Road<br>NW1 9HG |
| Management history | | No recent management noted. Tree located approximately 2m above ground level of basement flat. | | | | | |
| T3 | Bay | 9.5 | Ms | 7 | 6 | Younger than Property | Third Party<br>178 Camden Road<br>NW1 9HG |

| Tree No. | Species | Ht (m) | Dia (mm) | Crown Spread (m) | Dist. to building (m) | Age Classification | Ownership |
|---|---|---|---|---|---|---|---|
| Recommendation | | Remove (fell) to near ground level. Owner to physically remove any regrowth (no chemical treatment due to translocation risk). | | | | | |
| Recommendation | | Remove (fell) to near ground level and treat stump to inhibit regrowth. | | | | | |

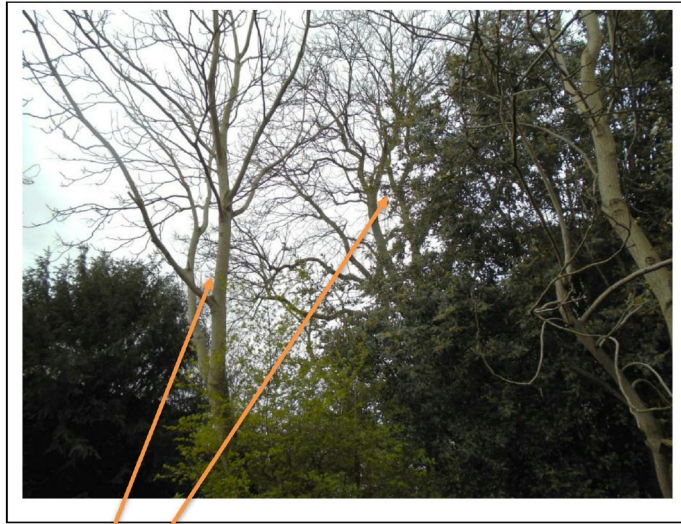
View of T5 and T4

| Tree No. | Species | Ht (m) | Dia (mm) | Crown Spread (m) | Dist. to building (m) | Age Classification | Ownership |
|---|---|---|---|---|---|---|---|
| T4 | Tree of Heaven | 14 * | 550 * | 14 * | 12 * | Younger than Property | Third Party<br>178 Camden Road<br>NW1 9HG |
| Management history | | No recent management noted. Tree located approximately 2m above ground level of basement flat. Unable to access the location to confirm species of tree. | | | | | |

| Tree No. | Species | Ht (m) | Dia (mm) | Crown Spread (m) | Dist. to building (m) | Age Classification | Ownership |
|---|---|---|---|---|---|---|---|
| T5 | Tree of Heaven | 9 * | 250 * | 7 * | 11 * | Younger than Property | Third Party<br>178 Camden Road<br>NW1 9HG |
| Management history | | No recent management noted. | | | | | |

| Tree No. | Species | Ht (m) | Dia (mm) | Crown Spread (m) | Dist. to building (m) | Age Classification | Ownership |
|---|---|---|---|---|---|---|---|
| Recommendation | | Reduce height by 2m and crown radius by 1m leaving balanced crown. Prune on a triennial cycle to maintain at broadly reduced dimensions. | | | | | |

| Tree No. | Species | Ht (m) | Dia (mm) | Crown Spread (m) | Dist. to building (m) | Age Classification | Ownership |
|---|---|---|---|---|---|---|---|
| Recommendation | | Maintain broadly at no more than current dimensions by periodic pruning. | | | | | |

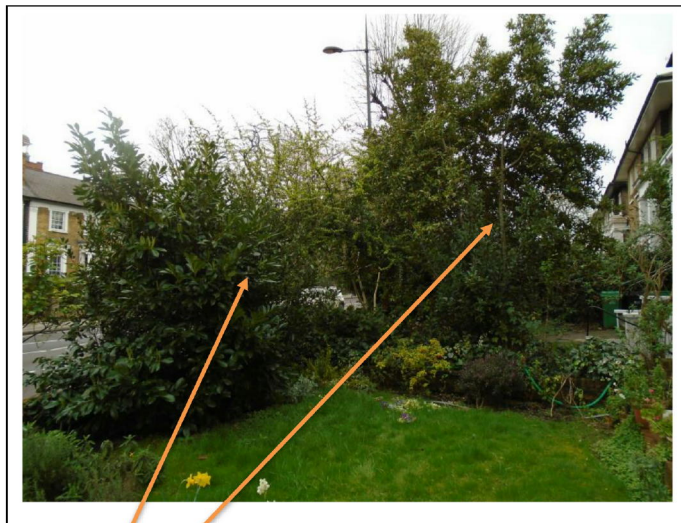
View of SG1 and T6

| Tree No. | Species | Ht (m) | Dia (mm) | Crown Spread (m) | Dist. to building (m) | Age Classification | Ownership |
|---|---|---|---|---|---|---|---|
| T6 | Holly | 6 | Ms | 5 * | 5 | Younger than Property | Third Party<br>182 Camden Road<br>NW1 9HG |
| Management history | | No recent management noted. | | | | | |

| Tree No. | Species | Ht (m) | Dia (mm) | Crown Spread (m) | Dist. to building (m) | Age Classification | Ownership |
|---|---|---|---|---|---|---|---|
| SG1 | Mixed species shrubs including Pyracantha & Laurel | 4 * | Ms | 3 | 6 | Younger than Property | Policy Holder |
| Management history | | No recent management noted. | | | | | |

| Tree No. | Species | Ht (m) | Dia (mm) | Crown Spread (m) | Dist. to building (m) | Age Classification | Ownership |
|---|---|---|---|---|---|---|---|
| Recommendation | | Reduce height by 2m and crown radius by 1m leaving balanced crown. Prune on a biennial cycle to maintain at broadly reduced dimensions. | | | | | |

| Tree No. | Species | Ht (m) | Dia (mm) | Crown Spread (m) | Dist. to building (m) | Age Classification | Ownership |
|---|---|---|---|---|---|---|---|
| Recommendation | | Maintain broadly at no more than current dimensions by periodic pruning. | | | | | |

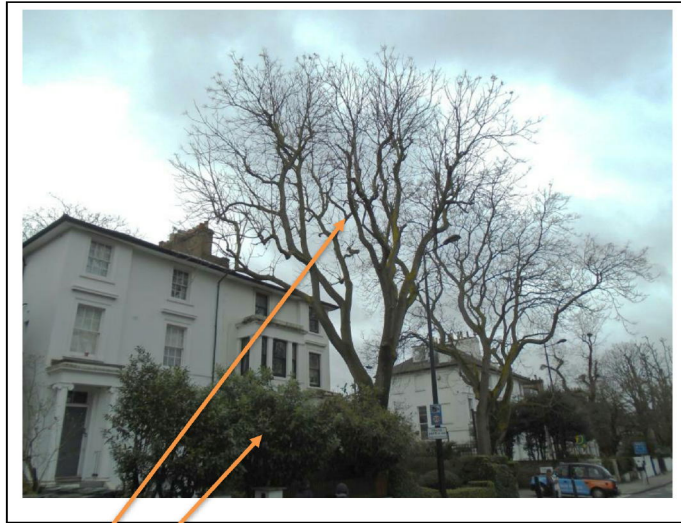
View of T7 and SG2

| Tree No. | Species | Ht (m) | Dia (mm) | Crown Spread (m) | Dist. to building (m) | Age Classification | Ownership |
|---|---|---|---|---|---|---|---|
| T7 | Tree of Heaven | 17 * | 650 * | 13 * | 12 * | Younger than Property | Third Party<br>178 Camden Road<br>NW1 9HG |
| Management history | | Subject to past management/pruning. | | | | | |

| Tree No. | Species | Ht (m) | Dia (mm) | Crown Spread (m) | Dist. to building (m) | Age Classification | Ownership |
|---|---|---|---|---|---|---|---|
| SG2 | Laurel | 3 * | Ms | 3 * | 9 * | Younger than Property | Third Party<br>178 Camden Road<br>NW1 9HG |
| Management history | | Subject to past management/pruning. | | | | | |

| Tree No. | Species | Ht (m) | Dia (mm) | Crown Spread (m) | Dist. to building (m) | Age Classification | Ownership |
|---|---|---|---|---|---|---|---|
| Recommendation | | Remove (fell) to near ground level and grind out stump to inhibit regrowth. | | | | | |

| Tree No. | Species | Ht (m) | Dia (mm) | Crown Spread (m) | Dist. to building (m) | Age Classification | Ownership |
|---|---|---|---|---|---|---|---|
| Recommendation | | Maintain broadly at no more than current dimensions by periodic pruning. | | | | | |
