# Site Investigation Report

| Job Information | |
|---|---|
| Client | Crawford & Co |

Auger were commissioned by Crawford & Co to undertake a site investigation and CCTV inspection of the underground drainage within the area of concern at the property.

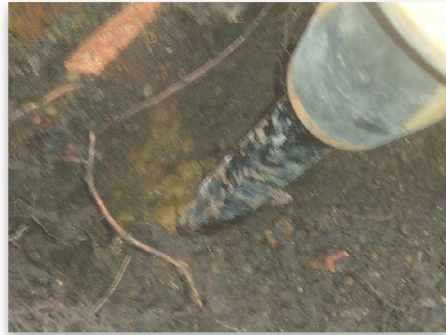
Fig 1.2: Trial Hole 1 Footing
