TECHNICAL REPORT ON A SUBSIDENCE CLAIM

[REDACTED]
**180 Camden Road
London
NW1 9HG**

27th November 2019

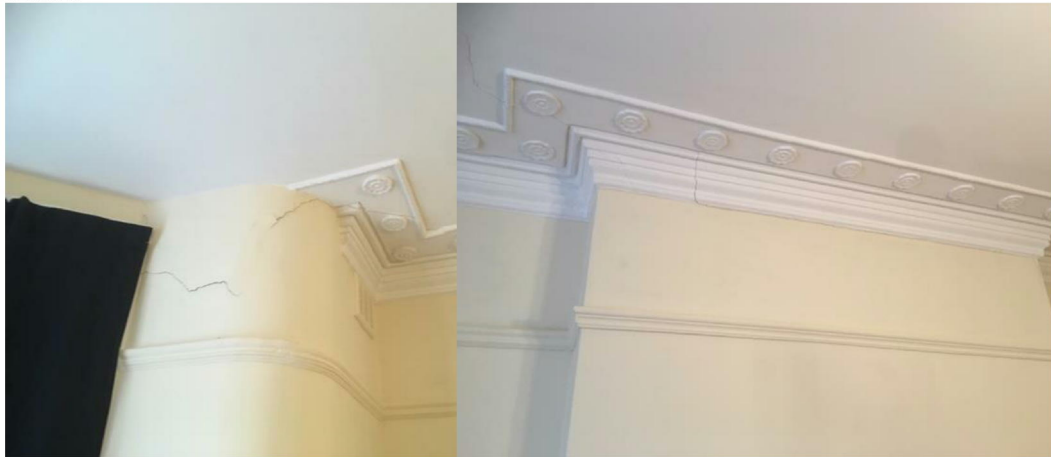
Cracking to first floor flat

- Slight cracking was noted to the left hand side of the bay at its junction with the main house.
- To the right hand dividing wall, a slight diagonal crack was noted to the front corner which extends up to the rear.

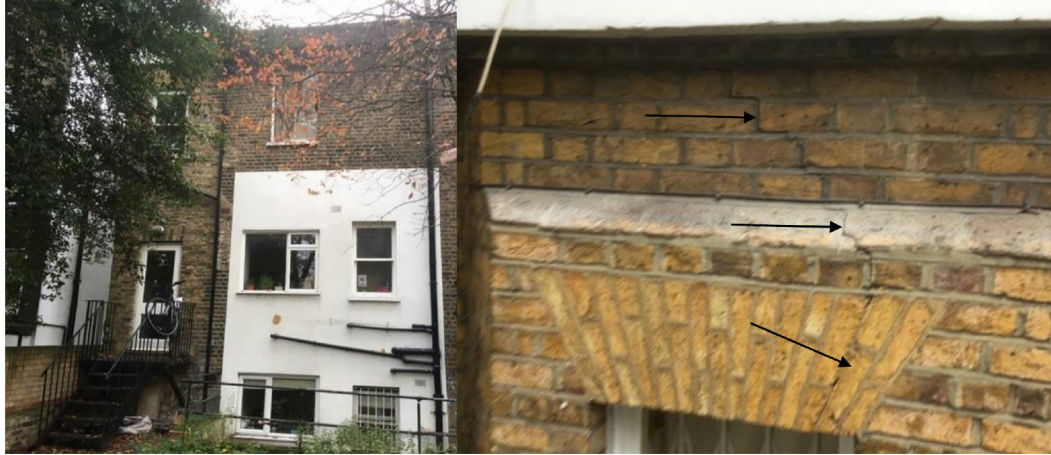
Rear elevation

Cracking to bay

- Stepped cracking / displacement of flat brick lintels were noted to the left hand return wall of the bay.

- Diagonal / stepped cracking was noted to above and below door and window openings.

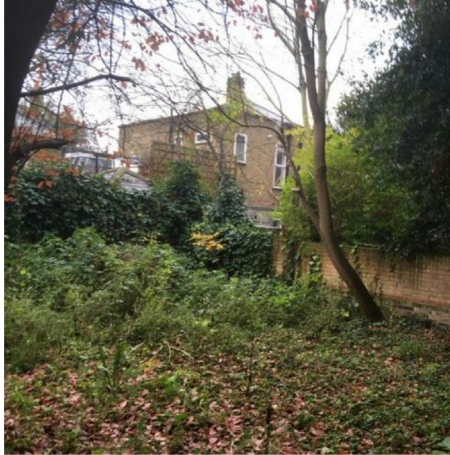
Trees at rear

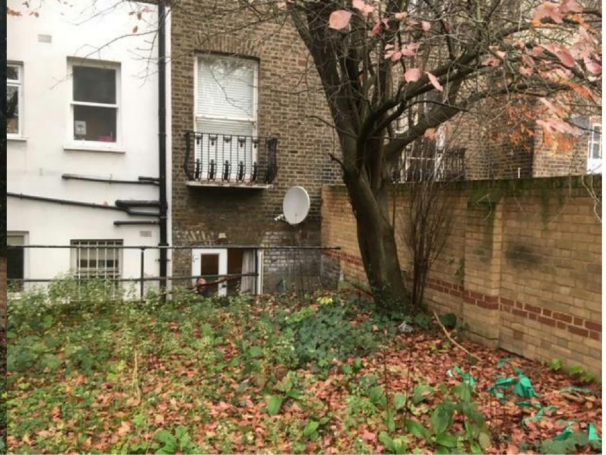
Trees at rear

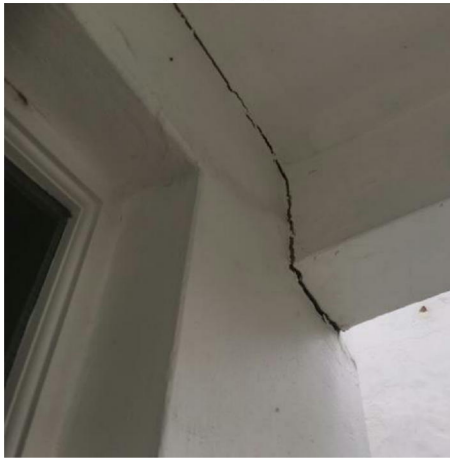
- Cracking, up to 10-15mm in width, was noted at the junction between the porch and main house/extension.
- Stepped cracking, up to 6mm in width was noted the right hand wall of the porch.

Cracking to porch

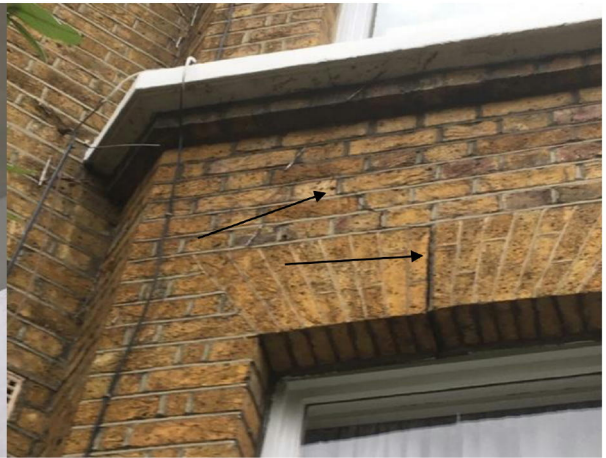
Cracking to bay

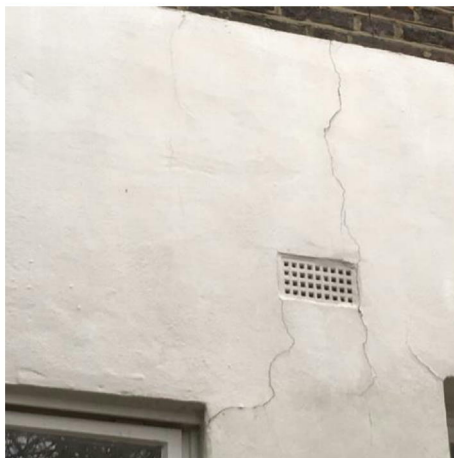
Cracking to rear elevation

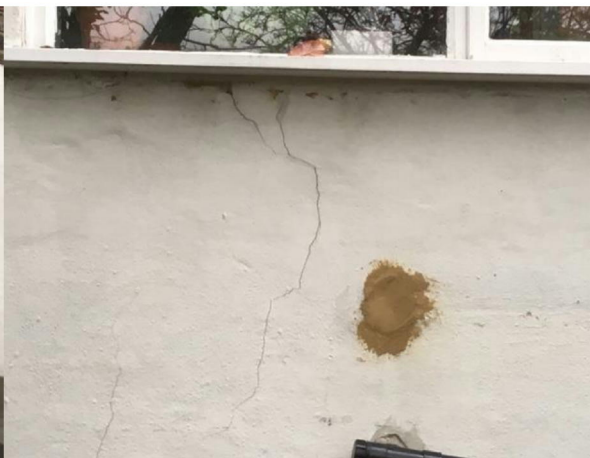
Cracking to rear elevation

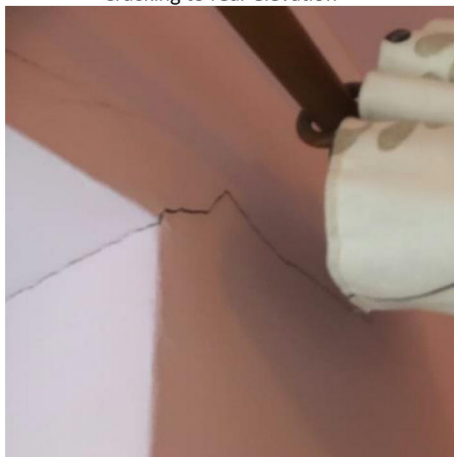
Rear Bedroom - Garden floor flat - rear wall

- To the right hand wall slight cracking was noted above the corridor door (seen both sides).
- To the rear wall, 3mm wide cracking was noted to the top right of the window.

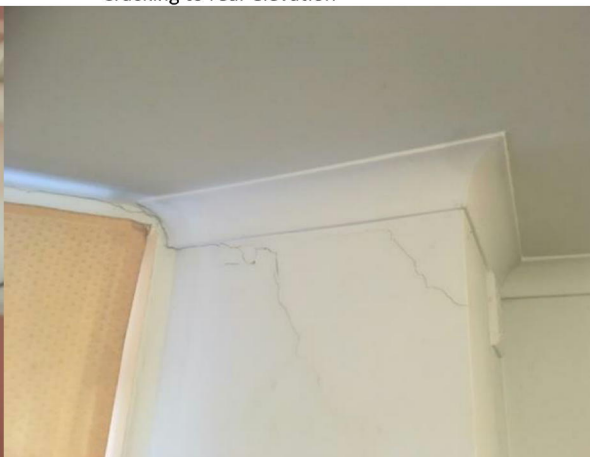
Garden flat - Lounge

- Slight cracking was noted to the left hand side of the bay at its junction with the main house.
- To the right hand wall cracking was noted either side of the hall door head.
