## Revised Arboricultural Appraisal Report

### Subsidence Damage Investigation at:

180 Camden Road  
London  
NW1 9HG

CLIENT:	Crawford & Company
CLIENT REF:	[REDACTED]
MWA REF:	[REDACTED]
MWA CONSULTANT:	Steve Swinburne
REPORT DATE:	12/03/2020
REVISED REPORT REV01 DATE:	10/07/2020
REVISED REPORT REV02 DATE:	29/11/2021

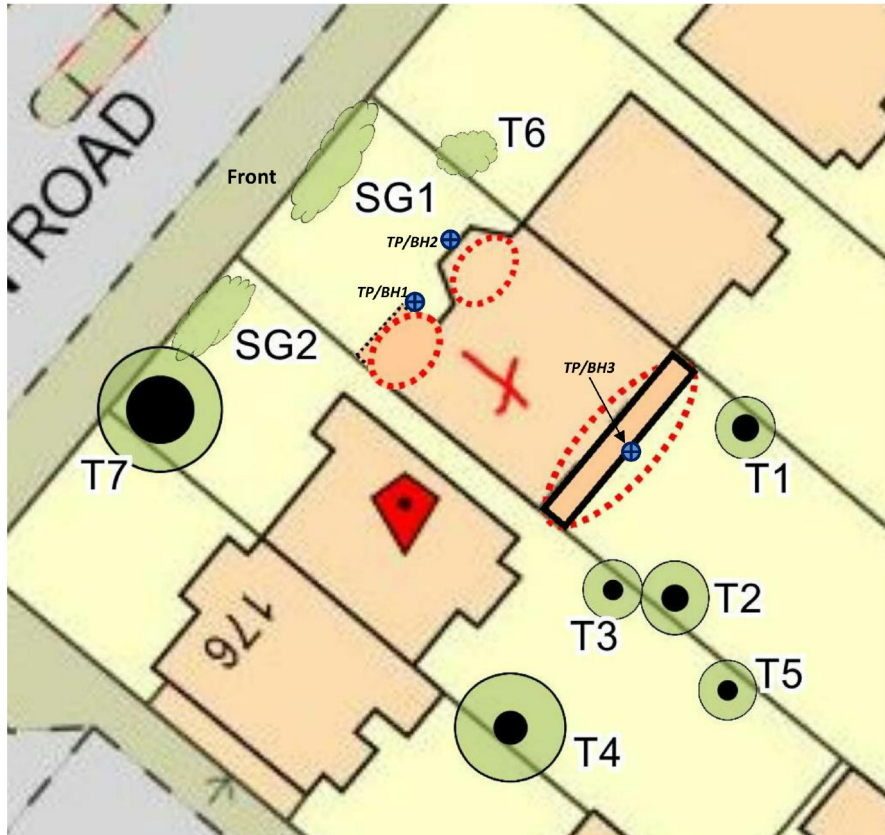
Site Plan

Approximate areas of damage

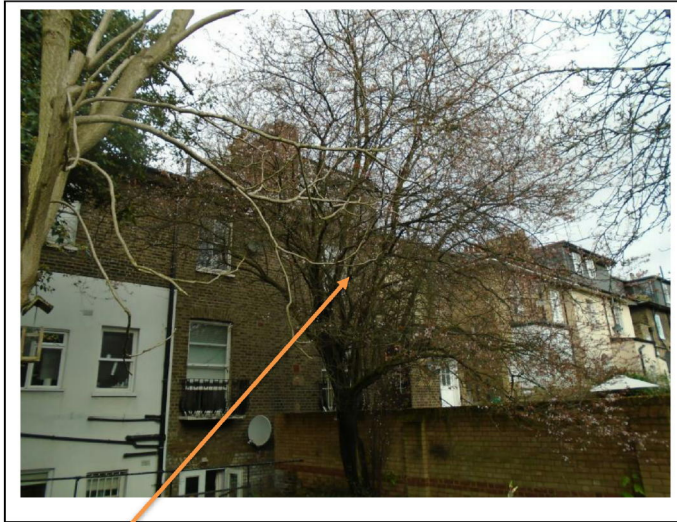
View of T1

Tree No.	Species	Ht (m)	Dia (mm)	Crown Spread (m)	Dist. to building (m)	Age Classification	Ownership
T1	Prunus	9.5	300 *	9	3.5	Younger than Property	Third Party Stella Wong-Lun-Sang of 180 Camden Road NW1 9HG
Management history		No recent management noted. Tree located approximately 2m above ground level of basement flat.					
Recommendation		Remove (fell) to near ground level and treat stump to inhibit regrowth.					
T2	Tree of Heaven	12	240	8	7	Younger than Property	Third Party Stella Wong-Lun-Sang of 180 Camden Road NW1 9HG
Management history		No recent management noted. Tree located approximately 2m above ground level of basement flat.					
Recommendation		Remove (fell) to near ground level. Owner to physically remove any regrowth (no chemical treatment due to translocation risk).					
T3	Bay	9.5	Ms	7	6	Younger than Property	Third Party 178 Camden Road NW1 9HG
Management history		No recent management noted. Tree located approximately 2m above ground level of basement flat.

Recommendation		Remove (fell) to near ground level and treat stump to inhibit regrowth.					
T4	Tree of Heaven	14 *	550 *	14 *	12 *	Younger than Property	Third Party 178 Camden Road NW1 9HG
Management history		No recent management noted. Tree located approximately 2m above ground level of basement flat. Unable to access the location to confirm species of tree.					
Recommendation		Reduce height by 2m and crown radius by 1m leaving balanced crown. Prune on a triennial cycle to maintain at broadly reduced dimensions.					
T6	Holly	6	Ms	5 *	5	Younger than Property	Third Party 182 Camden Road NW1 9HG
Management history		No recent management noted.					
Recommendation		Reduce height by 2m and crown radius by 1m leaving balanced crown. Prune on a biennial cycle to maintain at broadly reduced dimensions.

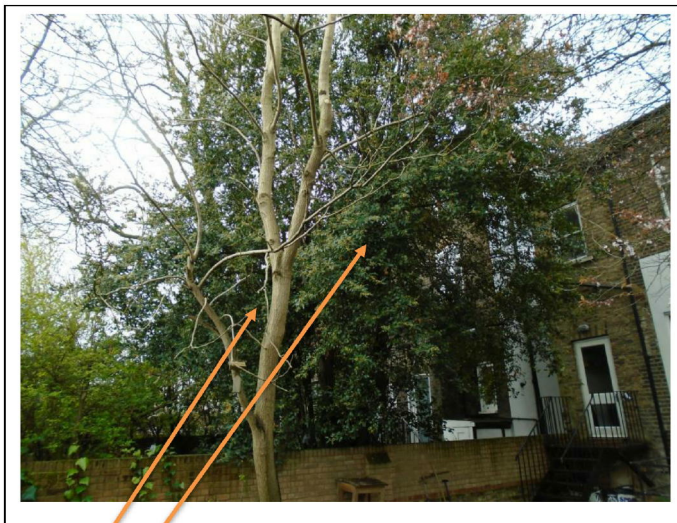
View of T2 & T3

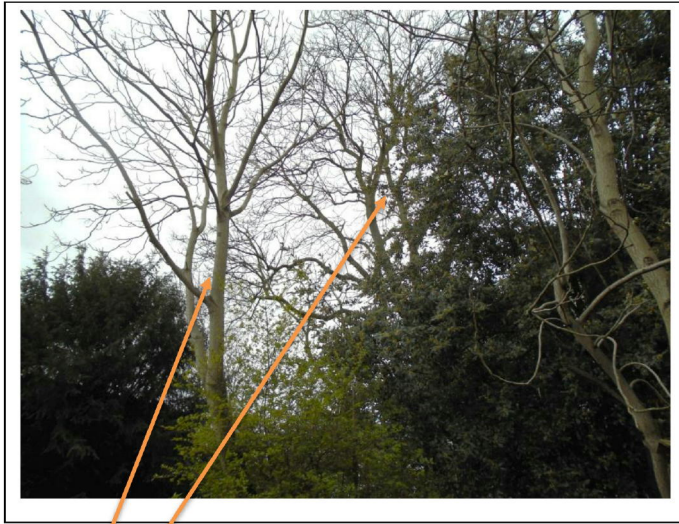
View of T5 and T4

Tree No.	Species	Ht (m)	Dia (mm)	Crown Spread (m)	Dist. to building (m)	Age Classification	Ownership
T5	Tree of Heaven	9 *	250 *	7 *	11 *	Younger than Property	Third Party 178 Camden Road NW1 9HG
Management history		No recent management noted.					
Recommendation		Maintain broadly at no more than current dimensions by periodic pruning.					
SG1	Mixed species shrubs including Pyracantha & Laurel	4 *	Ms	3	6	Younger than Property	Policy Holder
Management history		No recent management noted.					
Recommendation		Maintain broadly at no more than current dimensions by periodic pruning.					
SG2	Laurel	3 *	Ms	3 *	9 *	Younger than Property	Third Party 178 Camden Road NW1 9HG
Management history		Subject to past management/pruning.					
Recommendation		Maintain broadly at no more than current dimensions by periodic pruning.

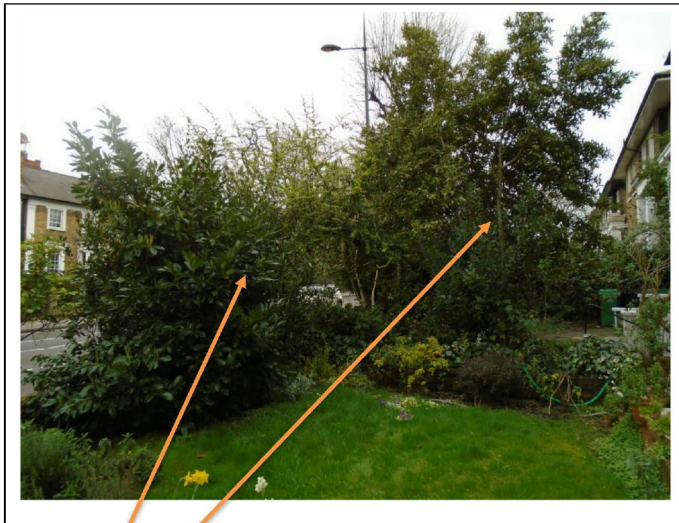
View of SG1 and T6

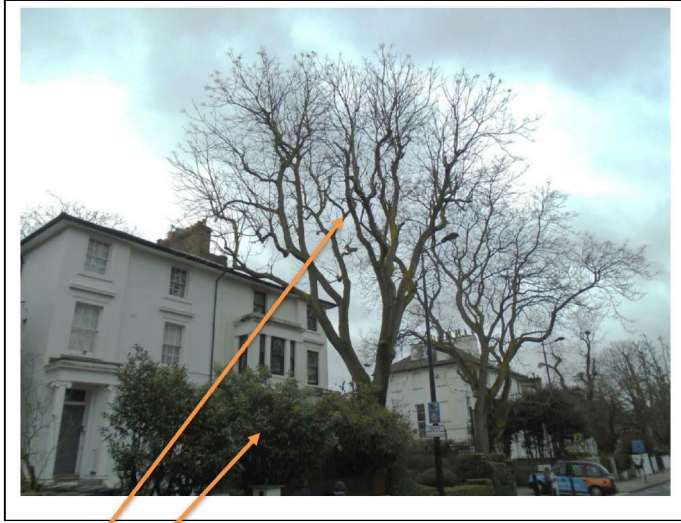
View of T7 and SG2

Tree No.	Species	Ht (m)	Dia (mm)	Crown Spread (m)	Dist. to building (m)	Age Classification	Ownership
T7	Tree of Heaven	17 *	650 *	13 *	12 *	Younger than Property	Third Party 178 Camden Road NW1 9HG
Management history		Subject to past management/pruning.					
Recommendation		Remove (fell) to near ground level and grind out stump to inhibit regrowth.
