## Site Investigation Report

Auger were commissioned by Crawford & Co to undertake a site investigation and CCTV inspection of the underground drainage within the area of concern at the property.

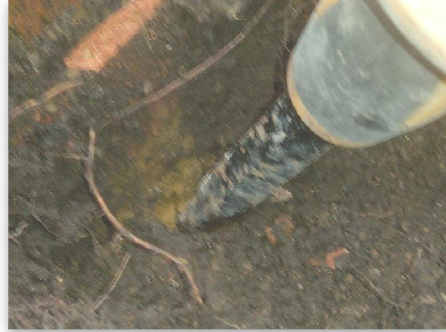
Fig 1.2: Trial Hole 1 Footing

| Depth<br>(m) | Symbolic Log | Strata Description | Insitu Tests | | Soil<br>Sample | Root<br>Sample |
|---|---|---|---|--|---|---|
| | | Brick Footing (No Proj) | | | | |

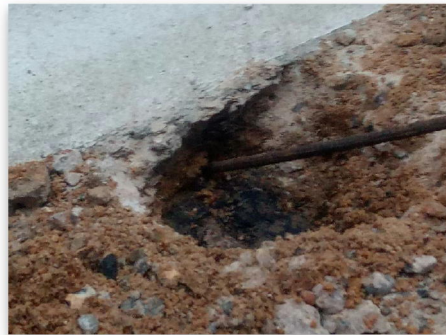
Fig 2.2: Trial Hole 2 Footing

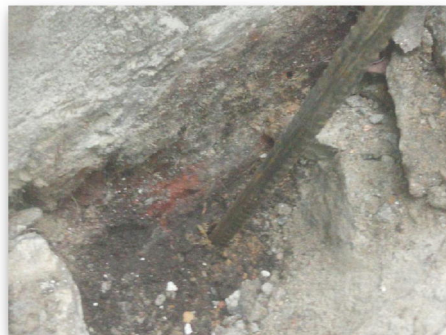
We were unable to collect root samples from TH3 because no roots were located within the trial hole.

Fig 3.2: Trial Hole 3 Footing
