TECHNICAL REPORT ON A SUBSIDENCE CLAIM

[REDACTED]
**180 Camden Road
London
NW1 9HG**

SUBSIDENCE CLAIM

27th November 2019

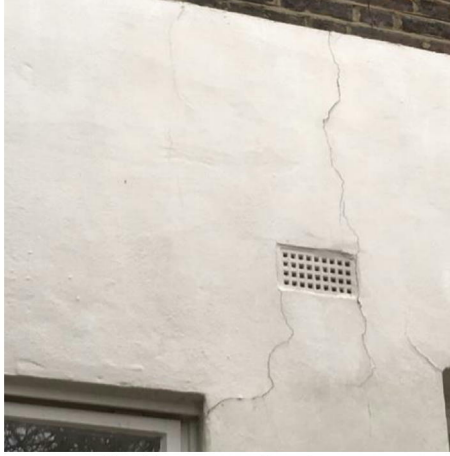
- Diagonal / stepped cracking was noted to above and below door and window openings.

Cracking to rear elevation

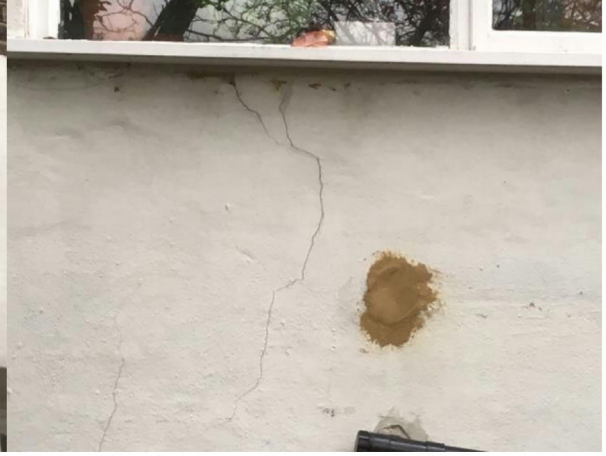
Cracking to rear elevation

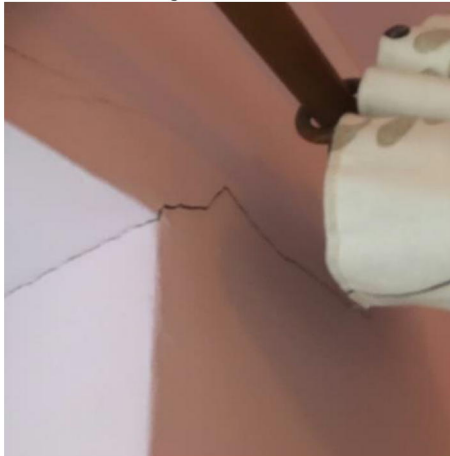
- To the right hand wall slight cracking was noted above the corridor door (seen both sides).
- To the rear wall, 3mm wide cracking was noted to the top right of the window.

Rear Bedroom - Garden floor flat - rear wall

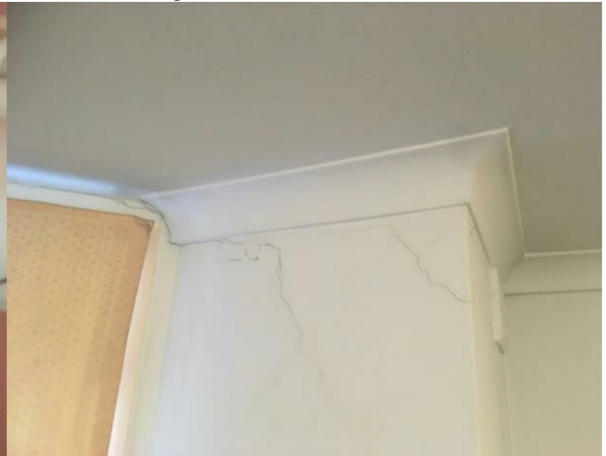
- Slight cracking was noted to the left hand side of the bay at its junction with the main house.
- To the right hand wall cracking was noted either side of the hall door head.

Garden flat - Lounge
