TECHNICAL REPORT ON A SUBSIDENCE CLAIM

**180 Camden Road
London
NW1 9HG**

SUBSIDENCE CLAIM

27th November 2019

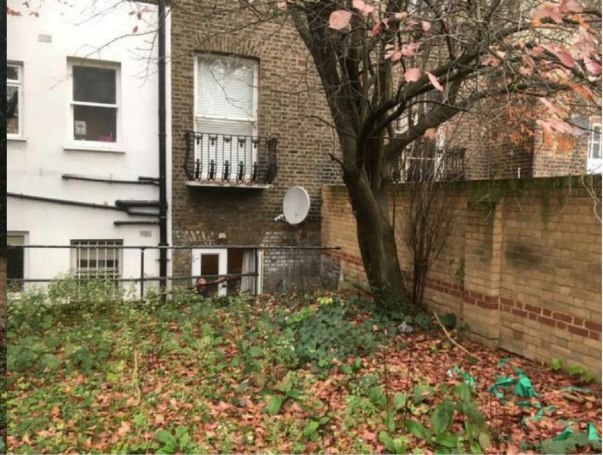
Trees at rear

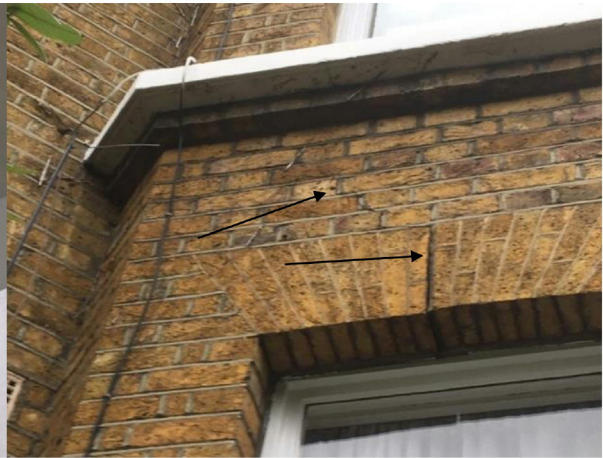
- Stepped cracking / displacement of flat brick lintels were noted to the left hand return wall of the bay.

Cracking to bay

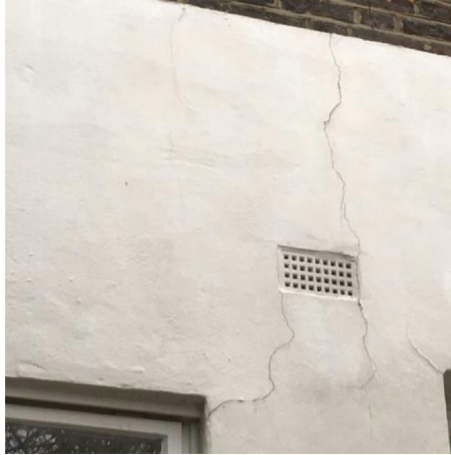
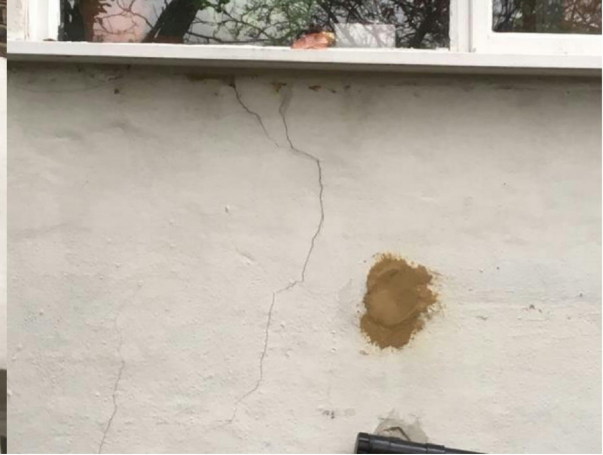
- Diagonal / stepped cracking was noted to above and below door and window openings.

Cracking to rear elevation

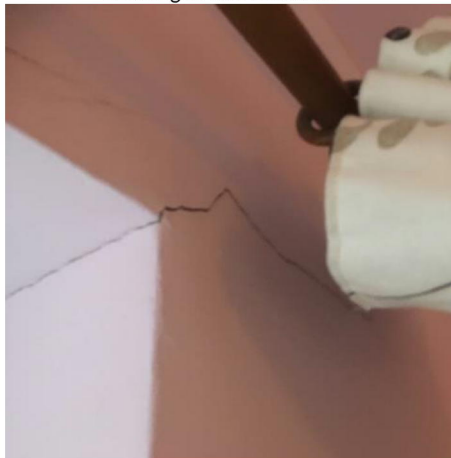
- To the right hand wall slight cracking was noted above the corridor door (seen both sides).
- To the rear wall, 3mm wide cracking was noted to the top right of the window.

Rear Bedroom - Garden floor flat - rear wall

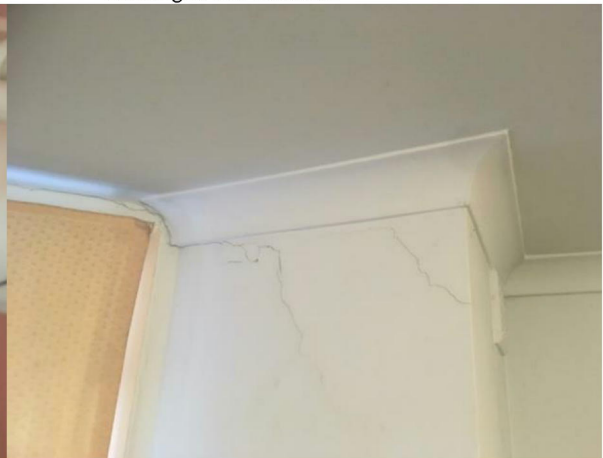
- Slight cracking was noted to the left hand side of the bay at its junction with the main house.
- To the right hand wall cracking was noted either side of the hall door head.

Garden flat - Lounge
