## Revised Arboricultural Appraisal Report

### Subsidence Damage Investigation at:

180 Camden Road  
London  
NW1 9HG

CLIENT:	Crawford & Company
CLIENT REF:	[REDACTED]
MWA REF:	[REDACTED]
MWA CONSULTANT:	Steve Swinburne
REPORT DATE:	12/03/2020
REVISED REPORT REV01 DATE:	10/07/2020
REVISED REPORT REV02 DATE:	29/11/2021

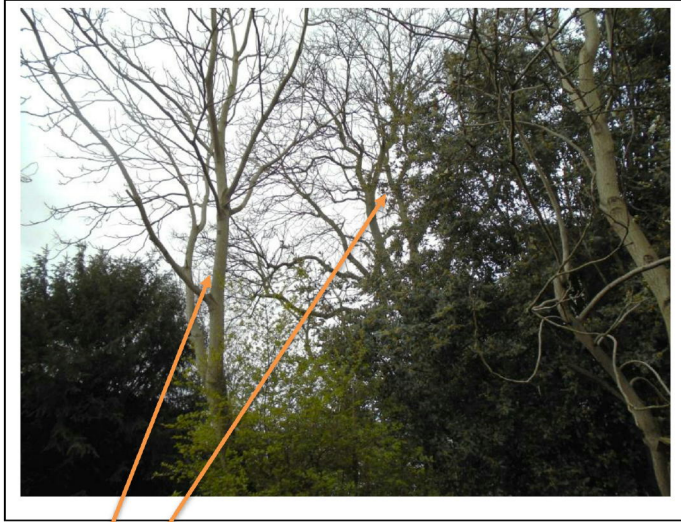
View of T5 and T4

Recommendation		Remove (fell) to near ground level and treat stump to inhibit regrowth.					
T4	Tree of Heaven	14 *	550 *	14 *	12 *	Younger than Property	Third Party 178 Camden Road NW1 9HG
Management history		No recent management noted. Tree located approximately 2m above ground level of basement flat. Unable to access the location to confirm species of tree.					
Recommendation		Reduce height by 2m and crown radius by 1m leaving balanced crown. Prune on a triennial cycle to maintain at broadly reduced dimensions.					
T6	Holly	6	Ms	5 *	5	Younger than Property	Third Party 182 Camden Road NW1 9HG
Management history		No recent management noted.					
Recommendation		Reduce height by 2m and crown radius by 1m leaving balanced crown. Prune on a biennial cycle to maintain at broadly reduced dimensions.

Tree No.	Species	Ht (m)	Dia (mm)	Crown Spread (m)	Dist. to building (m)	Age Classification	Ownership
T5	Tree of Heaven	9 *	250 *	7 *	11 *	Younger than Property	Third Party 178 Camden Road NW1 9HG
Management history		No recent management noted.					
Recommendation		Maintain broadly at no more than current dimensions by periodic pruning.					
SG1	Mixed species shrubs including Pyracantha & Laurel	4 *	Ms	3	6	Younger than Property	Policy Holder
Management history		No recent management noted.					
Recommendation		Maintain broadly at no more than current dimensions by periodic pruning.					
SG2	Laurel	3 *	Ms	3 *	9 *	Younger than Property	Third Party 178 Camden Road NW1 9HG
Management history		Subject to past management/pruning.					
Recommendation		Maintain broadly at no more than current dimensions by periodic pruning.

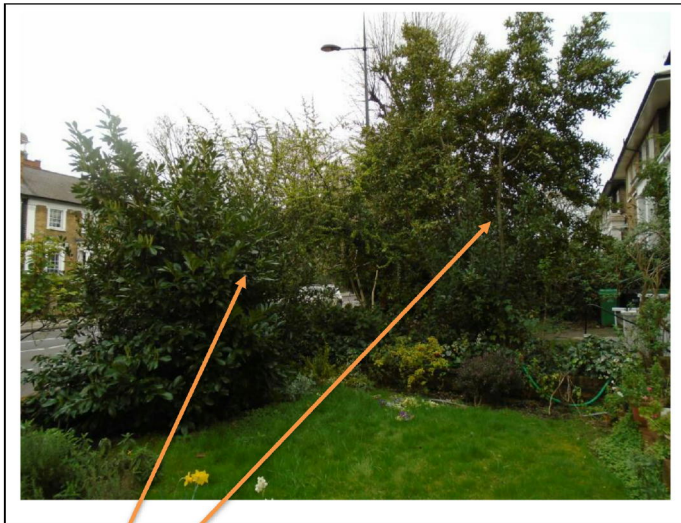
View of SG1 and T6
