Site Investigation Report

Job Information	
Client	Crawford & Co
Client ref	[Redacted]
Visit date	02/01/2020
Report date	06/01/2020

Auger were commissioned by Crawford & Co to undertake a site investigation and CCTV inspection of the underground drainage within the area of concern at the property.

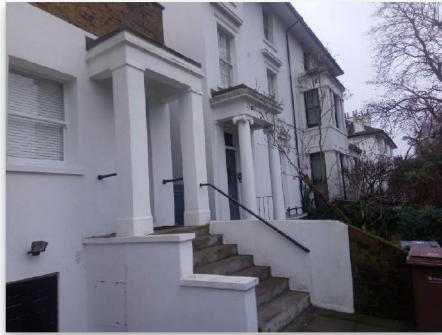
Fig 1.1: Trial Hole 1 Location

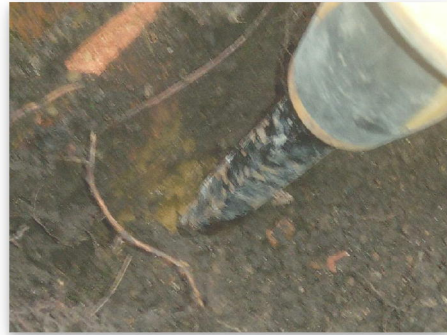
Fig 1.2: Trial Hole 1 Footing

Depth (m)	Symbolic Log	Strata Description	Insitu Tests		Soil Sample	Root Sample
			SV(19)			
0.0	<p>Ground Level</p> <p>Concrete</p> <p>Brickwork</p> <p>Brick Footing (No Proj)</p>					
0.5				54kpa	Soil @ 0.6m	
1.0				63kpa	Soil @ 1.1m	Root @ 1.1m
1.5				79kpa	Soil @ 1.6m	Root @ 1.6m
2.0				81kpa	Soil @ 2.1m	
2.5			90kpa	Soil @ 2.6m		
3.0		TRIAL HOLE TERMINATED	94kpa

Dry stiff Brown sandy fine to medium gravelly silty CLAY

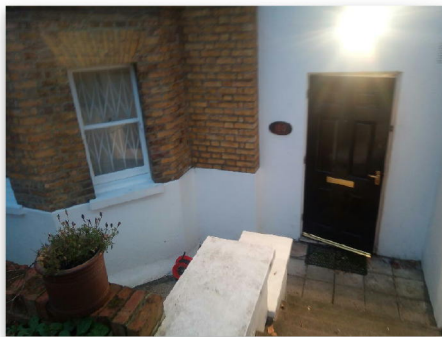
Fig 2.1: Trial Hole 2 Location

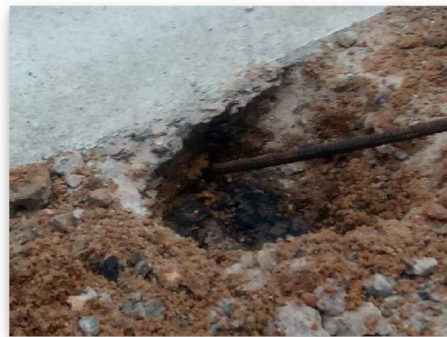
Fig 2.2: Trial Hole 2 Footing

Depth (m)	Symbolic Log	Strata Description	Insitu Tests		Soil Sample	Root Sample
			SV(19)			
0.0		Ground Level Concrete Brickwork Double Step				
0.6			41kpa		Soil @ 0.6m	
1.1			56kpa		Soil @ 1.1m	Root @ 1.1m
1.6			60kpa		Soil @ 1.6m	
2.1			61kpa		Soil @ 2.1m	
2.6			64kpa		Soil @ 2.6m	
3.0		TRIAL HOLE TERMINATED	71kpa

Dry stiff Brown sandy fine to medium gravelly silty CLAY

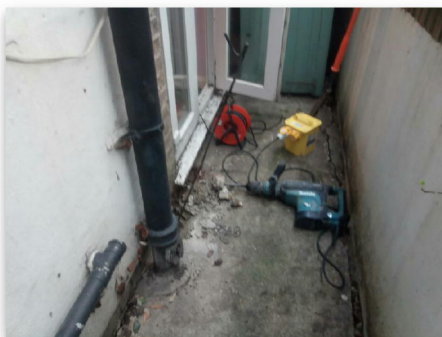
We were unable to collect root samples from TH3 because no roots were located within the trial hole.

Fig 3.1: Trial Hole 3 Location

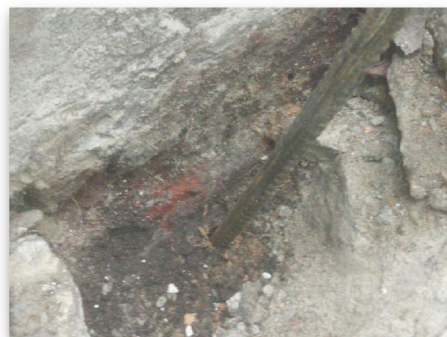
Fig 3.2: Trial Hole 3 Footing

Depth (m)	Symbolic Log	Strata Description	Insitu Tests		Soil Sample	Root Sample
			SV(19)			
0.0	<p>100mm</p> <p>Ground Level</p> <p>Concrete</p> <p>Brickwork</p> <p>Double Step</p>					
1.0			31kpa		Soil @ 1m	
1.5			49kpa		Soil @ 1.5m	
2.0		Dry firm Brown sandy fine medium gravelly silty CLAY	61kpa		Soil @ 2m	
2.5			69kpa		Soil @ 2.5m	
3.0		TRIAL HOLE TERMINATED	70kpa

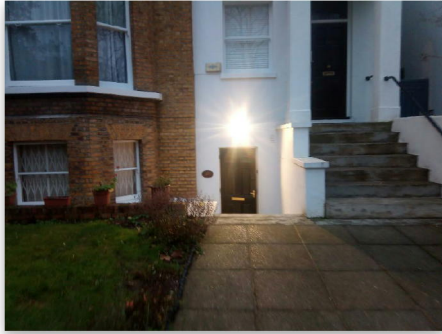
It should also be noted that there was a manhole located beneath the front set of stairs. This was over 2m deep and was a very tight manhole, due to this we could not survey any drainage lines entering it. If the LA wishes for this to be surveyed then 2 men will be required to attend site with confined space entry equipment which will come at a considerable cost. We believe that the drainage at the customers property is all accounted for and runs to the rear manhole.

Fig 7.1: Steps which MH is located beneath

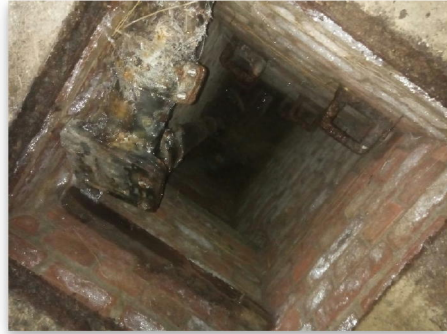
Fig 7.2: Deep MH
