Our ref: CIA/CLP/9185-01

27th January 2022

Garden walls and steps to the rear of 39 Eton Avenue, London NW1

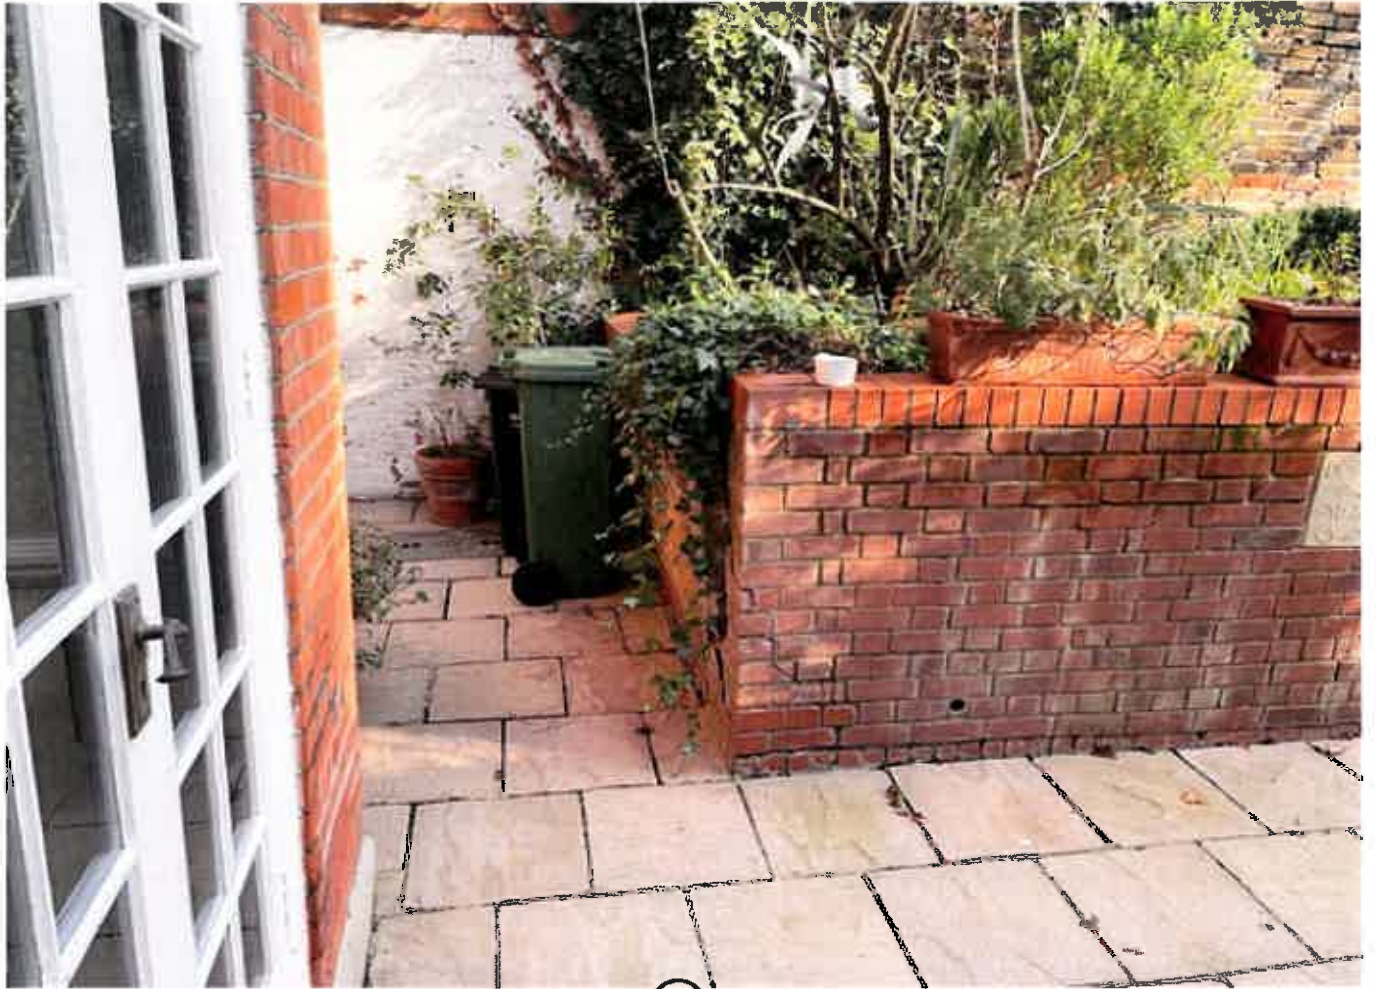
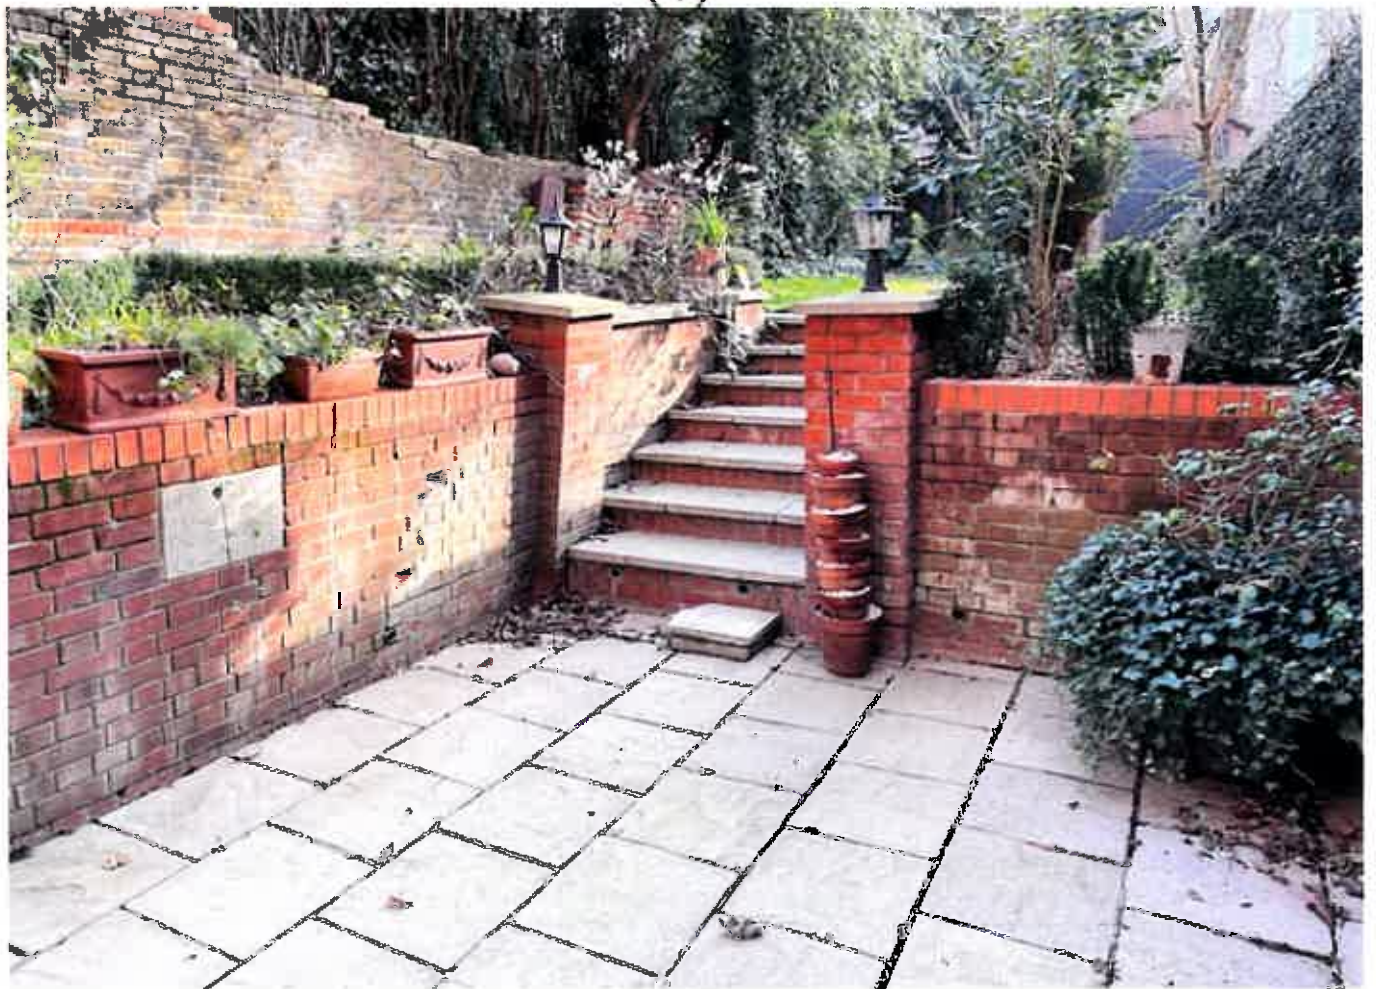
1. The garden to the rear of the main block of flats was some 1.1m above the level of the paved terrace, which was directly outside of Flat 1 (refer to photos 01 and 02). There was a set of 1.5m wide steps leading up from the terrace to the garden, which had brick retaining walls to both sides and 440x440mm brick piers at each end. On top of the retaining walls and brick piers were 50mm thick concrete coping stones (refer to photos 10 to 13).

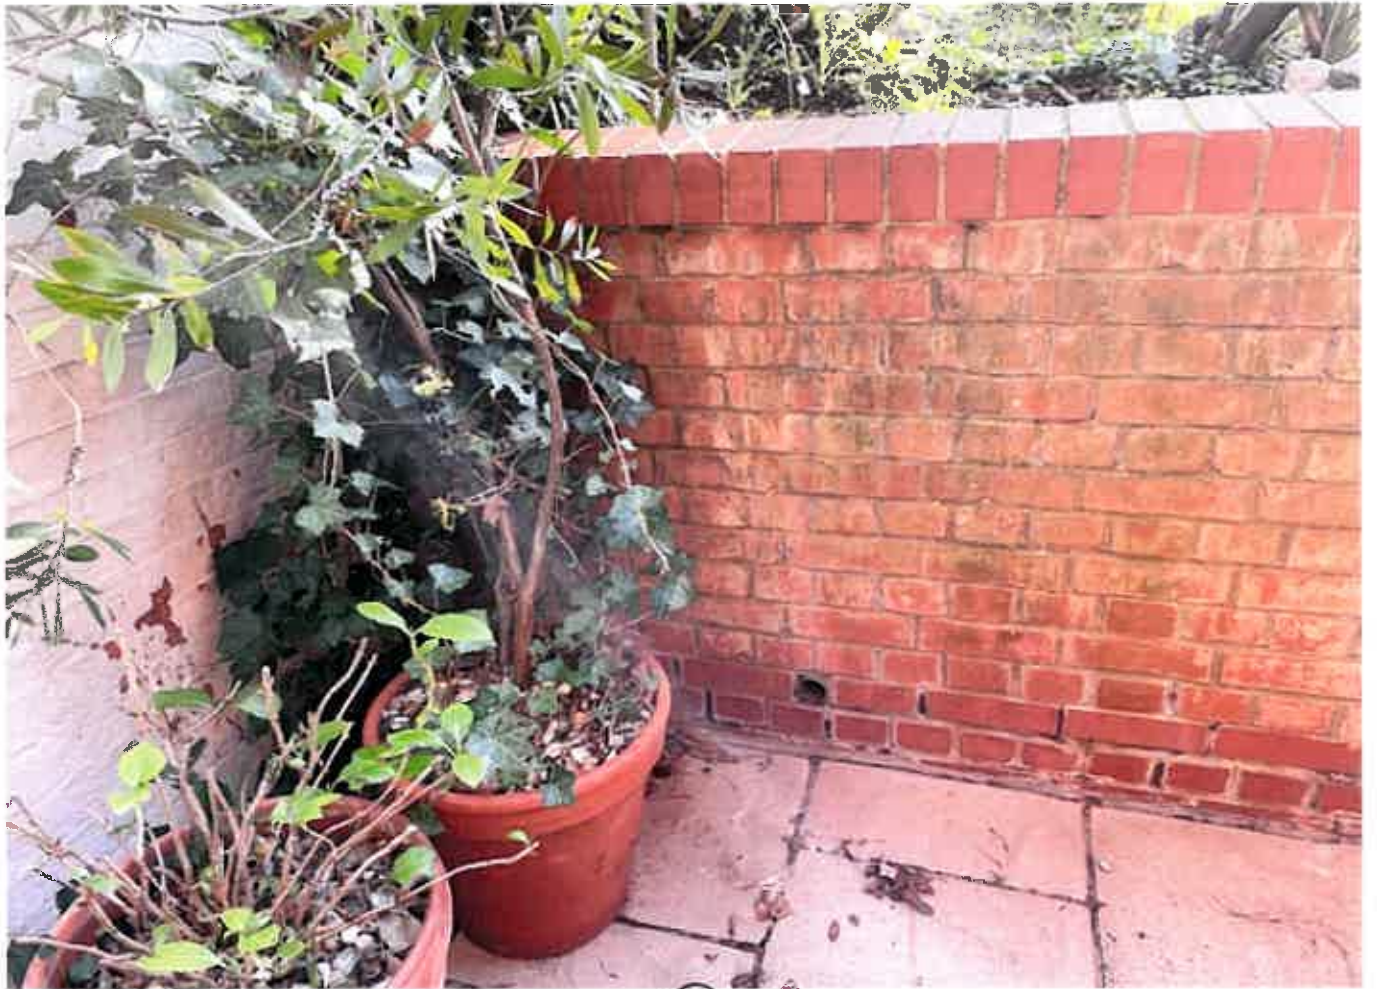
③

Coming off the front of the left hand brick pier (when viewed from the front) was a 1.1m high 'L' shaped retaining wall, the front return leg of which abutted the flank wall of the adjacent building No. 37 (refer to photos 03 and 04). The retaining walls appeared to be constructed from 215mm thick solid brickwork, on top of which was a brick-on-edge capping. There were 50mm diameter weep holes towards the bottom of the retaining walls at about 2.0m centres.

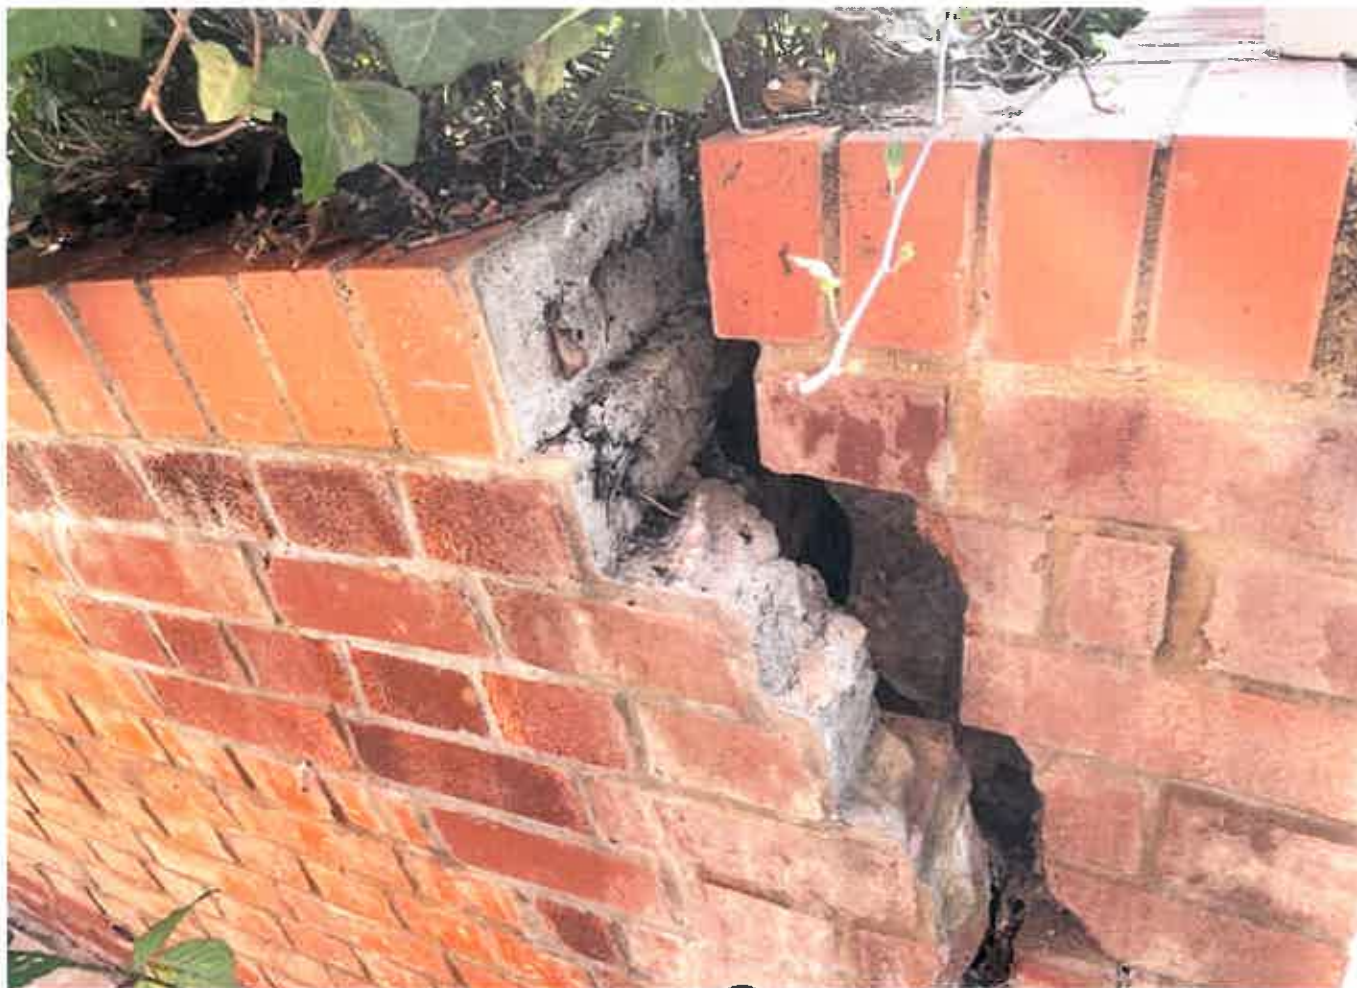
⑤

The front left hand wall was seen to be out-of-plumb, leaning 160mm in towards the terrace at the left hand end next to No. 37, and 130mm at the right hand end near to the steps (refer to photos 07 and 08). At the right hand end of this wall was a 60.0mm wide tapering vertical crack in the brickwork, which reduced to 10.0mm at just above paving level (refer to photos 05 and 06).

A retaining wall is generally considered as unstable when the centre of gravity of the wall is outside of the plan area of the wall itself. This means that for a 215mm thick wall it can only be out-of-plumb by a maximum of 70.0mm before it is considered to be unstable. In this instance the two left hand retaining walls have suffered between 120mm and 160mm of outward rotational movement and are therefore unstable.

All of the retaining walls, and the two front piers to the steps, will need to be taken down and re-built. To resist the applied forces in the long term it is likely that the new walls will need to be increased to at least 330mm thick. The walls can then be reduced to 215mm thick for the last few courses above the upper ground level.

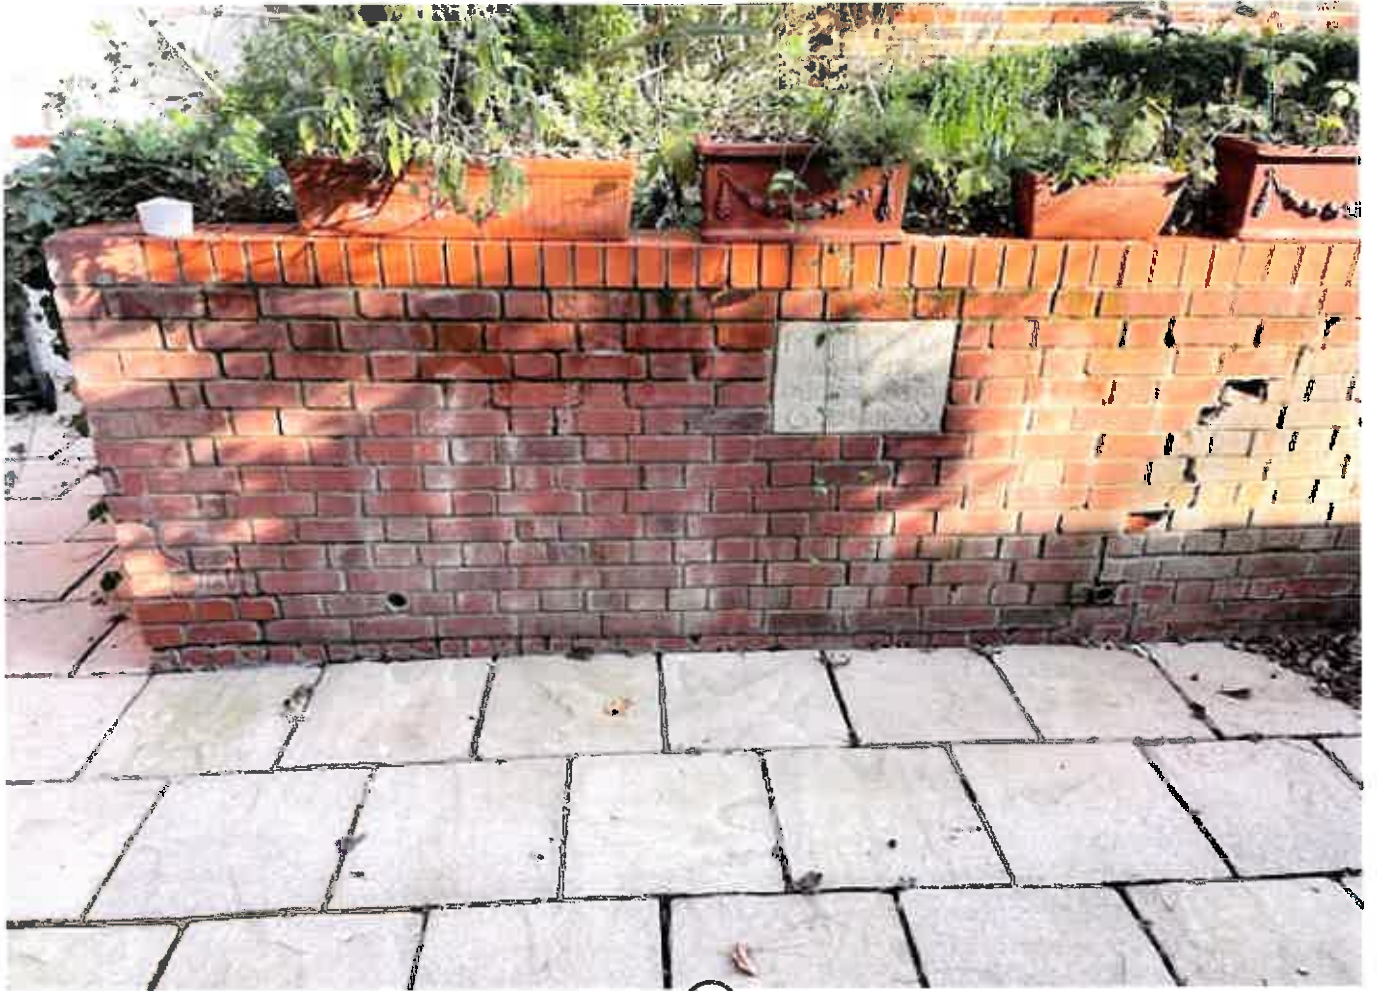
The return retaining wall, which abutted the left hand pier to the steps, was seen to be out-of-plumb, leaning by up to 120mm in towards the terrace (refer to photo 09). There was a 10.0mm wide tapering diagonal crack in the wall some 1.0m in from the pier (refer to photos 10 and 11).

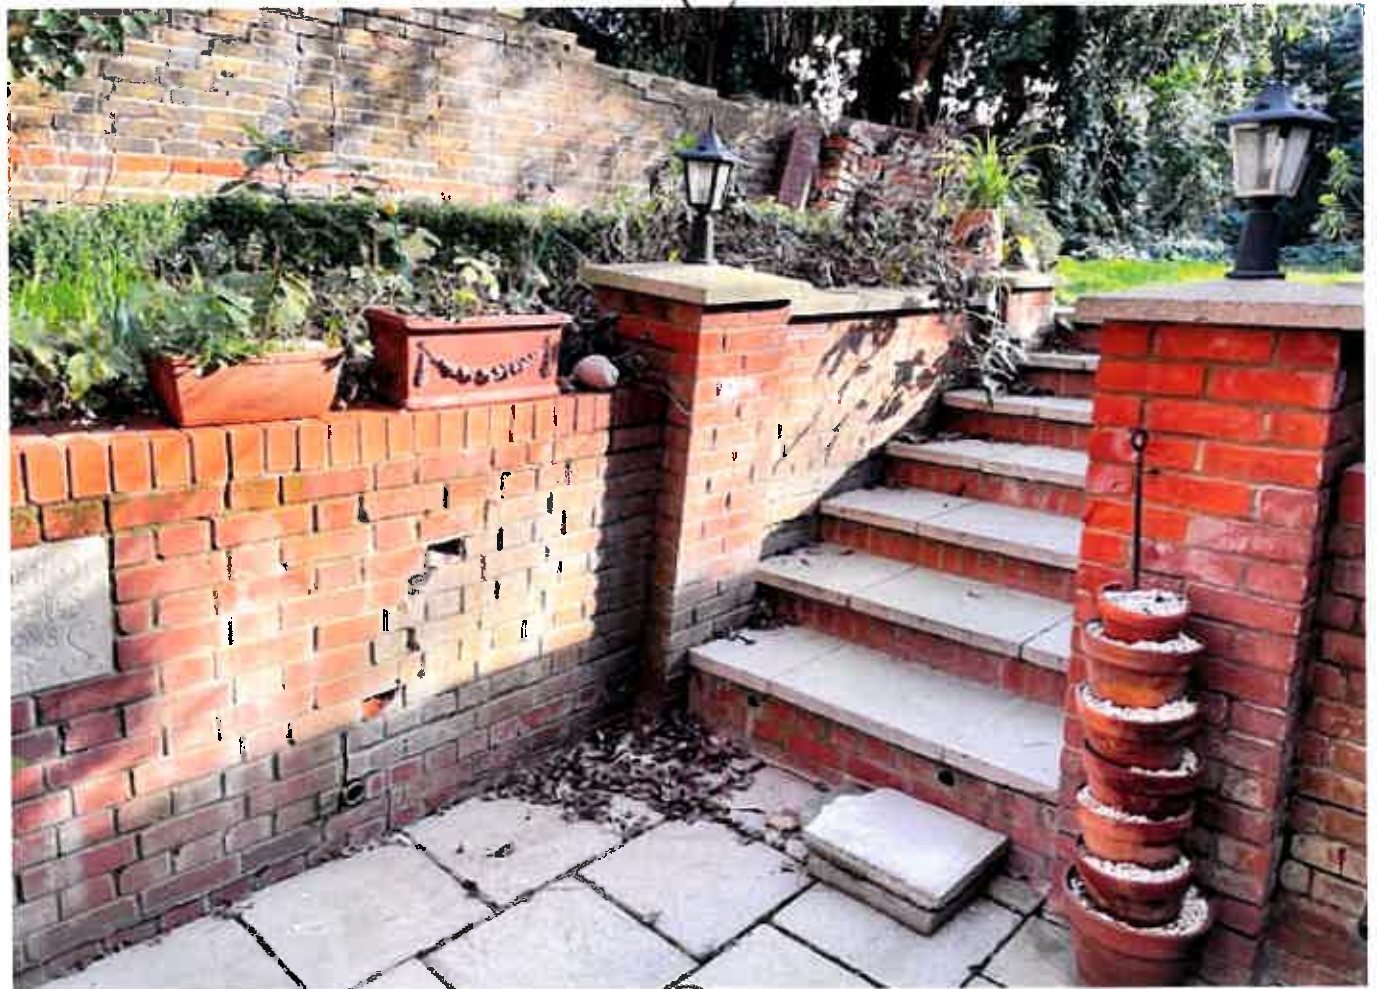
The front left hand pier to the steps was seen to be out-of-plumb, leaning 120mm in towards the terrace (refer to photo 10). There was a 5.0mm wide stepped horizontal crack towards the bottom of the retaining wall that ran along the side of the steps. This wall had also suffered up to 35mm of inwards horizontal movement at the crack location (refer to photo 12).

The 50.0mm thick paving slabs forming the treads to the steps were seen to be badly cracked in places (refer to photos 18 and 19). The steps generally had 175mm risers, except for the bottom tread which had a 290mm riser (refer to photo 10).

The steps themselves do not comply with Building Regulations, in that the bottom tread is 290mm high and is therefore much higher than the other steps which are only 170mm high. All of the steps need to have the same riser dimension to meet Building Regulations, and so they are going to have to be removed and re-levelled to suit.

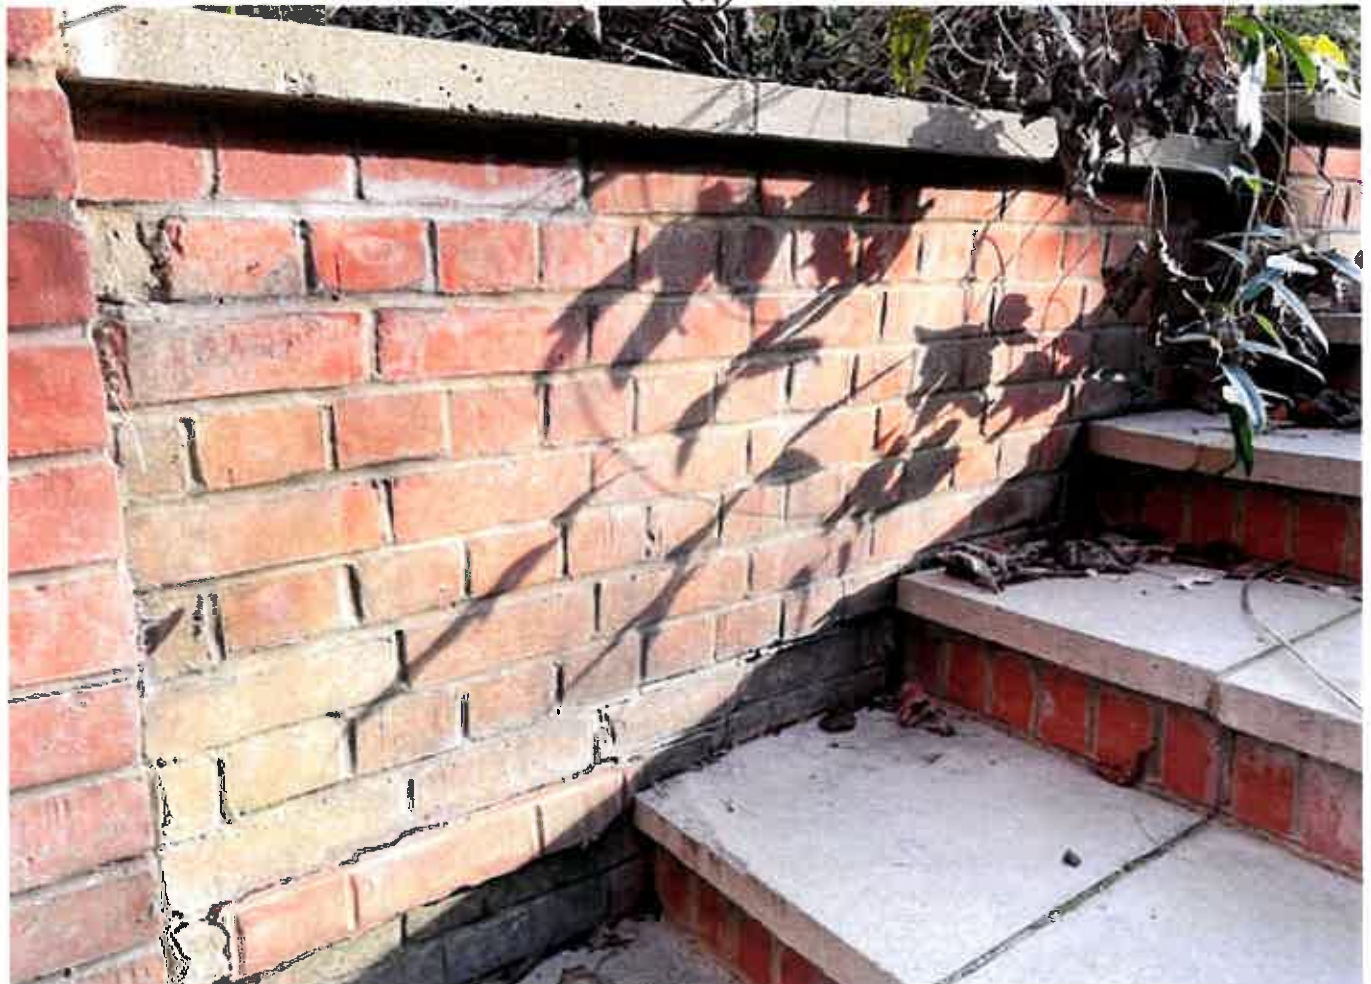
12

The left hand wall to the steps, and the front pier, have suffered significant movement and have failed. Similarly, the right hand front pier to the steps has suffered outward rotational movement, as has the front retaining wall coming off this pier.

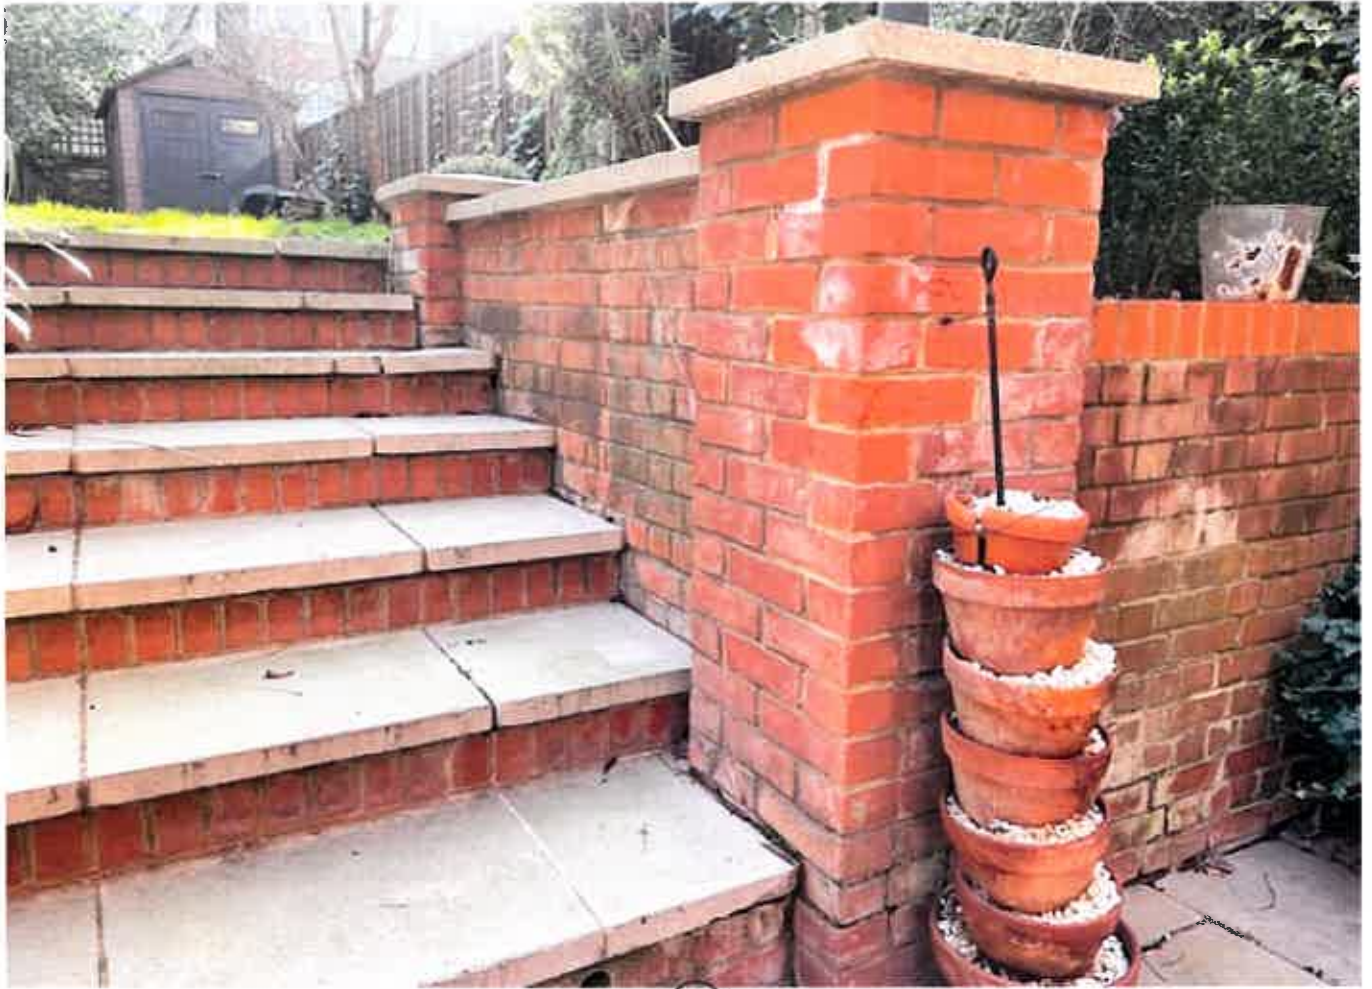
(13)

The front right hand pier to the steps was seen to be out-of-plumb, leaning 20mm in towards the terrace (refer to photo 13). There was a 5.0mm wide diagonal crack in the retaining wall just to the rear of this pier, which would have been due to the previous outward movement of the pier (refer to photos 13 and 15).

The short length of retaining wall from the front right hand pier to the boundary wall with the adjacent Flat 2 was seen to be out-of-plumb, leaning 20mm in towards the terrace (refer to photo 13). There were a number of 5.0mm wide diagonal cracks in the retaining wall, together with signs of 10.0mm outward horizontal movement of the central portion of the retaining wall (refer to photos 16 and 17) .
